AVIATION OCCURRENCE REPORT

A9800104

IN-FLIGHT WING SEPARATION

**SKYHOPPER (AMATEUR-BUILT) C-FRDG
SMITHS FALLS-MONTAGUE
(RUSS BEACH) AIRPORT, ONTARIO 2 mi S
01 MAY 1998**

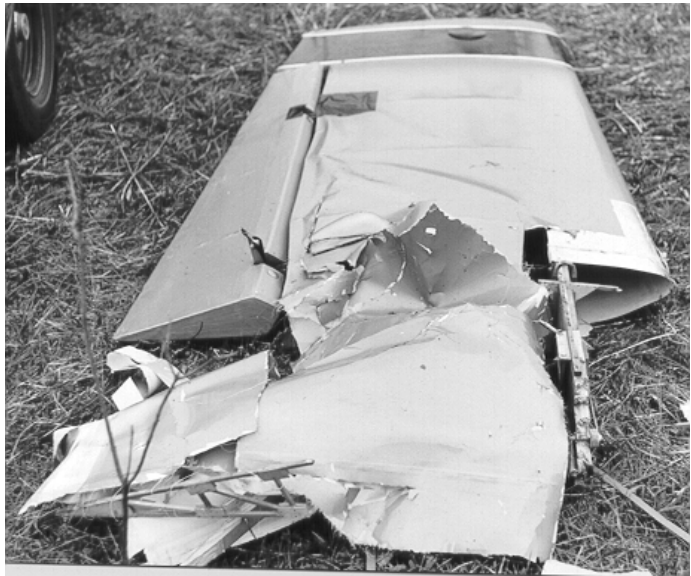
The main wreckage was located two miles south of the airport and the separated section of the right wing was 3 000 feet north of the main wreckage, resting above the ground in brush type trees. The right wing main spar separated from the aircraft 97 inches in from the wing tip, and the rear spar separated 56 inches in from the wing tip. The front spar had fractured in one location and the rear spar in three locations. There was no sign of rubbing on the surfaces of any of the spar fractures. The bottom surface of the trailing edge of the right wing tip was ground down through two layers of wood. The ground-off surface had a fresh appearance and was free of dirt or debris.

Figure 1 - Separated section of right wing

The spars failed in flight, likely under normal flight loads, and the right wing separated from the aircraft. The aircraft then descended out of control and struck the ground.

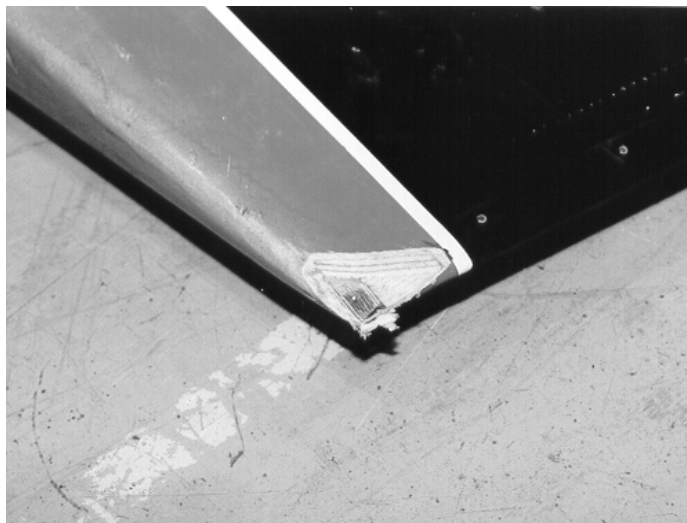
Figure 2 - Scrape mark on bottom of right wing tip

The freshly ground-off surface on the bottom side of the aircraft right wing tip was typical of damage resulting from the wing tip contacting the ground during a recent ground loop or severe swerve to the left. The lack of dirt or debris on the scrape mark indicates the damage occurred from contact with an asphalt or concrete surface. Although it was not possible to quantify the forces applied to the wing as a result of the tip scrape, it can be concluded, from appearance alone, that the forces applied at the time of the scrape were significant enough to crack and weaken one or both of the right wing spars. The lack of any sign of rubbing on the fractured surfaces also indicates that any cracking of the wing spars was recent, possibly as recent as the last take-off or landing. Had there been cracks in the wood spars for a lengthy period of time there likely would have been signs of rubbing on the fracture surfaces as a result of the two surfaces of the crack rubbing together during normal wing loading in flight.

The right wing failed and separated from the aircraft in flight. A recent right wing tip scrape likely weakened the wing and contributed to the in-flight failure of the wing.
