**AVIATION OCCURRENCE REPORT**

**LOSS OF DIRECTIONAL CONTROL**

**HIGHLAND HELICOPTERS LTD.  
BELL 206B JETRANGER II (HELICOPTER) C-GHHT  
WHITECOURT, ALBERTA 30 NM N  
07 MAY 1998**

**REPORT NUMBER A98W0086**

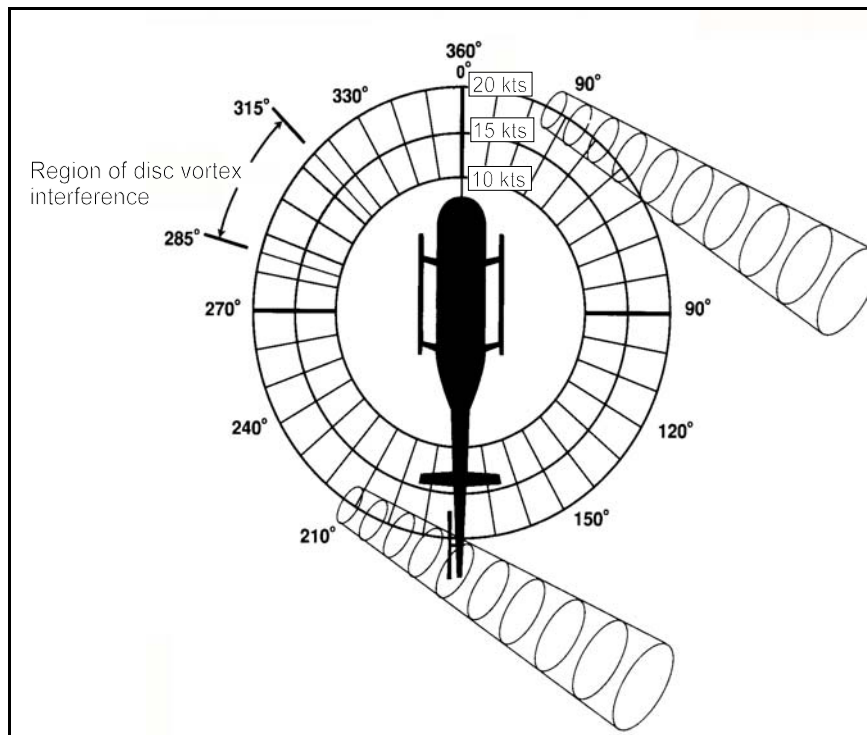
extensive flight and wind tunnel tests as contributing factors in loss of tail rotor authority. In one characteristic known as "Main Rotor Disc Vortex", there is a loss of tail rotor authority as a result of the tail rotor entering the main rotor vortex and causing a reduction in tail rotor blade angle of attack and thrust. The relative wind azimuth in this characteristic is from 285 to 315 degrees. This condition can culminate in a rapid, flat spin and sudden ground contact.

Figure 1 - Main rotor disc vortex interference.

The loss of directional control experienced by the pilot could have been the result of a self-generated loss of tail rotor authority, or the same effect may have been caused by encountering drifting main rotor vortices. While filming the Bell 205 picking up water with a bucket, the pilot of the Bell 206B was flying a slow, parallel course in a westerly direction, low over the trees on the right side. As the Bell 205 climbed away, it flew above and ahead of the Bell 206B. Since the wind was from the southwest, conditions were favourable for the main rotor vortices from the Bell 205 to drift into the path of the Bell 206B. These vortices could cause a sudden reduction in tail rotor thrust with a resultant uncommanded right yaw that could develop into a high rate of turn. The pilot's low height over the trees precluded the reduction of collective pitch to effect recovery.

It is likely that the loss of directional control experienced by the Bell 206B helicopter pilot resulted from a loss of tail rotor authority when he encountered main rotor vortices of the Bell 205 helicopter.

Recovery technique would normally require a collective pitch reduction; however, in this case there was insufficient height available to prevent obstacle contact.
