## AVIATION INVESTIGATION REPORT

A98Q0087

### IN-FLIGHT FIRE—LANDING GEAR WELL

SWEARINGEN SA226-TC C-GQAL

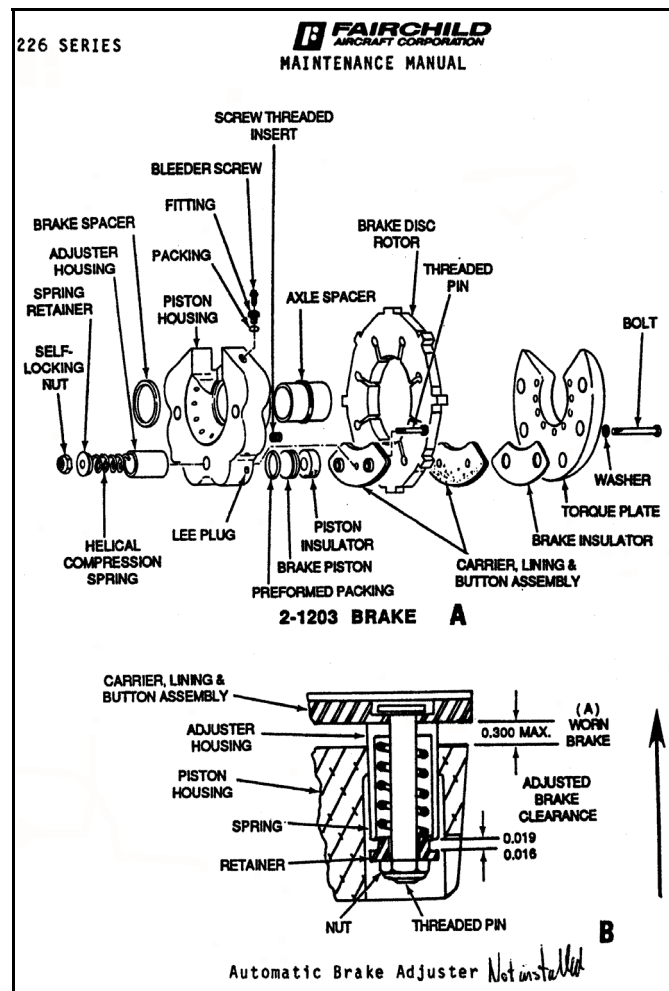
Figure 1 - Aircraft brake assembly

The second set of piston cylinders were found separated from the piston housing. The blackening was more pronounced on these two cylinders than on cylinders one and two described above because they were exposed to higher temperatures.

The brakes are equipped with insulators placed between the pistons and the brake carrier, lining, and button assemblies. The insulators are made of an asbestos compound. Of the 12 insulators on both left brake assemblies, 9 were recovered from the wreckage. All insulators showed excessive heat damage, some showed ovalization of the inner hole with indication of step marks, and others showed traces of soot at an angle to the insulator surface.

The damage to the front of the torque plate was consistent with ground impact. A flatness reading of 0.068 inch was obtained between the highest and lowest points on the surface of the torque plate. Hardness tests on the surface of the torque plate indicated that the material had lost some hardness due to heat in the wheel well. The warp in the torque plate is consistent with ground impact damage; the maximum deviation from flatness at overhaul is 0.020 inch.

No part number was found on the disc from the left outboard brake. The left outboard disc thickness varied from 0.385 to 0.390 inch, and the left inboard disc thickness varied from 0.380 to 0.390 inch. The minimum thickness is specified as 0.300 inch for BFGoodrich parts; therefore, both discs were within the wear limits prescribed by BFGoodrich. The outboard left brake assembly showed 87% average wear, and the left inboard brake assembly showed 70% average wear. The left inboard brake assembly included an RFS disc, approved by the FAA for installation in this brake assembly.

Uniform heat discolouration and heavy lining pressure marks were on both sides and over the full circumference of the brake discs. The steel in the discs showed a grayish-blue colouration indicative of overheating. The discolouration of the brake discs is a sign of tempering by exposure to heat. The discolouration and the shade of colour show that the discs were exposed to temperatures exceeding 600°C (1112°F) for a sustained period. The circumference friction flatness indications observed on both faces of the disc showed that the disc was not warped.

The damage to the various components of the left inboard brake assembly was very similar to the damage observed on the components of the left outboard brake assembly, with the same signs of friction and overheating.
