AVIATION INVESTIGATION REPORT

A98Q0114

SPIN—LOSS OF DIRECTIONAL CONTROL

CESSNA 152 C-GZLZ

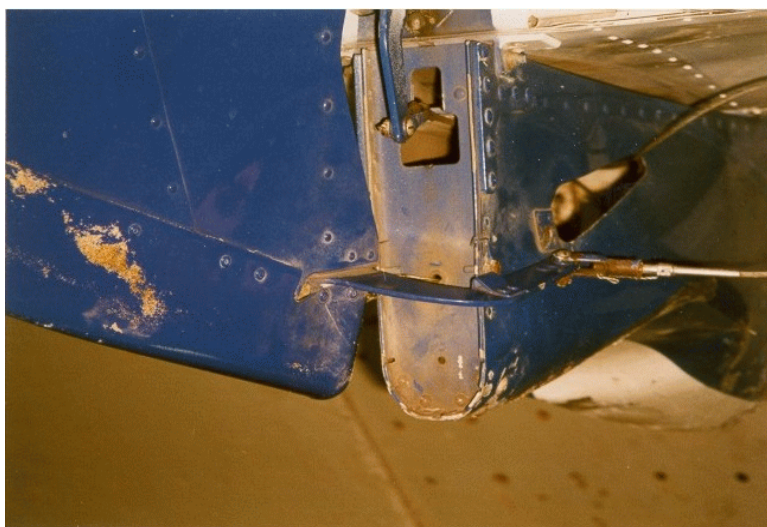
The rudder components and the front end of the aircraft were sent to the TSB Engineering Laboratory in Ottawa, Ontario. It was observed that the rudder stop plate on the right-hand half of the rudder horn was firmly jammed behind its stop bolt on the fuselage. The rudder was deflected 34 degrees measured perpendicular to the hinge line, whereas the maximum allowable deflection for setting the stops is 23 degrees. When the rudder was released from its jam, the deflection was 23 degrees. It

Figure 1 - Rudder jammed in 34-degree deflection

required 36 pounds of steady pull on the trailing edge of the rudder to break the rudder out of its jammed position. This steady pull of 36 pounds equated to 180 pounds if the force was applied to the rudder pedal. However, given that the direction of cable pull tended to increase the jamming by closing the horn, it would not have been possible to break the rudder jam with the application of right rudder.

It can therefore be concluded that the aircraft entered a left spin with the rudder locked at a 34-degree deflection. With the rudder jammed the way it was, no amount of right rudder pedal force would have released the jammed rudder, as the direction of cable pull tends to increase the jamming by closing the horn.

On 14 March 2000, Cessna notified the TSB that it had designed a rudder horn stop bolt with a larger head diameter to prevent over-travel of the rudder following a hard rudder input. Cessna has notified the Federal Aviation Administration (FAA) Aircraft Certification Office about this matter and expects to issue a Service Bulletin offering the new configuration rudder stop bolt for all Cessna 150s and 152s built after 1966. A time frame for these actions was not specified.

The Department of Transport issue an Airworthiness Directive to all Canadian owners and operators of Cessna 150 and 152 aircraft addressing a mandatory retrofit design change of the rudder horn stop bolt system to preclude over-travel and jamming of the rudder following a full rudder input.
