AVIATION OCCURRENCE REPORT

A98O0190

STALL/COLLISION WITH TREES ON TAKE-OFF

PIPER PA 28-151 C-GDVL
ESPANOLA WEST, ONTARIO
27 JULY 1998

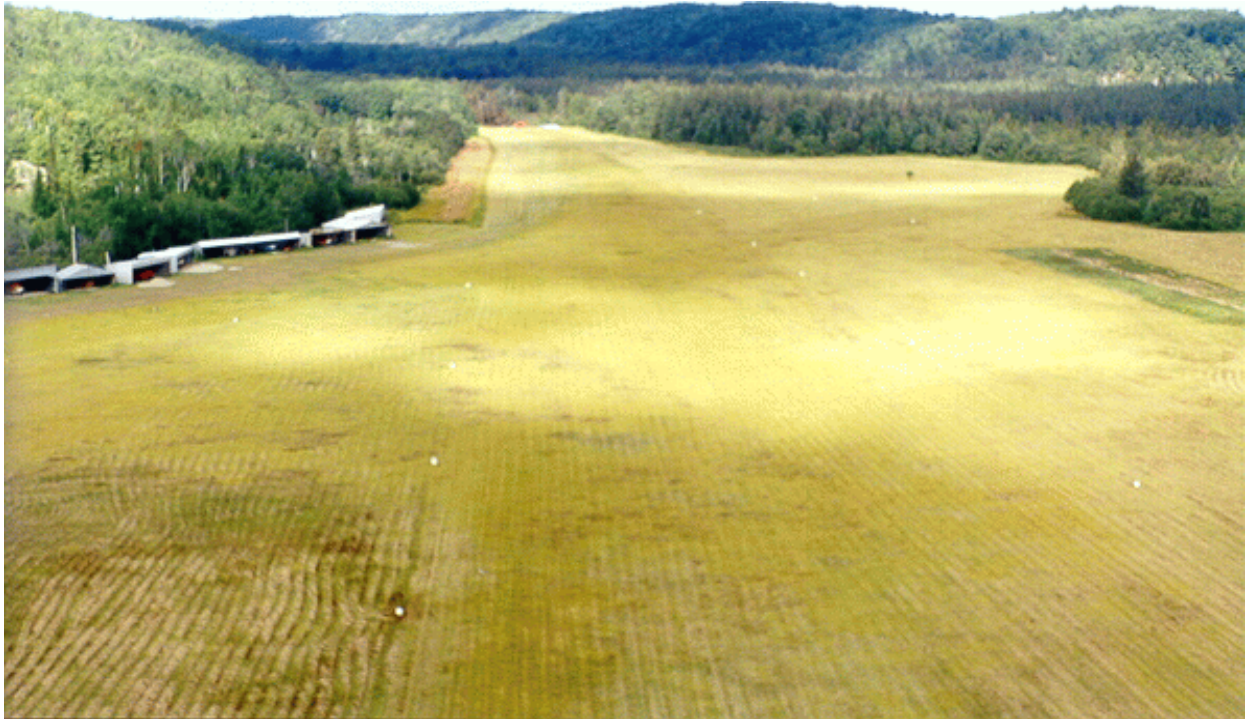
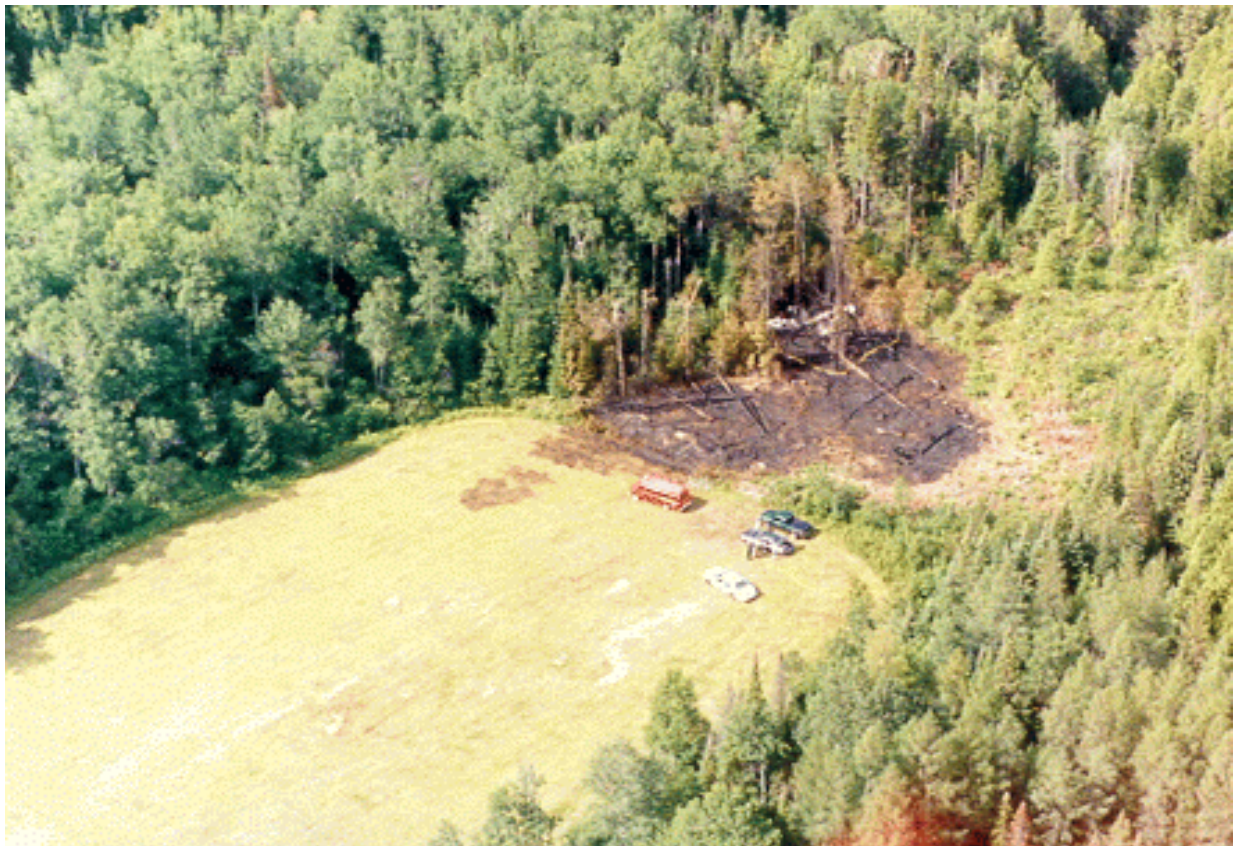
Appendix A - Runway and Crash Site

The runway, approximately 250 feet wide and 2 900 feet long, was surrounded by trees and was oriented on a heading of 283 degrees magnetic. There were patches of ground on the runway surface where the soil was very soft. The grass had been cut recently and was two to three inches long. It was learned from an operator familiar with the airport that their tricycle-equipped aircraft were not permitted to use the airstrip after rain had fallen because the soil becomes very soft when wet. Higher ground is located at the end of the departure runway and to the west. (See Appendix A.)

Information gathered at the scene indicated that the aircraft, while flying straight ahead, first struck two trees with the left wing, which yawed the aircraft to the left, then it struck more trees while travelling sideways from left to right. The aircraft struck the ground still travelling from left to right and came to rest in an upright position with the right wing failed at the root and supported by a tree trunk. An intense fuel-fed fire erupted on or immediately after impact. The most intense fire was in the cabin of the aircraft and broke out before the occupants exited the aircraft.
