AVIATION OCCURRENCE REPORT

A98C0173

RUNWAY OVERRUN

BAe 748-2A (HS-748-2A) C-GTAD

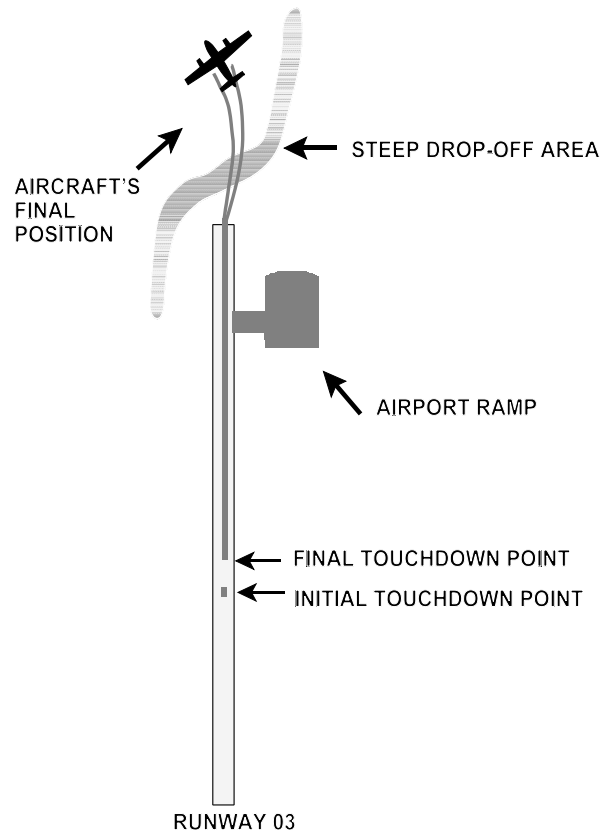
Appendix A - Runway and Ground Roll Diagram

The aircraft's touchdown point, at 1 469 feet from the threshold of runway 03, was slightly farther down the runway than the factored landing distance point assumed by the manufacturer in calculating the aircraft's landing distance required. The selection of runway 03 as the landing runway, and the late touchdown point, placed the aircraft in a position where the distance required exceeded the runway distance remaining, under ISA conditions. Although the manufacturer's calculated landing distance required included a 1.67 safety factor, that safety factor was consumed by the combined effects of the long landing, high ambient temperature, gravel-surfaced runway, possible tailwind, and probable momentary lack of propeller braking.

9. The aircraft landed at a point 1 469 feet from the threshold; the remaining 2 057 feet had a down-slope of 1.28 per cent.
10. The aircraft's propellers probably did not attain ground fine pitch position until about five seconds after landing.
