AVIATION INVESTIGATION REPORT

A98O0214

IN-FLIGHT MAIN ROTOR BLADE SEPARATION

BELL 47-G2 (HELICOPTER) C-FODS

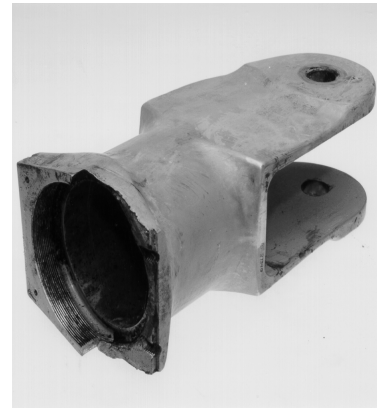
Figure 1 - Failed Blade Grip

The main rotor head, mast and transmission assembly, with the yellow blade attached, as well as the blue blade with the portion of the failed grip attached, were transported to the TSB Engineering Laboratory for examination. Heavy deposits of grease were present in and adjacent to the bore of the failed blue blade grip. The blue blade grip was removed from the blade for further examination. Examination of the components of the blue blade grip attached to the main rotor blade showed no pre-separation deficiencies and both the main rotor radial outboard and duplex bearings were found to be in good condition. Removal of the yellow blade from the grip and disassembly of the yellow blade grip from the main rotor hub revealed the same presence of heavy deposits of grease in and adjacent to the bore of the blade grip, and the bearings were in good condition. It was noted that a quantity of water was dislodged upon disassembly of the yellow blade grip from the main rotor hub.

The blue main rotor blade separated in flight as a result of fatigue cracking initiated in the rotor blade grip's internal threads at the last complete outboard-most thread. Failure occurred instantaneously as the crack grew to critical dimensions under normal service loading. Cracks found in the yellow main rotor blade grip were similar yet less advanced.

The threads in both the Serial Number A100 and A68 grips were found to conform with the standard UN fine thread form, although the root radii were much smaller than those for an exemplar spare. The sharp root radii coupled with extensive pitting found on both blade grips provide one plausible explanation for the premature fatigue failure of the blue grip. Both sharp root radii and pitting are known stress concentrators which facilitate fatigue crack initiation.

1. One of the helicopter main rotor blades separated from the helicopter in flight when the blade grip failed due to fatigue cracking initiated within the thread area of the blade grip.
2. The reason for the rotor blade grip's fatigue failure could not be determined.
3. The blade grip failed 992 hours before the first in-service required inspection cycle.

Current inspection requirements for the main rotor blade grips of Bell 47 helicopters may not adequately reduce the risk of structural failure and loss of life. Therefore, the TSB sent an Aviation Safety Advisory to Transport Canada suggesting that they determine whether any Canadian registered Bell 47 helicopters are equipped with main rotor blade grips belonging to the affected batch lots. The TSB suggested the possible need for a fatigue crack examination at an interval that provides a greater margin of safety than the existing inspection cycle.

1. Identify and inspect the Bell 47 helicopter main rotor blade grips from the same batch lots as on the accident helicopter; and
2. Modify Alert Service Bulletin 47-85-12, Rev A, and U.S. Airworthiness Directive 86-06-08 R1 to include eddy current testing.
