RAILWAY INVESTIGATION REPORT
R10Q0037

MAIN-TRACK DERAILMENT

CANADIAN NATIONAL
FREIGHT TRAIN M-365-21-23
MILE 165.80, SAINT-MAURICE SUBDIVISION
CLOVA, QUEBEC
23 AUGUST 2010

Report Number R10Q0037

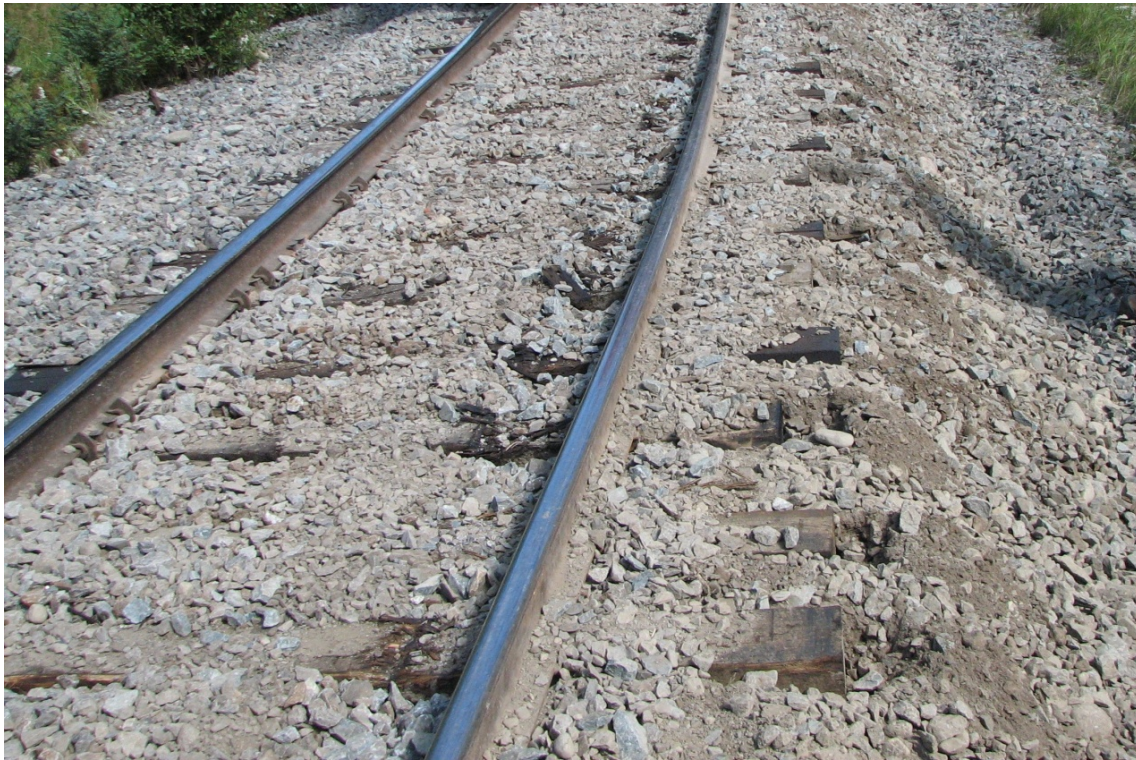
In the eastern part of the curve, about 75 feet behind the last derailed car, the track had shifted laterally about 12 inches toward the outside of the curve (south side of the track). The ballast consisted mainly of crushed rock, was in good condition and showed no signs of fouling. The ballast was disturbed and the shoulder was only about 6 inches wide (see Photo 1). Over 50% of the ties had been replaced recently.

Photo 1. Disturbed ballast at ends of ties

The visual quality control was carried out after the completion of the work. During this task, the narrow shoulder was not noticed by the inspector. Visual inspection may be adequate for identifying major deficiencies; however, this type of inspection may not be adequate for

1. The derailment occurred when the track shifted laterally as the train was passing.
2. Since the rail-neutral temperature in the derailment area was lowered due to the work, the track became more susceptible to buckling.
3. Track levelling, tie replacement and the narrow shoulder, which was not detected during the quality control performed at the end of the work, weakened the track structure and reduced its capacity to resist lateral loads generated by the cars.

On 31 August 2010, Canadian National issued new procedures concerning the action to be taken after ties are laid and the dynamic stabilizer is used. Before normal train speed is resumed following work, a 10 mph slow order must be in place for the first 2 trains and 30 mph for the next 2 trains, and the track must be inspected after the passage of each of those trains.
