Corrosion of Domestic Oil Tanks

By: William Moody, P. Eng.
Moody Engineering Consultants
Dartmouth, Nova Scotia

February 2000

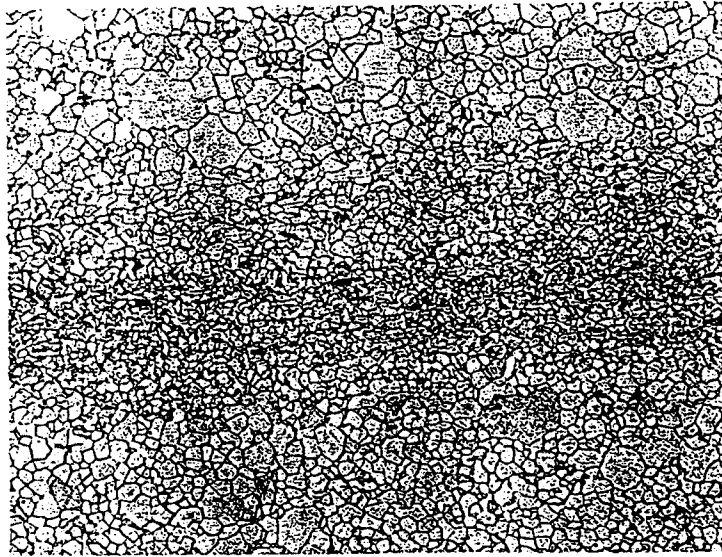
Figure 1: Ferritic Grain Structure in Older Steel Oil Tank 100X

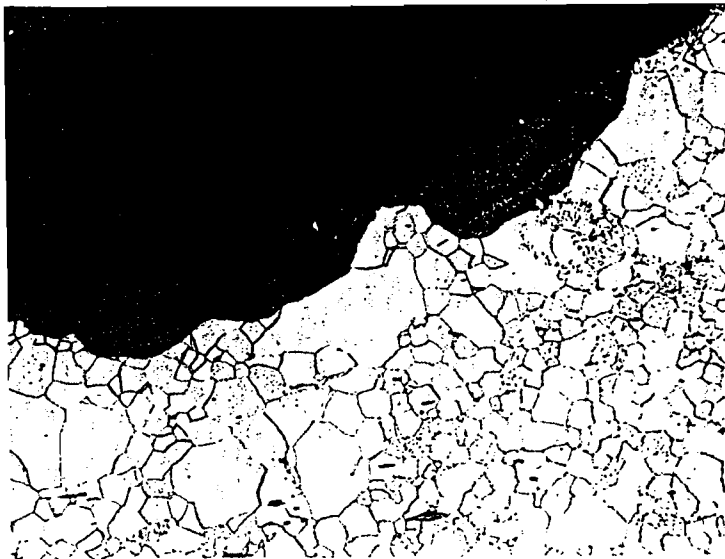
Figure 2: Pitting Action Initiated at Inner Surface of Oil Tank 200X

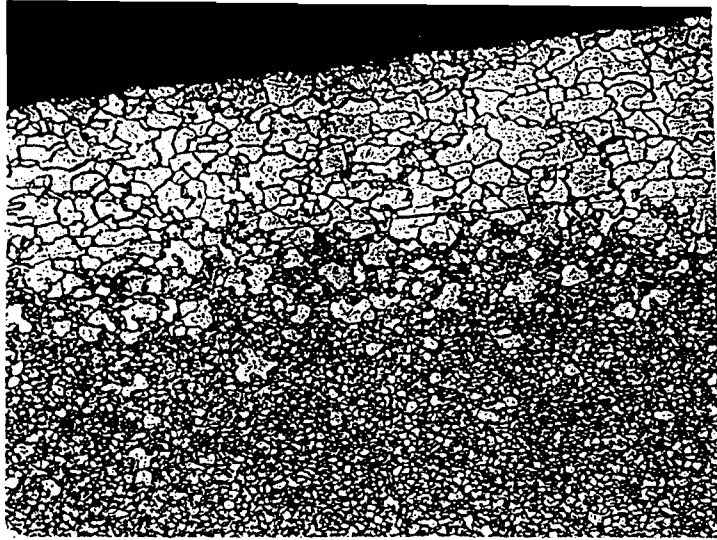
Figure 3: Ferritic Grain Structure in Newer Steel Oil Tank 100X

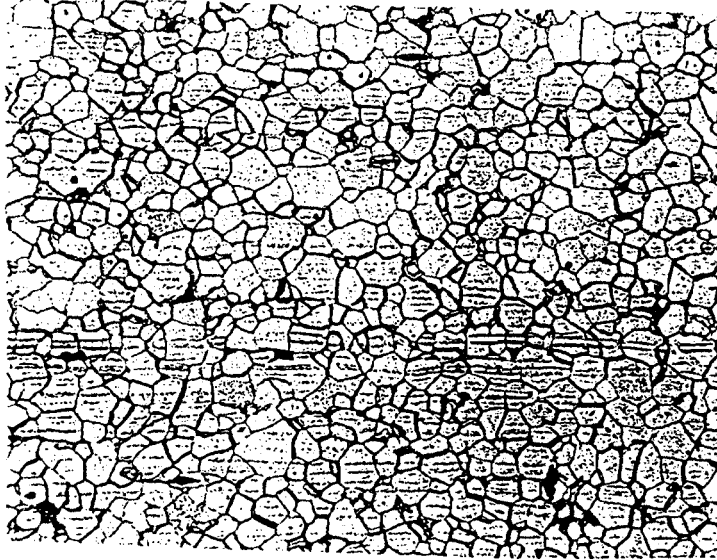
Figure 1: Ferritic Grain Structure in Steel Sample B7 at 200X

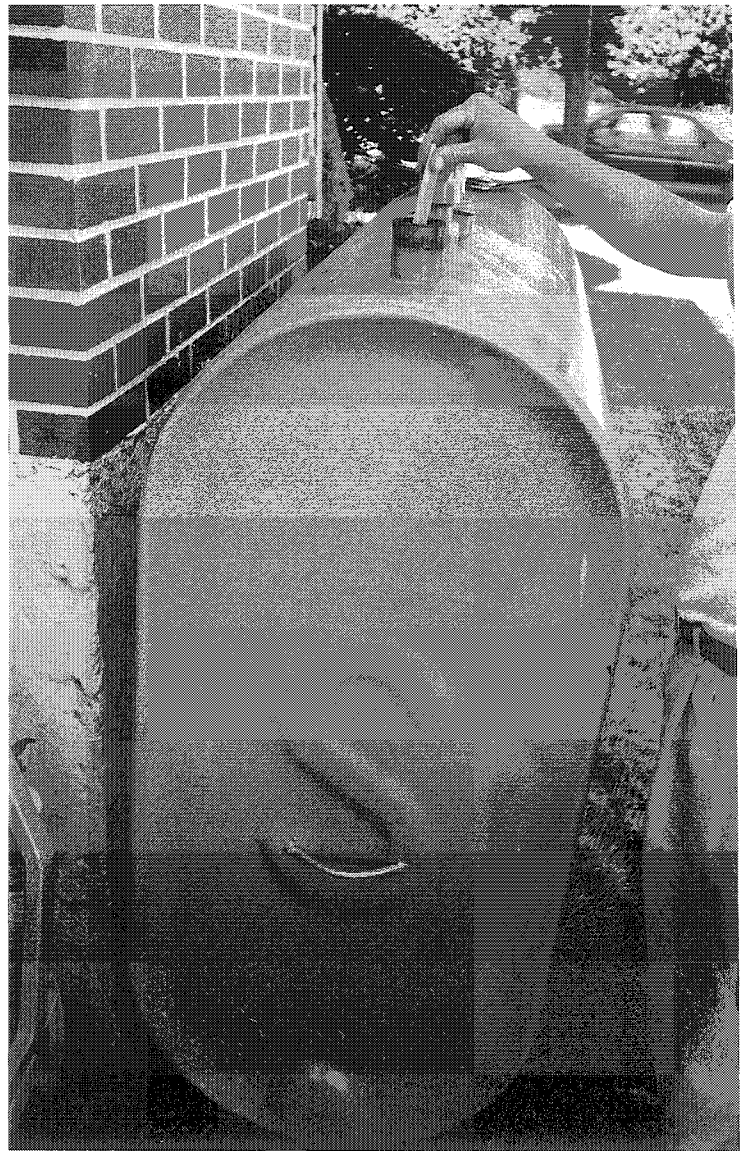
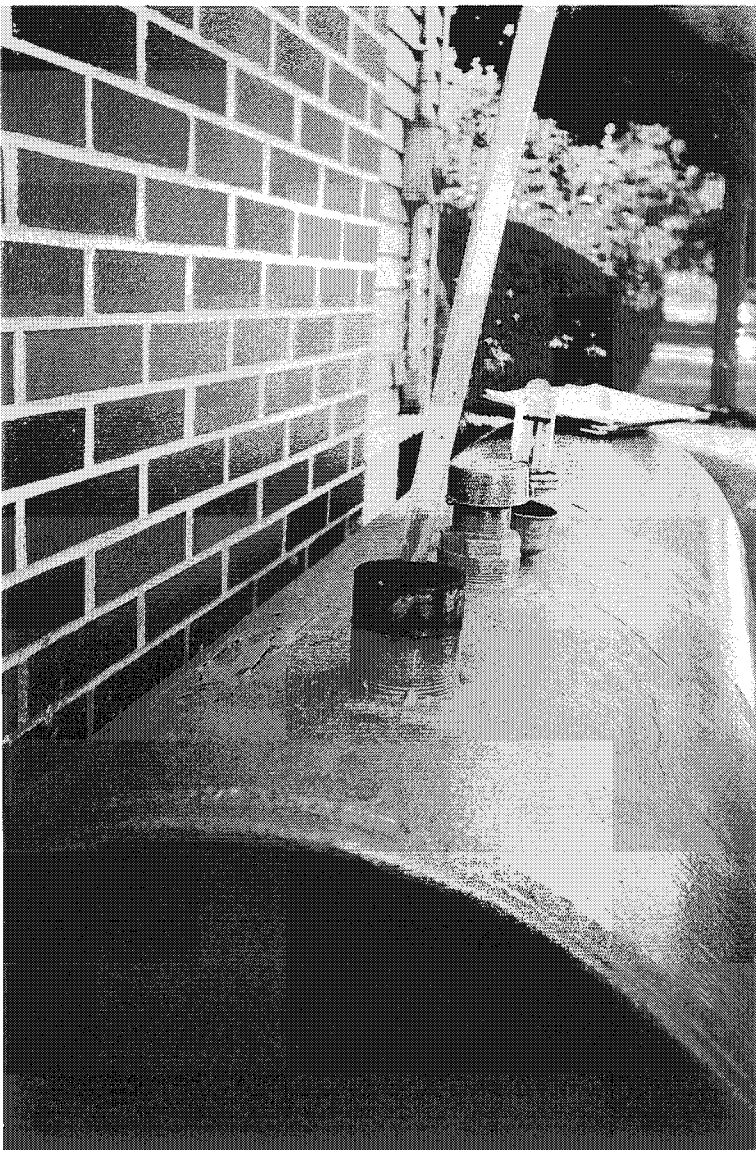
As noted in the last item above, included as part of the inspection was an investigation to determine the presence of water in a tank. The test could be completed only if there was easy access to the interior of the tank through an existing opening and consisted of inserting a dipstick through this opening. Water indicating paste (alkanolamine a dye, in clay as manufactured by Kolor Kut Products, Houston, TX) was applied to the end of the dipstick. If present, water being heavier than oil, sits on the bottom of the tank and is detected by a colour change in the paste. Eight such tests were performed and water was recorded in three instances. (See Figure 1)

Figure 1 - Test using "Water Finding" paste

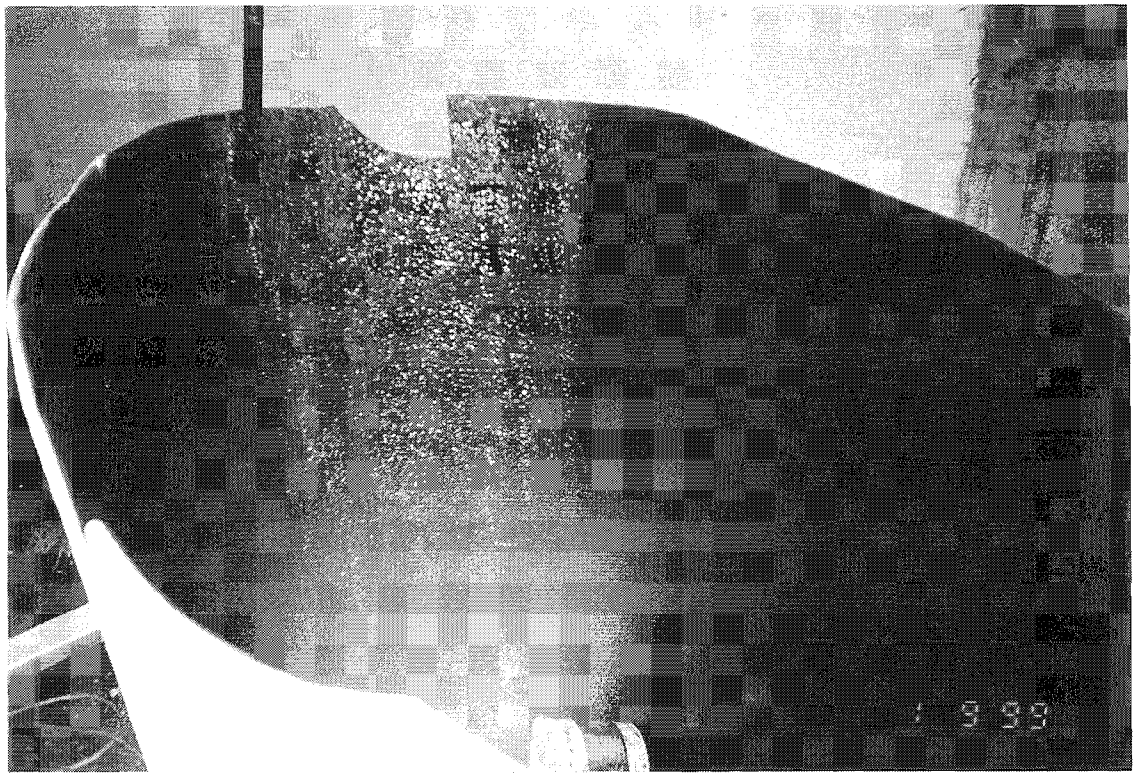
Figure 4 - Interior tank sludge and shell test sample

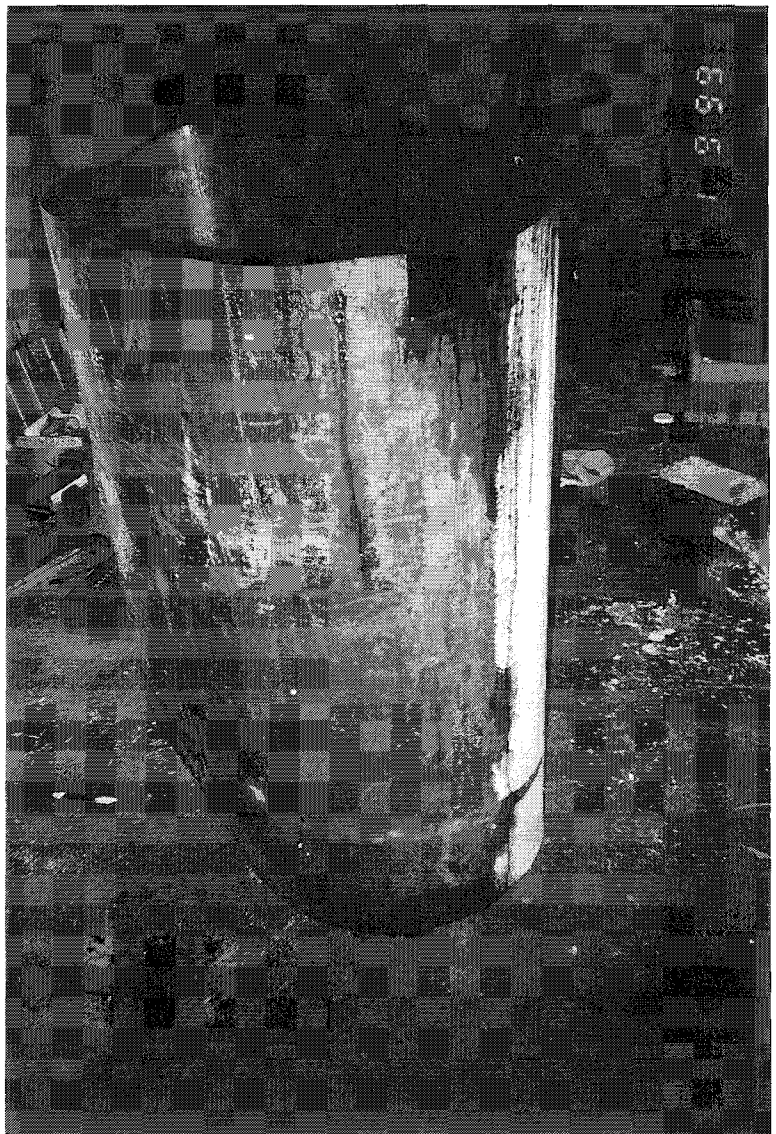
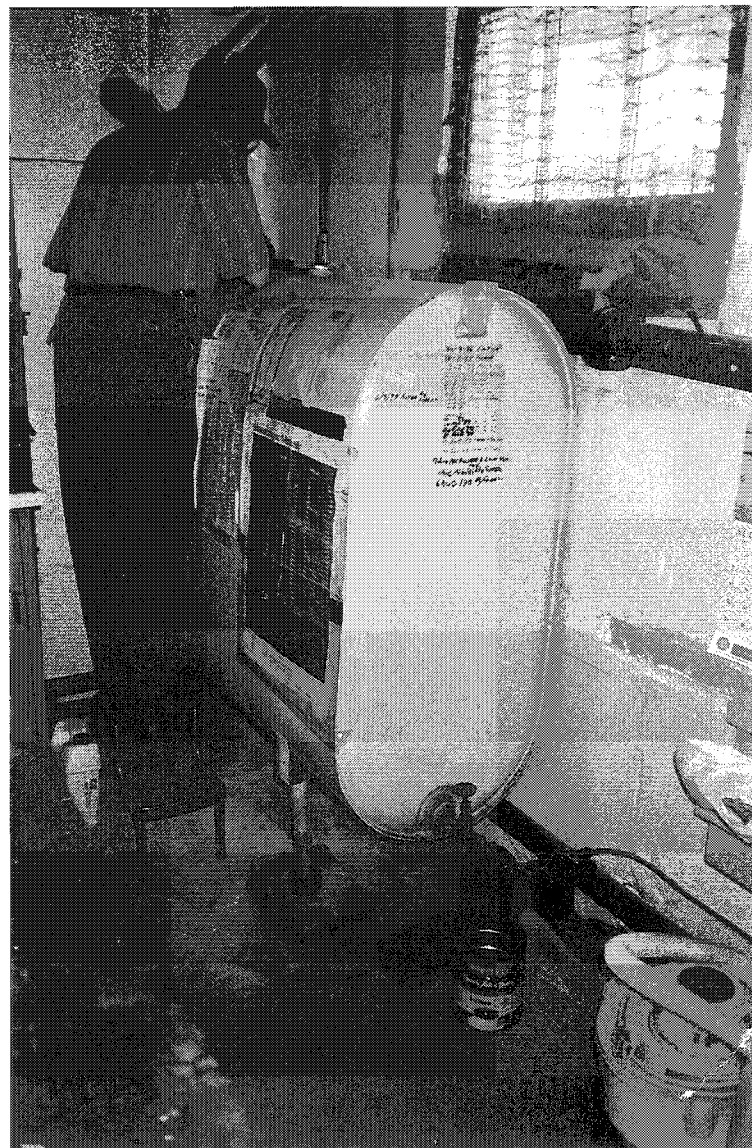
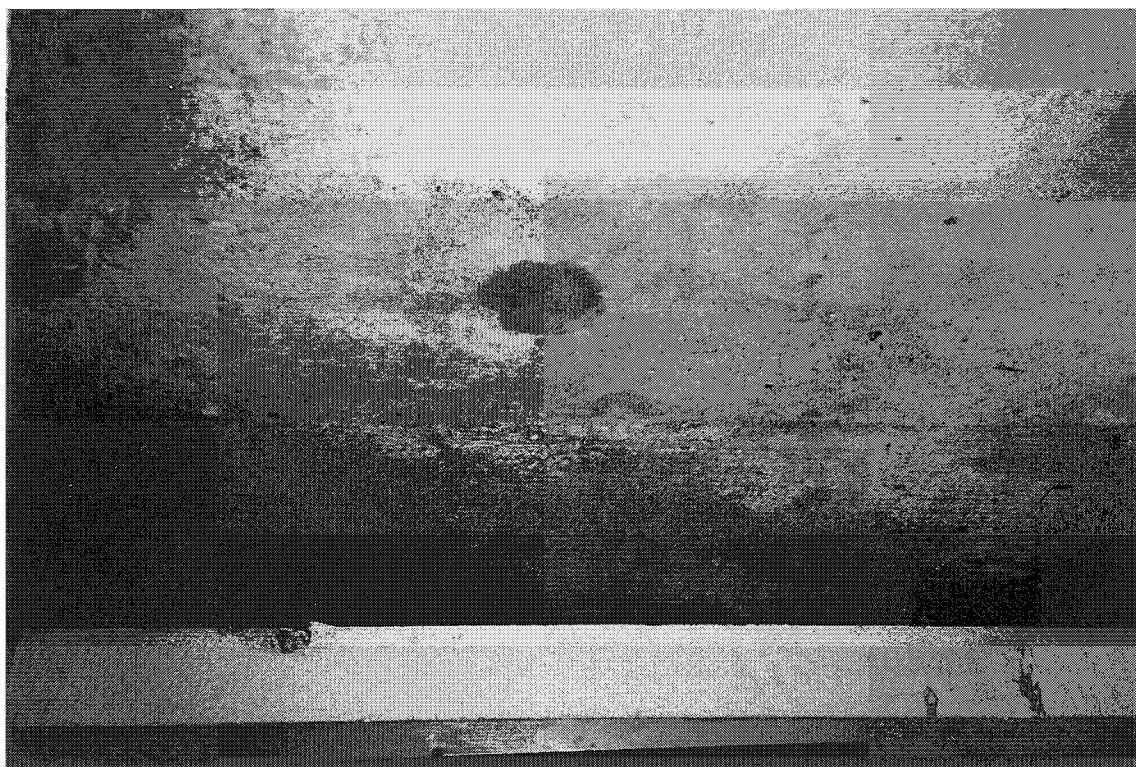
This tank was determined to be leaking during an inspection carried out under Section 3. Samples were taken after the tank was taken out of service and replaced with a new tank. Figure 5 show the tank installation and the bottom leak.

Figure 5 - Leaking tank installation
