Cost-Effective Indoor Air Quality and Energy Efficiency Recommendations for First Nations Housing

Cost-Effective Indoor Air Quality And Energy Efficiency Recommendations For First Nations Housing

Final Report

January 2001

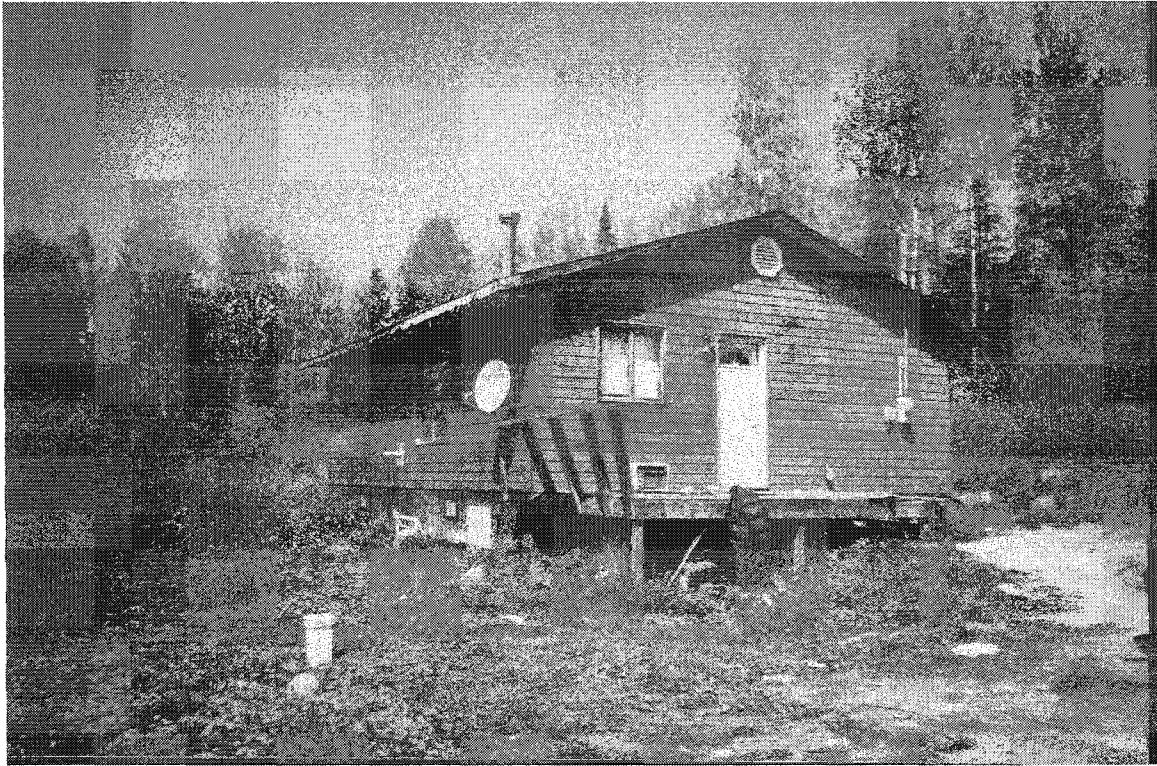
Figure 1: House 1 exterior, southeast corner

Detached bungalow about 10 years old
Sloping grade toward house on the north side
Settled grade adjacent to foundation
Both porches missing boards – unsafe
Scattered debris
Good sun exposure and airflow
Bathroom fan exhaust hood on roof
No air intakes
Wood frame construction with wood siding
Original windows – unpainted wood frame
horizontal sliders, double glazed, no screens,
broken pane in northeast bedroom
Doors – insulated steel, no trim or airseal on
inside of doorframe
All caulking in poor condition
Wood soffits and fascia
No eavestroughs or downspouts
Medium slope roof, asphalt shingles, good
condition
Interior prefabricated metal chimney with cap
– not used – woodstove taken out, sidewall
vented pellet stove installed

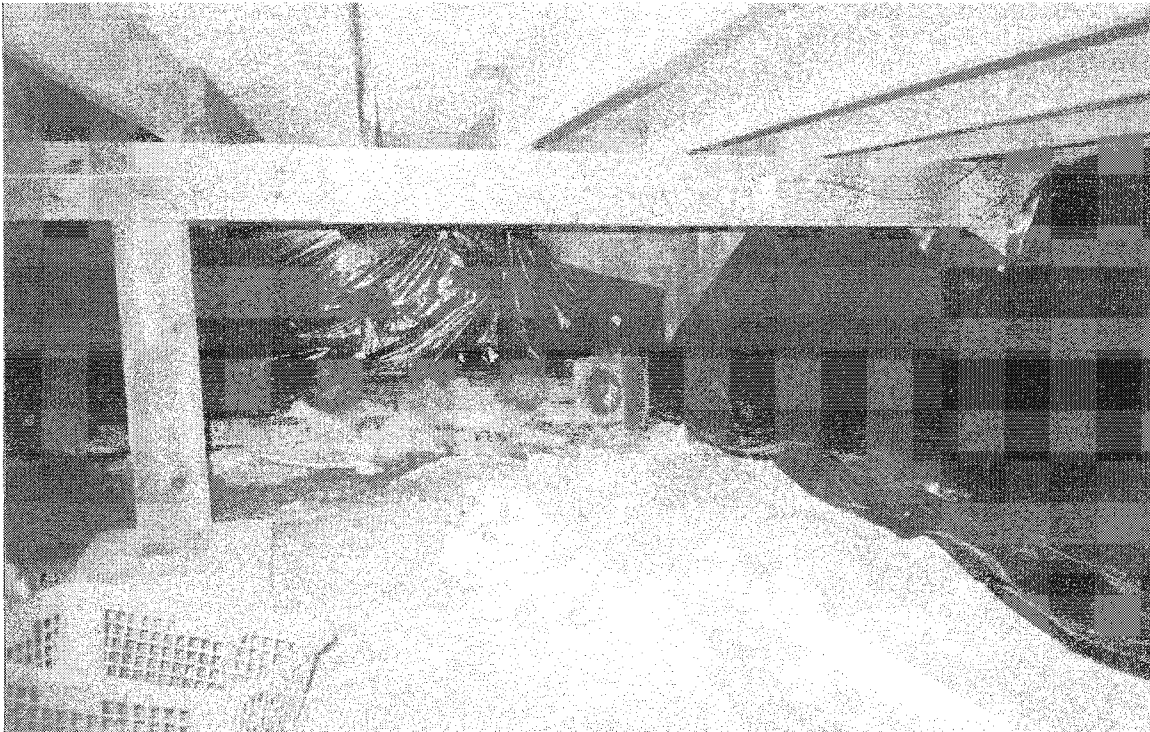
Footing exposed at grade level on south side
Ventilated to outside in some seasons – 2
south vents, closed; none on other sides
Heated in some seasons – portable electric
heater on floor
Ill-fitting plywood access door, south side
Earth floor – no moisture barrier
Some mold on debris
White, wispy mold on soil
No floor insulation, drain, or sump pit
Evidence of repaired bathroom plumbing leak
Plumbing drain, waste and venting (DWV) not
well supported
Wall insulation – R20 glass fibre batts – some
missing
Wall 6mil poly air/vapour barrier, not
continuous – hanging, unsealed
Floor joists – 2x8 with plywood subfloor
No rim joist insulation or airsealing
Some storage – old glass fibre batts, rags,
planks, old plumbing line

Figure 2: House 1, crawl space, no floor moisture barrier, poor air/vapour barrier, debris

- 2. Install a sealed moisture barrier over the crawl space dirt floor.** Even out any dips in the floor. Lay sheets of 6mil or preferably thicker polyethylene, tough enough to resist tears, over the whole floor. Overlap and seal joints with caulking or sheathing tape. Adjacent to each wooden floor beam support post, temporarily jack up the main beam slightly. Slip a sheet of poly between the bottom of the wood post and the concrete footing. If this is not possible, at least seal the main sheets of poly to the edges of the post footings. (Do not seal the poly to the wood post, which could cause the bottom of the post to rot faster). At the edges of the floor, ensure that the poly extends up and over the concrete footing to the preserved wood framing. Seal it to the bottom plate of the preserved wood framing. A sealed floor moisture barrier is an important step in reducing moisture in the crawl space as well as in the rest of the house. Set the existing electric construction heater on a level concrete patio slab.

- 4. Re-install the existing poly on the crawl space walls.** Remove the existing poly. Discard any wet glass fibre batts. Note any foundation leaks that may be corrected from the outside. Remove the crawl space vents and seal the openings. Ensure that the preserved wood frame walls are dry and fully re-insulated with dry glass fibre batts. Re-install a 6 mil poly air/vapour barrier on the inside face of the crawl space walls, ensuring that all joints are overlapped and sealed with sheathing tape. Seal the top edge to the top plate of the preserved wood framing. A continuous wood furring strip along the top edge can help to ensure an airtight seal. Note: moisture from the ground will still wick up through the concrete footing and into the preserved wood framing. PWF foundation walls should never be built on concrete footings without some type of capillary break between the concrete and the wood. Drainage is important to keep the foundation as dry as possible. An interior sealed wall air/vapour barrier is needed to make the best of a bad situation.

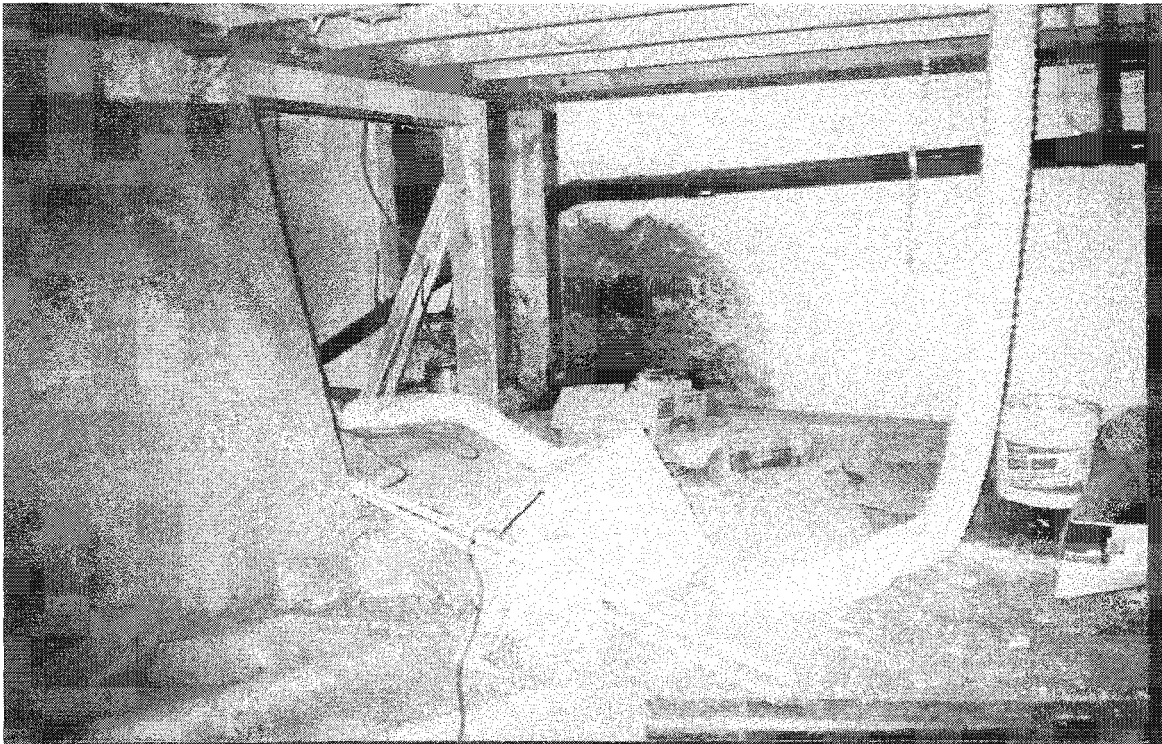
the northeast corner of the party wall under the laundry room. This leak, which has probably existed since the house was built, is a continuing source of contaminated water that wets the party wall drywall. This has caused an area of mold growth on the drywall that is approximately 2 feet x 3 feet. Ensure that all drain lines are well supported. (See medium cost #2.)

Figure 4: House 2 crawl space, plumbing leak, mold

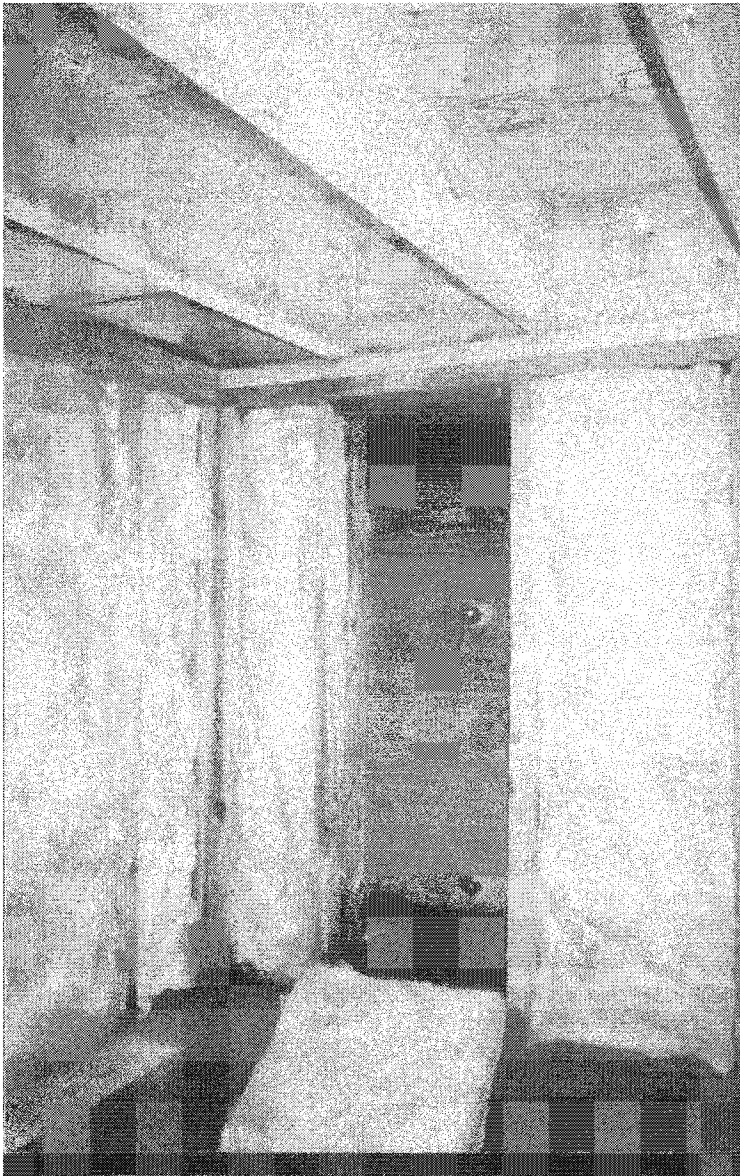
Figure 5: House 2 foundation walls and insulation wet from capillary action and condensation

5. **Remove the existing glass fibre batt insulation from the crawl space walls.** Discard any wet glass fibre batts. Note any foundation leaks that may be corrected from the outside. Ensure that the preserved wood frame walls are dry and fully re-insulated with dry glass fibre batts. Install a 6mil poly air/vapour barrier on the inside face of the crawl space walls, ensuring that all joints are overlapped and sealed with sheathing tape. Seal the top edge to the top plate of the preserved wood framing. A continuous wood furring strip along the top edge can help to ensure an airtight seal. Note: moisture from the ground will still wick up through the concrete footing and into the preserved wood framing. PWF foundation walls should never be built on concrete footings without some type of capillary break between the concrete and the wood. Drainage is important to keep the foundation as dry as possible. An interior sealed wall air/vapour barrier is needed to make the best of a bad situation.

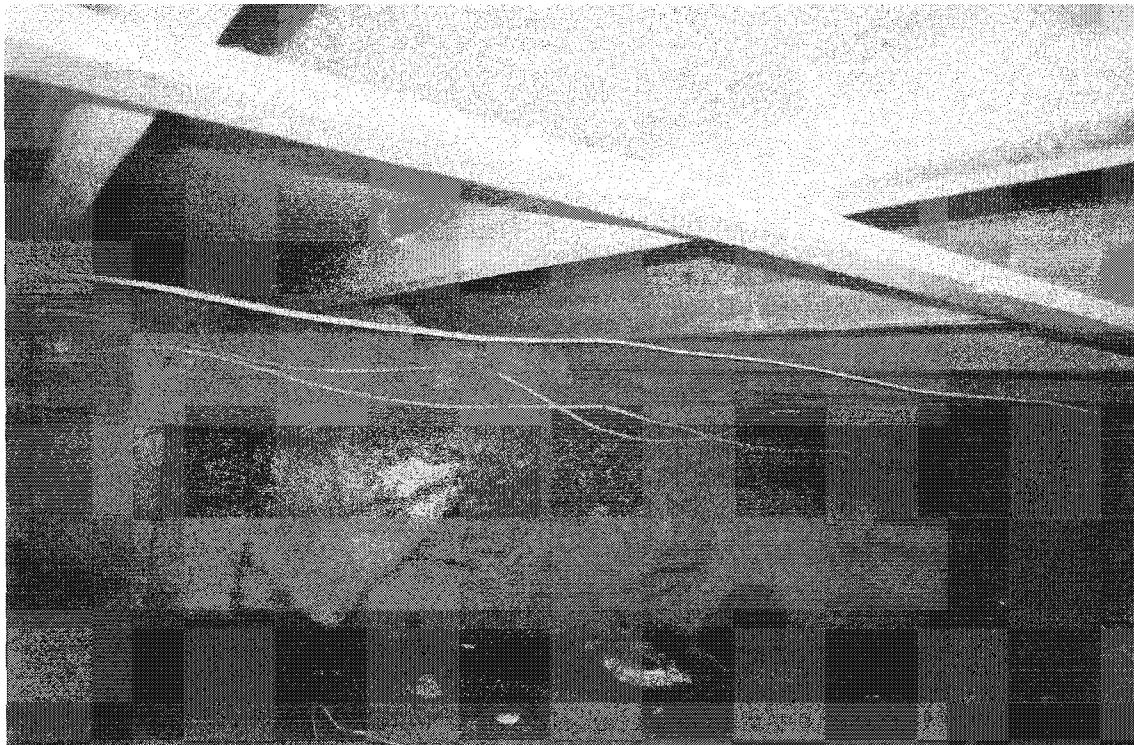
Figure 7: House 3 crawl space

T 16C, RH 60%
Access hatch from main floor
Uninsulated dirt floor, damp at galvanized water pipe section below hatch
Electric heater laying on ground, disconnected
No crawl space ventilation
Concrete block walls, deteriorated at bottom course southwest side, freeze-thaw
Three inches of expanded polystyrene on inside of block walls
Crawl space ceiling not airtight but insulated with R12 glass fibre batts held up with ¼" hardboard
Rim joist insulated with R12 glass fibre batts, no air/vapour barrier
Some storage on dirt floor
Only the northwest side of the crawl space is accessible – glass fibre batts at the main floor beam split the crawl space in half – other side looks similar but difficult to see
