**TESTING OF
DOMESTIC
OIL TANKS**

By: William Moody, P.Eng.
Moody Engineering Consultants
Dartmouth, Nova Scotia

October 1998

The scope and objective of the research covered by this report is to develop a practical, efficient and economical method of determining the condition and projected remaining life of operational above ground domestic oil tanks.

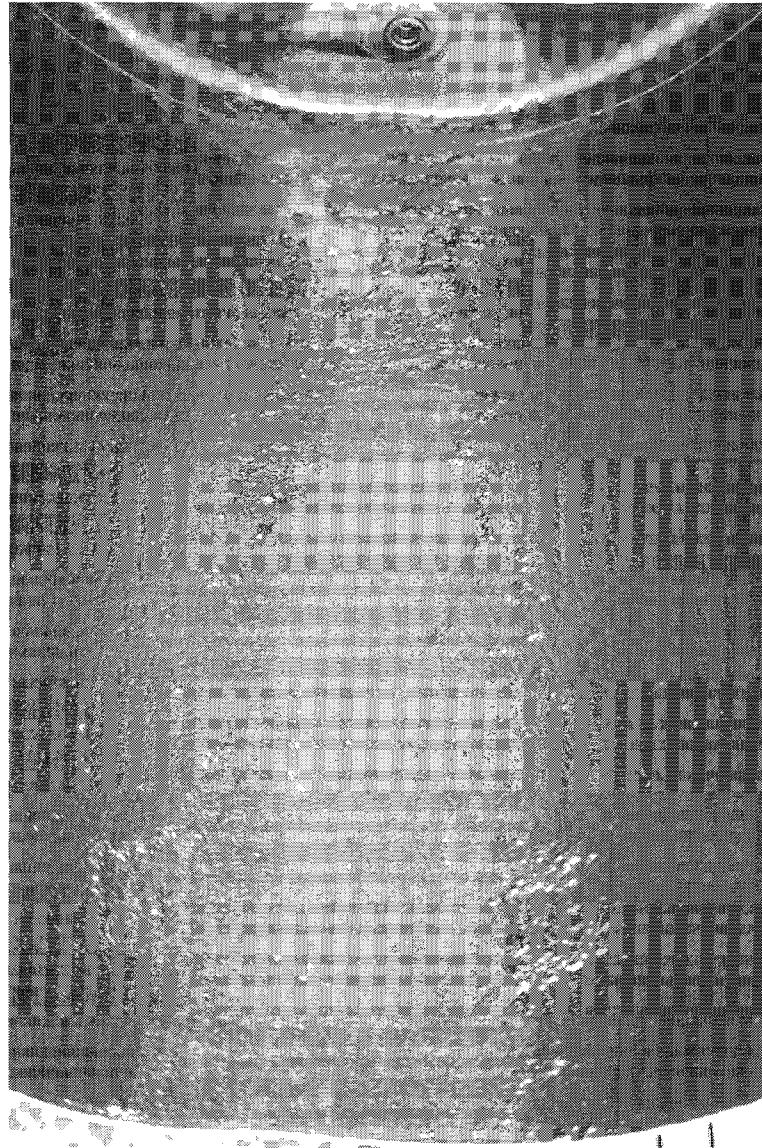
Both of the contractors stated that there was almost always a black sludge in the bottom of a used tank when taken out of service. This sludge is noted when the tank is first cut open. In the tanks inspected under this report it was located in what seemed to be random patches of varying sizes over the tank bottom. The evidence of sludge is not necessarily an indication of underlying corrosion. Once the soft residue is removed, with a cloth for example, there is not necessarily erosion beneath.

Figure 3 – Typical Interior Sludge Encountered Upon Taking A Tank Out of Service

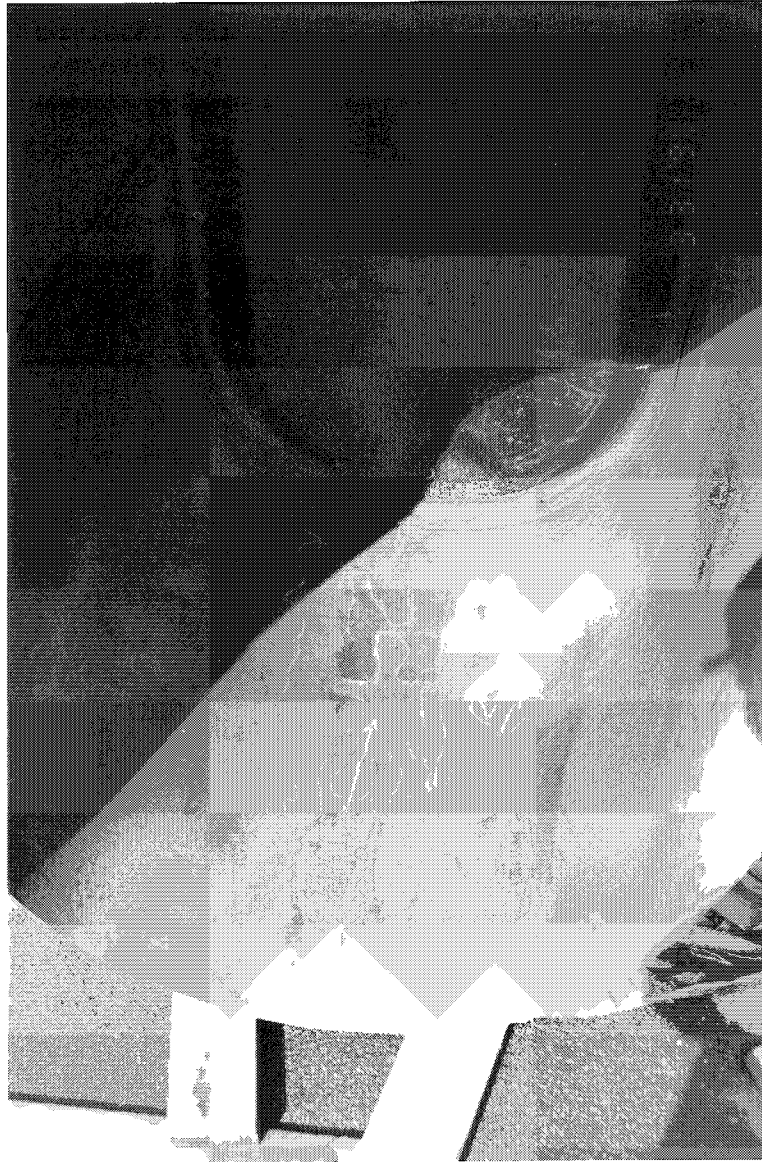
After a period of time in service domestic heating oil tanks start to corrode, usually from the inside. Corrosion of this kind is an electrochemical process whereby metals progressively lose the atoms of their base elements, in the presence of a suitable electrical conductor, to areas of a different electrical potentialⁱⁱ. Corrosion cells are set up within the tank - regions of higher potential, called anodes, lose their iron atoms to regions of lower potential, called cathodes. Water, sediments and other contaminants act as the electrical conductor or electrolyte. Water in tanks installed outside above ground can enter the oil from condensation as temperatures change, particularly when the tanks are not kept filled; or from leaking fill and vent pipes. Sometimes water and sludge is carried into the tank with the fuel itself due to improper handling at bulk terminals or in transport. This water combines with sulphur or other components to become acidic and corrosiveⁱⁱⁱ. Dissimilar metals (copper piping verses steel tank for example or rust particles from an old tank pumped into a new tank) can initiate corrosion cells, as can metallurgy differences at the heat-affected zone of welds. Although less common, tanks can corrode on the outside. An example is a tank sitting directly on the ground or one where water, ice or snow are trapped under the tank. In this instance areas with lower oxygen concentrations become anodic and areas with higher oxygen concentrations become cathodic leading to corrosion.

Figure 4 -- Typical Interior Corrosion

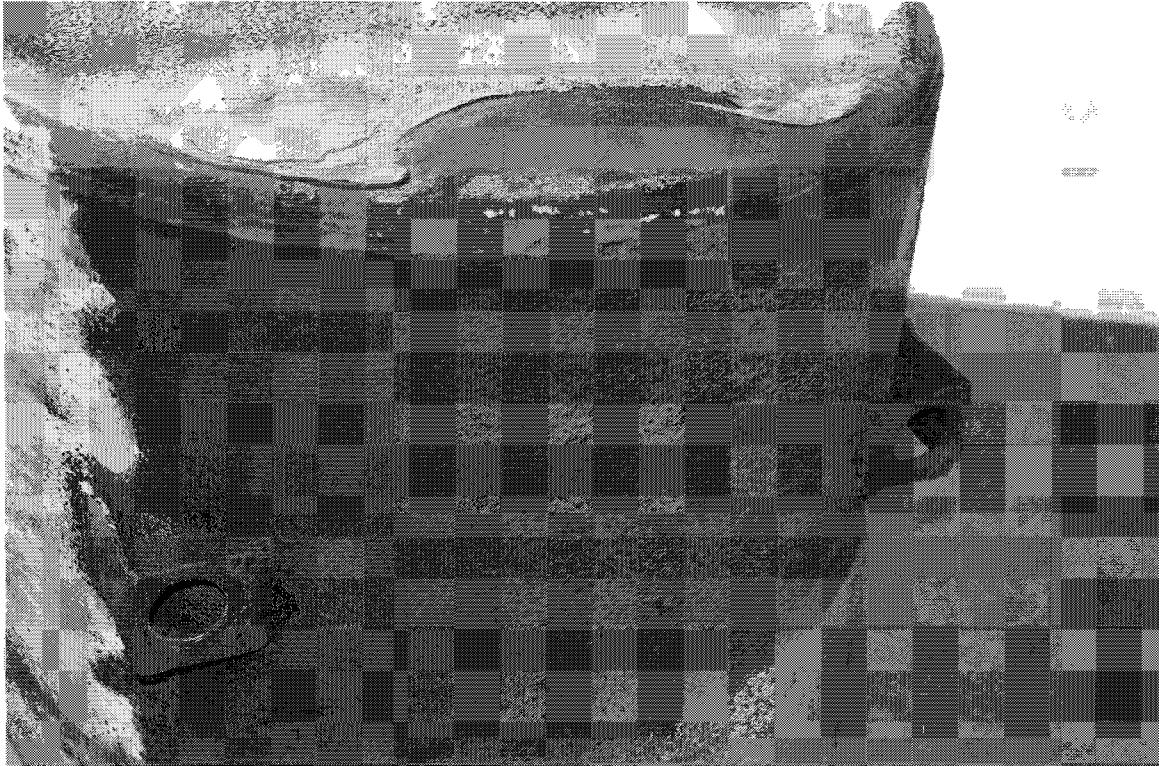
Figure 5 – Typical Exterior Corrosion

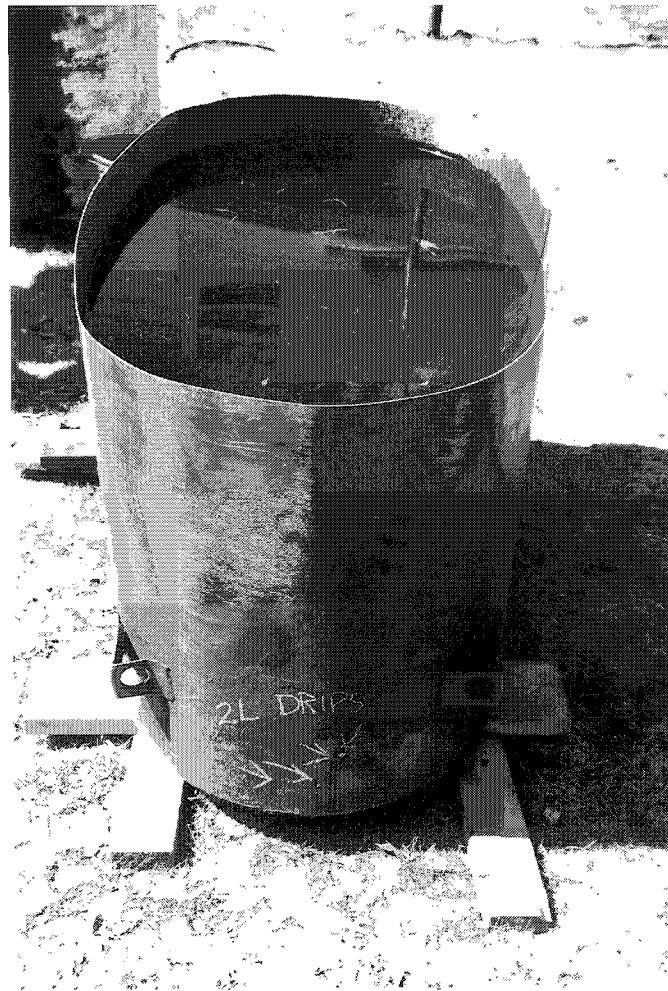
The first step was to determine the exact location of leaks using a hydrostatic tank test. Any openings were plugged; the tank halves filled with water and areas of seepage or drips noted (Figures 6 and 7). After emptying the tanks the ultrasonic instrument was used to try to detect and evaluate the defective areas.

Figure 6 – Hydrostatic Test of Tank Half to Determine Leak Location

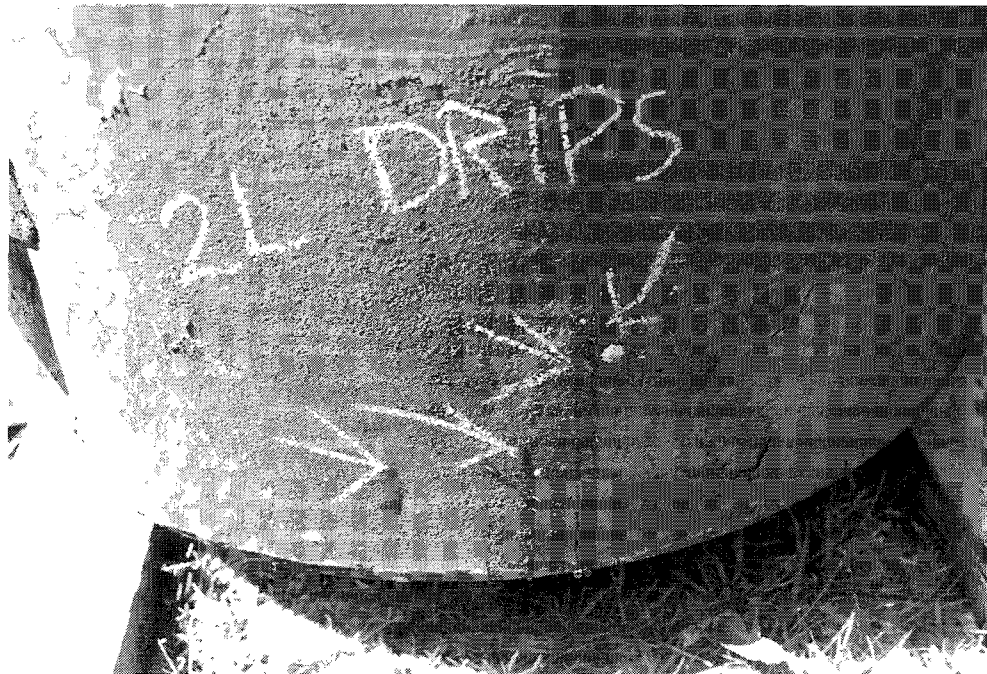
Figure 7 – Location of Leaks (Due To Internal Corrosion)

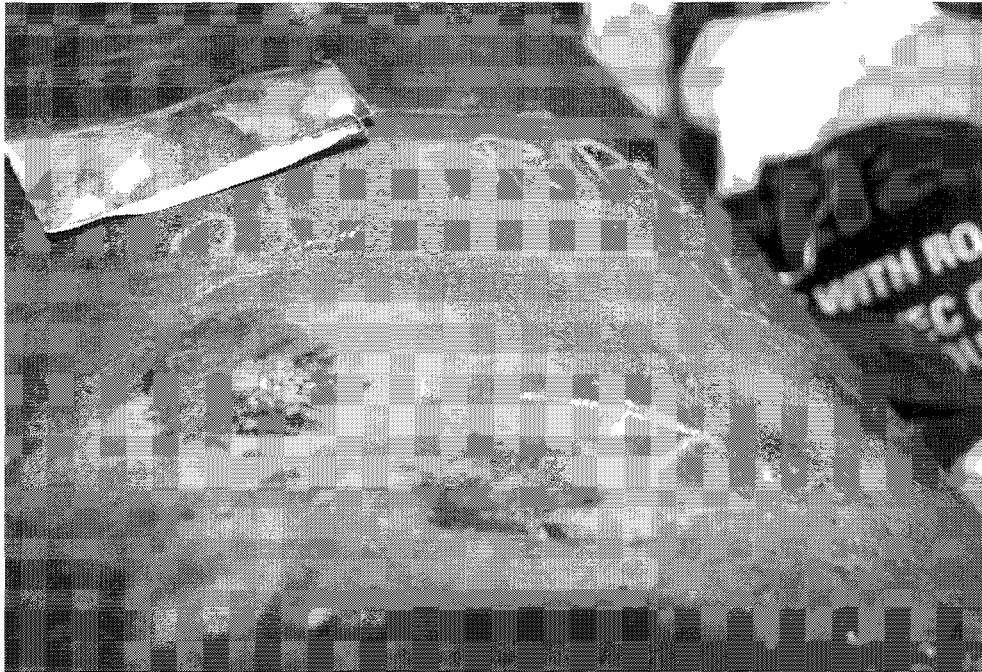
Without cleaning the exterior of the tank in any way the transducer and appropriate couplant were applied to the previously identified leaking areas. No readings could be obtained. The regions were then wire brushed to remove surface rust. Again there was no reading. It was only when emery paper was used to bring the surface down to bare metal that a thickness reading was achieved (Figure 9). The instrument however was not precise enough to identify interior pitting in the area where this reading was taken. As verification of this latter point a portion of the tank that was badly corroded inside (Figure 10) was identified and a grid set up on the exterior. Spot ultrasonic readings were then taken from the outside after the region had been cleaned. No definitive areas of pitting could be detected (Figure 11). As another experiment, tank exterior areas that were uncorroded and painted were ultrasonically tested. Sometimes a thickness reading could be obtained and sometimes not, apparently dependent on the thickness of paint and sensitivity of the instrument.

Figure 9 – Leak Areas after Cleaning with Emery Paper

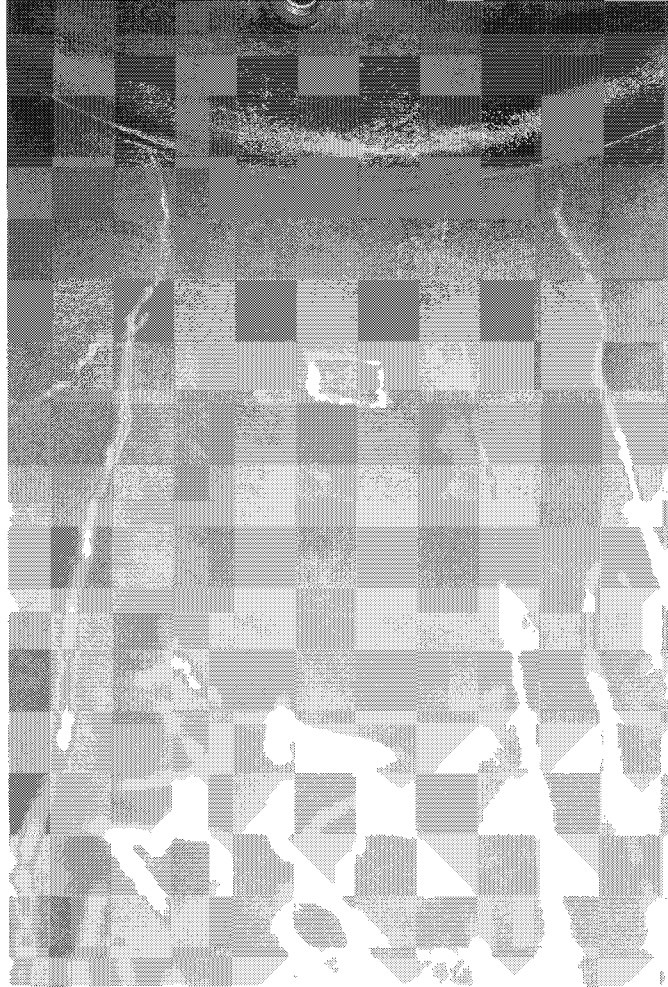
Figure 10 – Interior Corroded Area

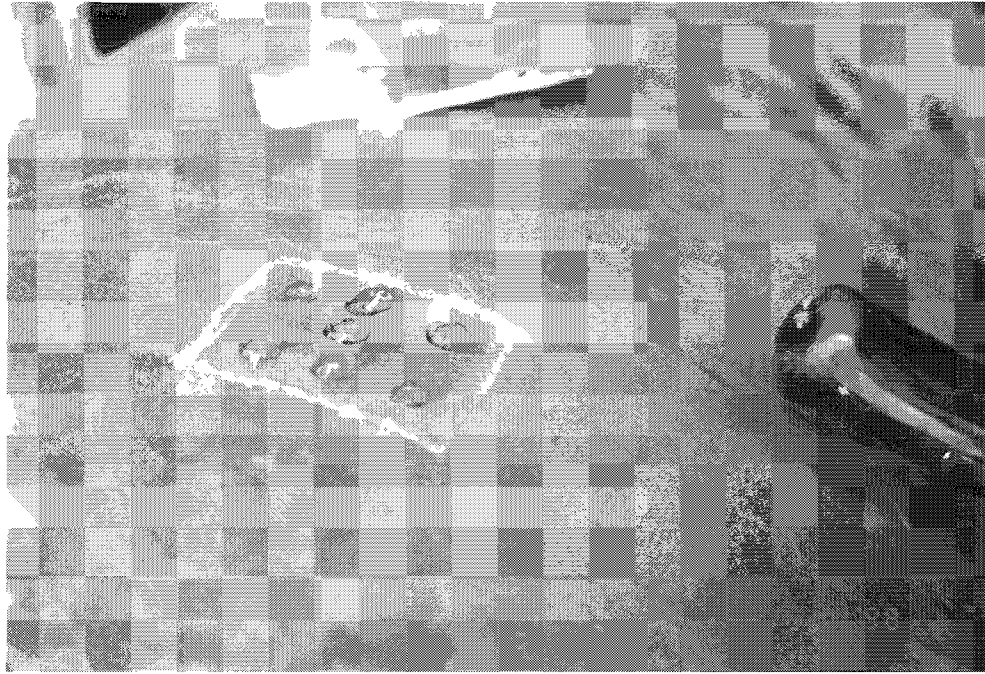
Figure 11 – Exterior of Area Shown in Figure 10 Showing Test Grid Set-up (Note Couplant Application)
