Study Of Houses Affected By Hazardous Lands: Appendixes A, B, C, D, E and F

**STUDY OF HOUSES AFFECTED BY
HAZARDOUS LANDS
APPENDIXES A, B, C, D, E, AND F**

**THE RESEARCH DIVISION
CANADA MORTGAGE AND HOUSING CORPORATION**

**CH2M HILL ENGINEERING LTD.
in association with
SHELTAIR SCIENTIFIC
APPIN ASSOCIATES
XCG CONSULTANTS LTD.**

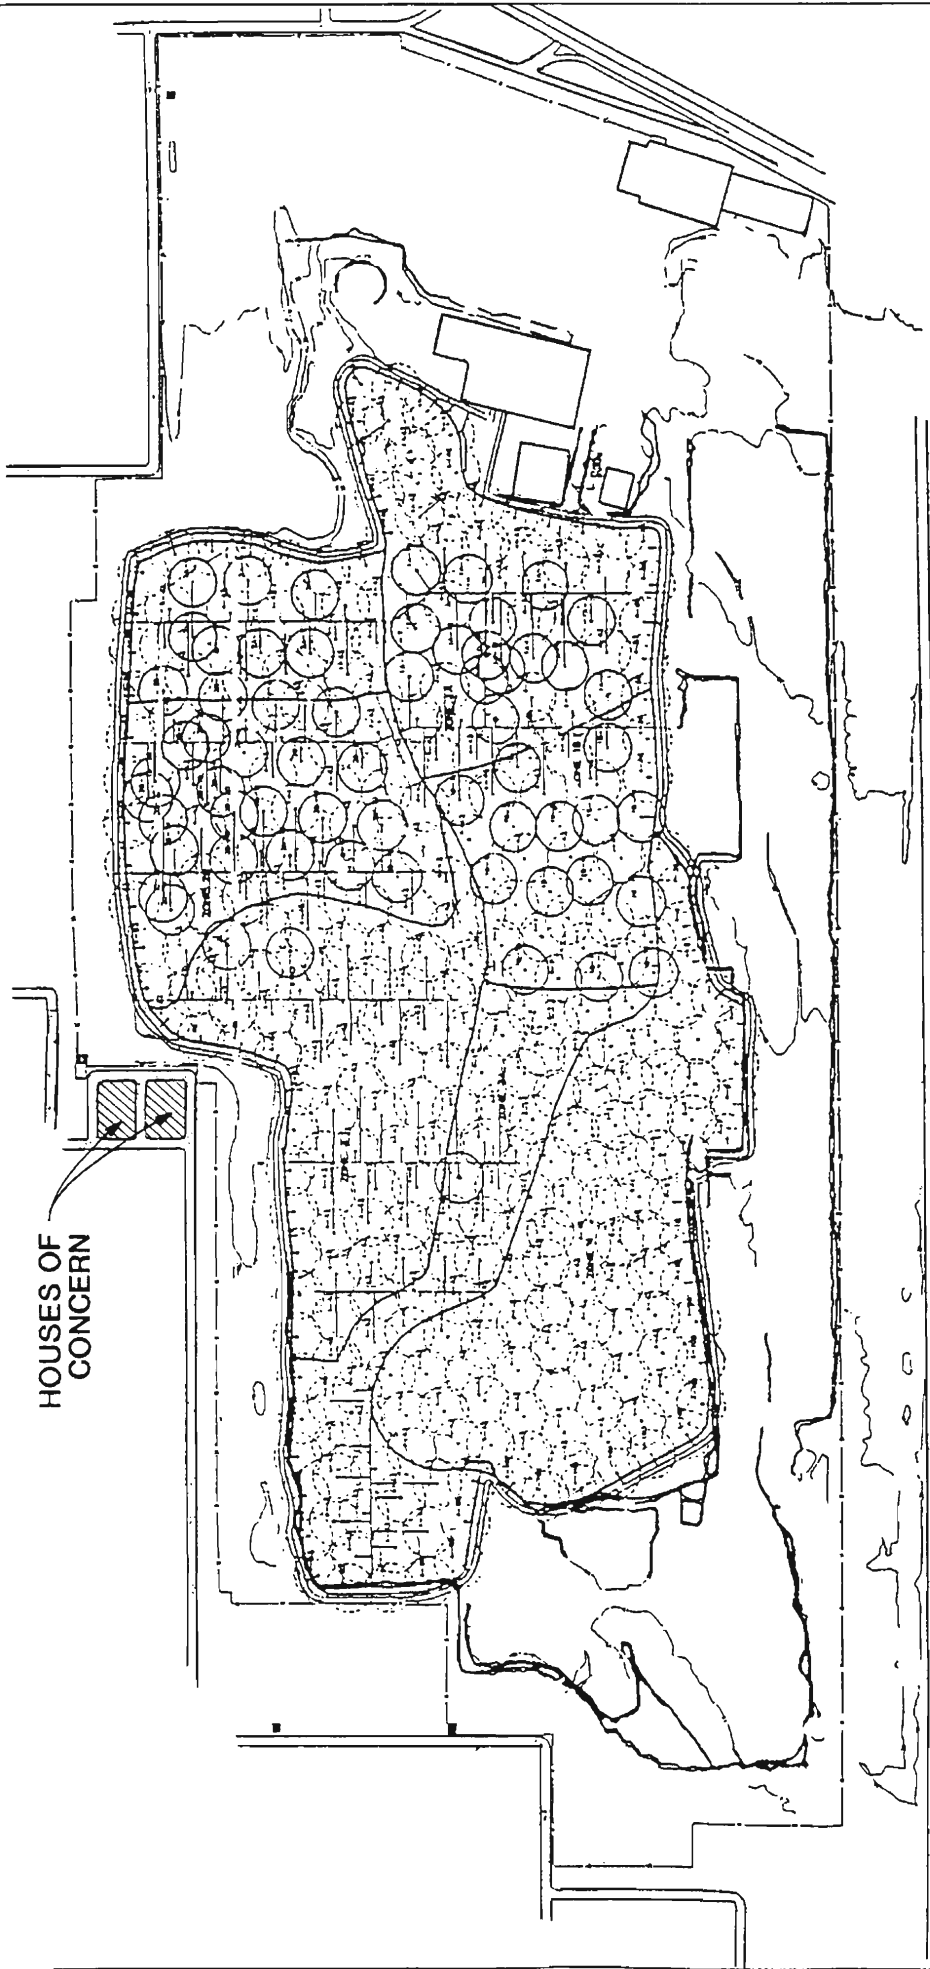
FIGURE A-2:
MIRON QUARRY LANDFILL

It is estimated that by 1994, the landfill will produce an approximate 20,400 cubic metres of gas per day. Some houses are located within 50 metres of the edge of the landfill (Figure A-2). There is concern that gas from the landfill may migrate into the nearby houses through the fractures of the bedrock. The Municipality is presently installing an extensive network of interceptor wells within and around the edge of the landfill (Figure A-3). Monitoring wells (about 40) will also be bored around the quarry to monitor the chemical composition of the leachate and of the migrating gas. An interceptor trench, extending down to the level of the water table, will also be constructed around the site to intercept gases migrating through the overburden. The network of interceptor wells installed at the periphery of the landfill was first operated in January 1991; the wells installed at the core of the landfill will become operational progressively as sections of the landfill are closed.

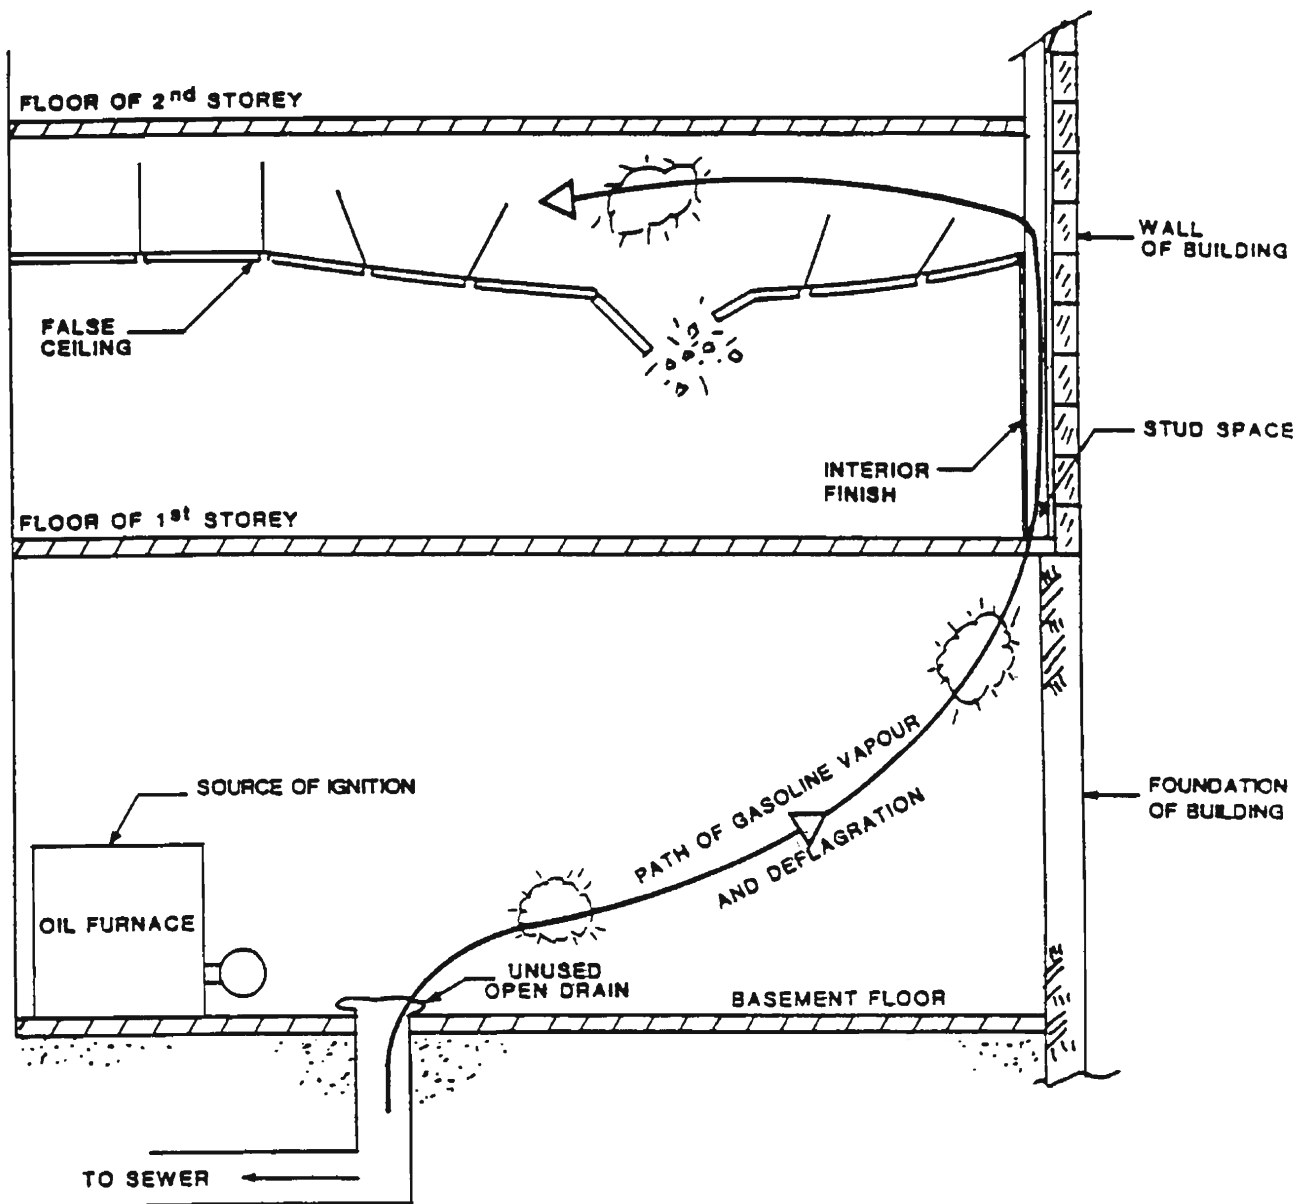
**FIGURE A-10:
PLAN OF SEWER SYSTEM IN
THE VICINITY OF THE SPILL
(Source: Cooke, 1986)**

Some time on the night of April 18/19, 1986, a pipe between some gasoline storage tanks and pumps broke at a local service station leaking an uncertain quantity of gasoline. The spill found its way into a connector drain which joined to the main sewer. Gasoline vapours backed up through the drain connectors of at least four buildings, forming an explosive mixture. The explosive vapour reached the upper levels of some of the buildings, making its way through stud spaces into spaces above false ceilings.

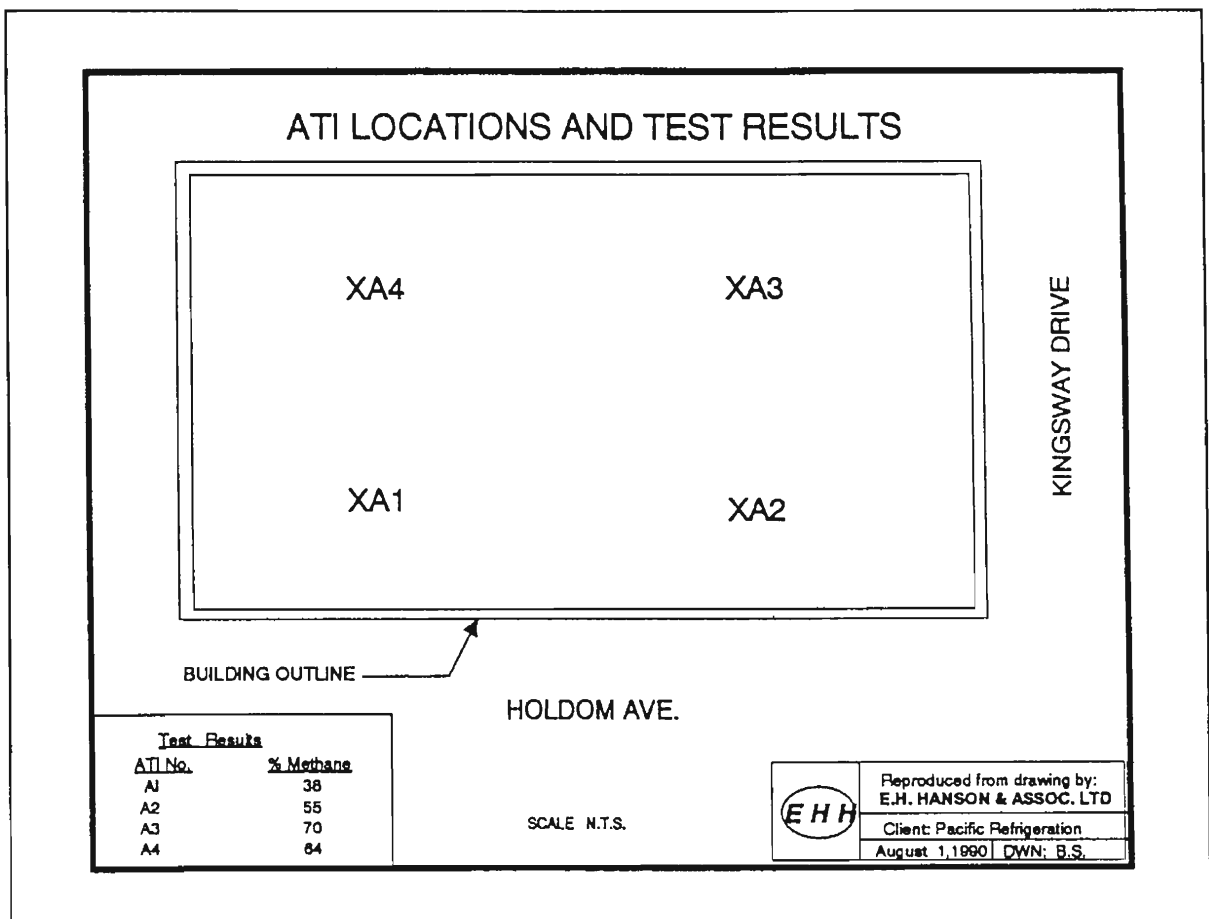
Figure C-16
Plan of Building Showing ATI Locations and Results

The new Thunderbird retail supply building was being constructed in areas suspect of methane generation. Tests inside the building prior to completion indicated up to 70% methane. (An aquarium pump and tubing were used to suction air from beneath the slab through cracks in concrete; the pumped gases were shown to maintain a constant flame at the outlet of the tubing.) A complete exterior piping system was installed across the building (over 30 m). One connection point was provided to install a vacuum blower if necessary. When construction was nearing completion, the municipality refused to issue an occupancy permit until evidence was provided of an effective solution. At that time of writing, the system had not been hooked up.
