RESEARCH REPORT

ICE DAMMING FIELD RESEARCH:
ICE DAMMING SOLUTIONS

Ice Damming Field Research Ice Damming Solutions

Ottawa, ON

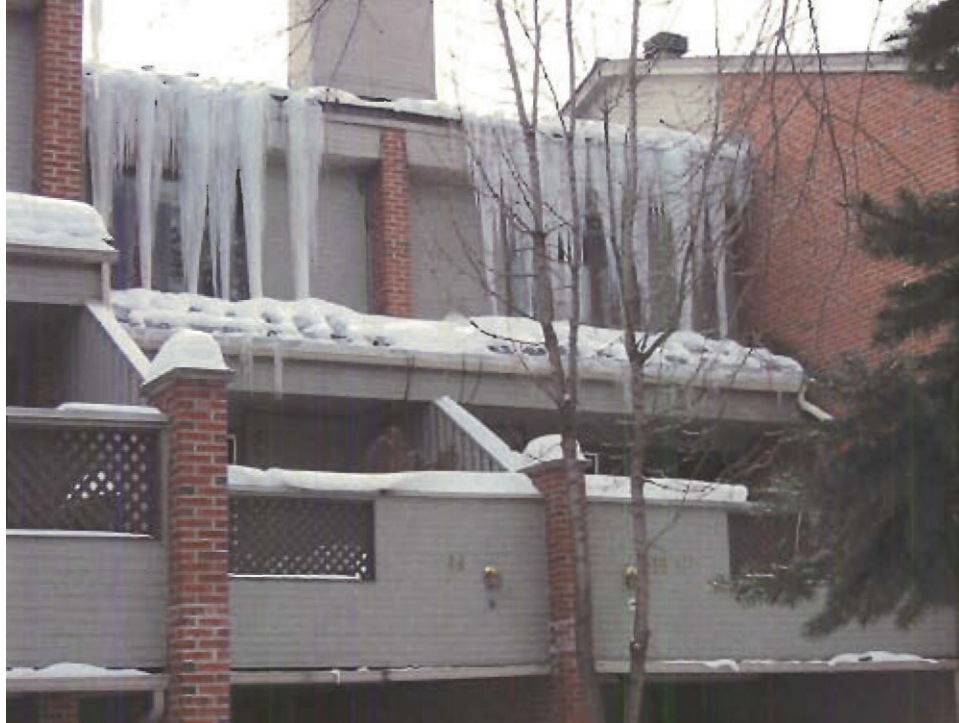
Site 1 is a wood framed townhouse complex constructed in 1984 (Photo 1). The buildings have been experiencing severe ice damming problems since occupancy (Photos 2 and 3). The problems have been well documented with reports and Photographs. Approximately 85% of the units have experience ice dam related roof leaks within the last nine years. Seven consultants had provided opinions and implemented various repairs prior to our involvement in 2001.

Photo 03: Site 1, Typical ice formation

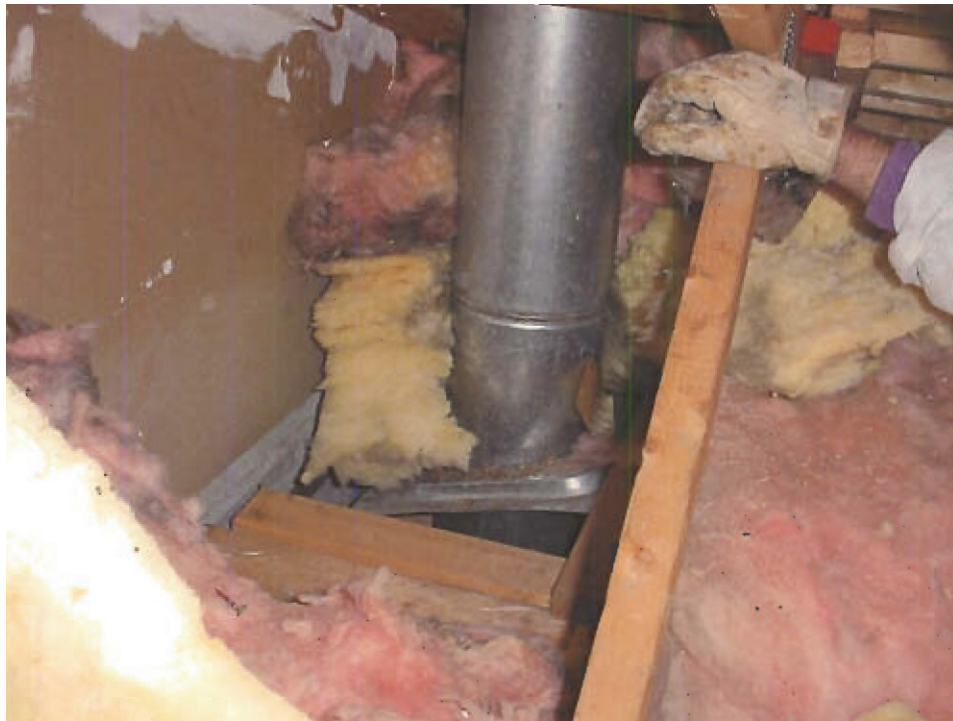
- The fireplace chimney chase was not sealed as the chimney passed into the attic. A sheet metal baffle was present, but it fit loosely in the chase (Photo 4).

Photo 04: Site 1, Air Leakage Path at Chimney

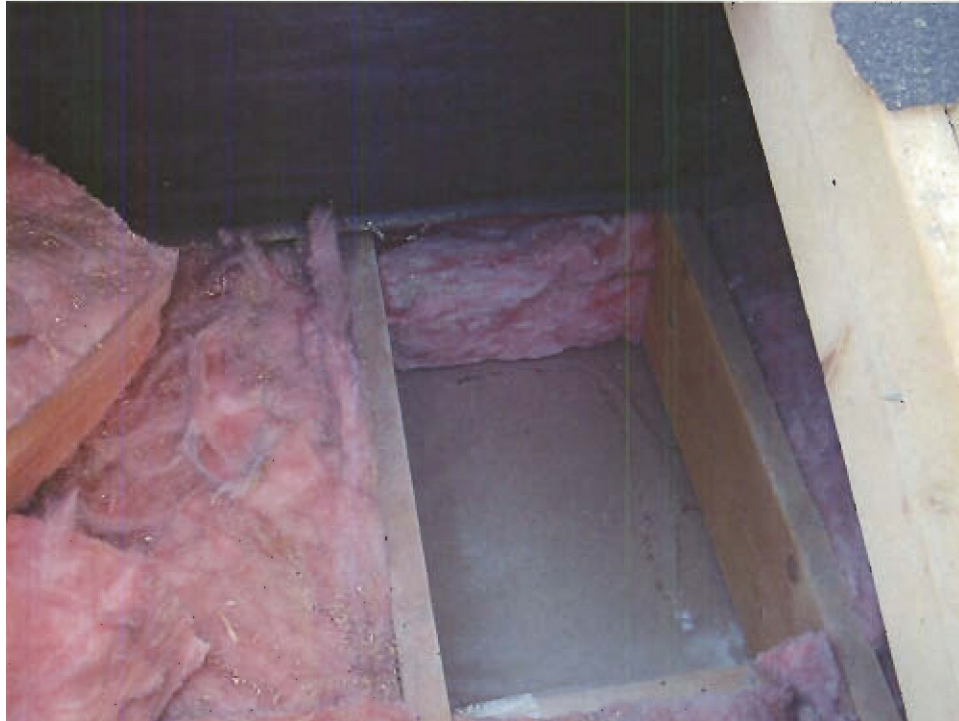
- We noted that the floor framing extending past the line of the uppermost interior room wall into the attic spaces was not sealed to prevent air leakage. A similar condition also existed at the rear middle roof. Effectively, this created a 200 mm deep hole that ran the entire length of the wall through which air could freely enter the attic space (as shown in Photo 5 and Figure 5).

Photo 05: Site 1, Air Leakage Path at Joist Penetration

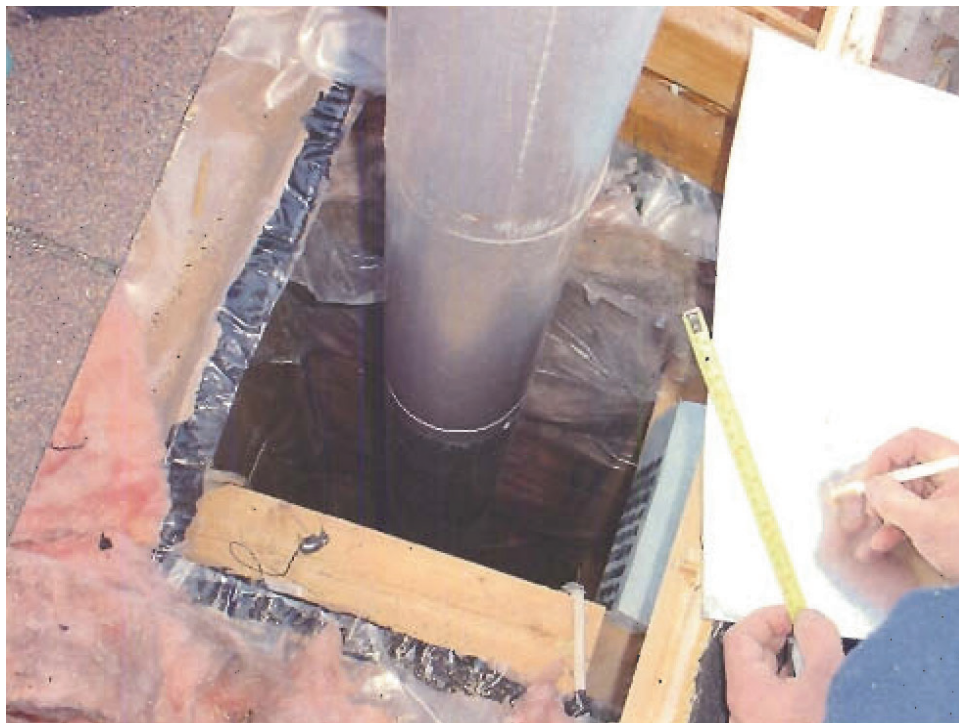
- The furnace chimney (B vent) was not sealed as it passed through the cathedral ceiling (Photo 6)
- The attic hatch was found to be poorly sealed.
- The tops of concrete block party walls in cathedral ceiling areas were not grouted, resulting in the potential for free flow of warm air into the attic spaces (Photo 7).

Photo 06: Site 1, Air Leakage Path at B-Vent (Furnace) Chimney

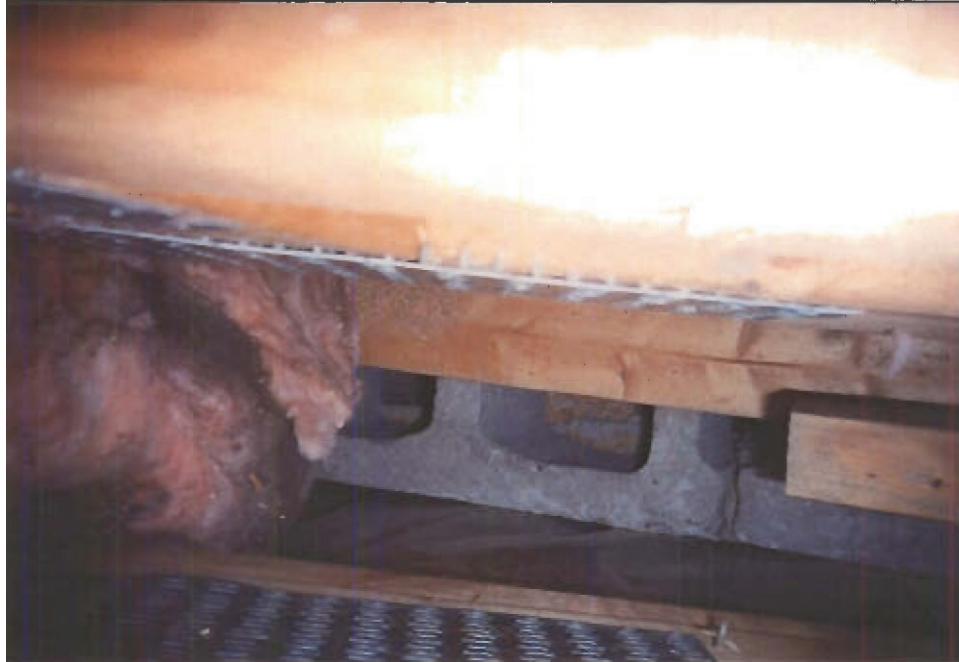
Photo 07: Site 1, Air Leakage Path at Party Wall

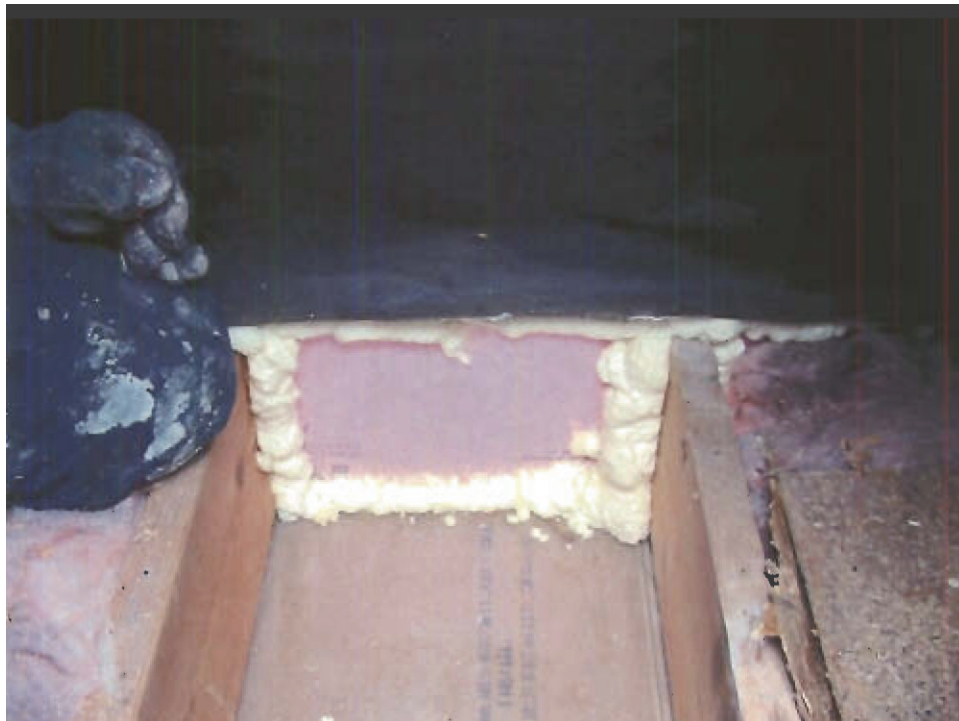
Photo 08: Site 1, Air Sealing Repairs, Joists

Air sealing was performed using two component polyurethane foam for smaller gaps (Photos 9 and 10), and extruded polystyrene (cut to fit) and two component polyurethane foam for large penetrations (Photo 8). The attic hatch was weather-stripped using a closed cell foam strip with a self adhesive backing. This weatherstripping was 9.5 mm wide by 4.5 mm deep. These repairs were performed in the fall of 2001.

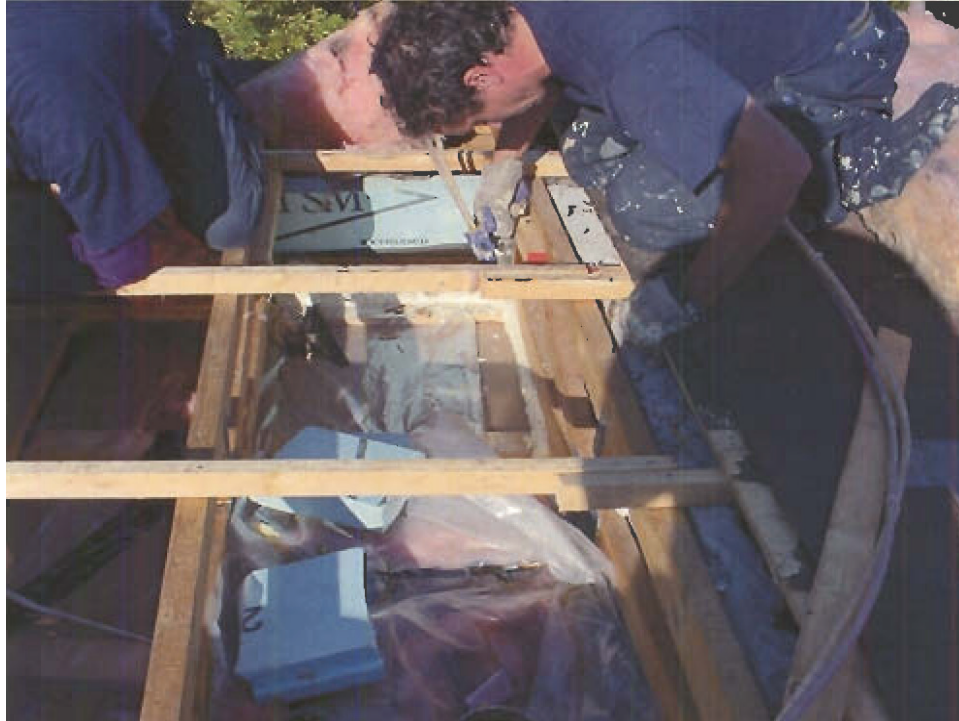
Photo 09: Site 1, Air Sealing Repairs, Party Wall in Cathedral Ceiling

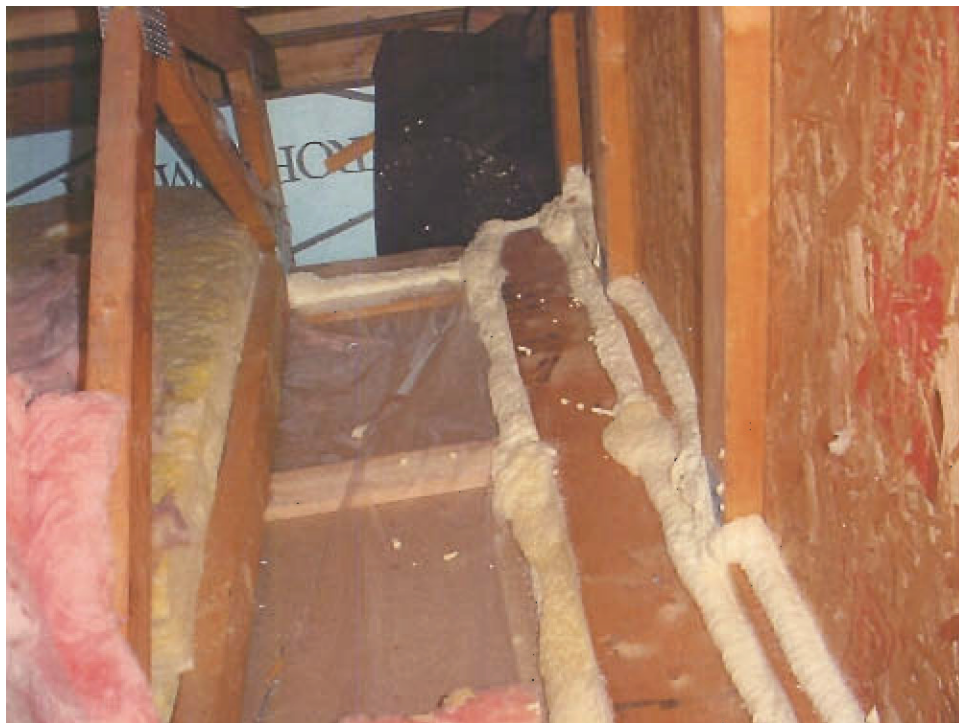
Photo 10: Site 1, Air Sealing Repairs, Party Wall in Main Attic

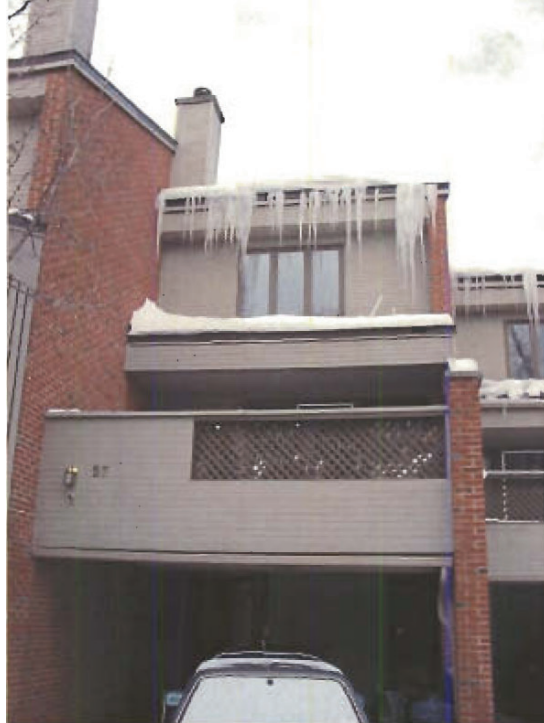
Our visual reviews noted a significant reduction in ice formation during the winter of 2003/04. Photographs 11 through 13 display icicles on typical non-repaired units while Photos 14 through 16 convey similar information on repaired units. These Photos were taken on February 19, 2004, although similar visual results were noted at other times during the winter. It is important to note that the winter of 2004 was not a particularly problematic year for ice damming, as noted in section 4.3, so even small amounts of roof ice could be an indication of a problematic roof from an ice damming perspective.

Photo 11: Site 1, Unrepaired Unit, February 19, 2004

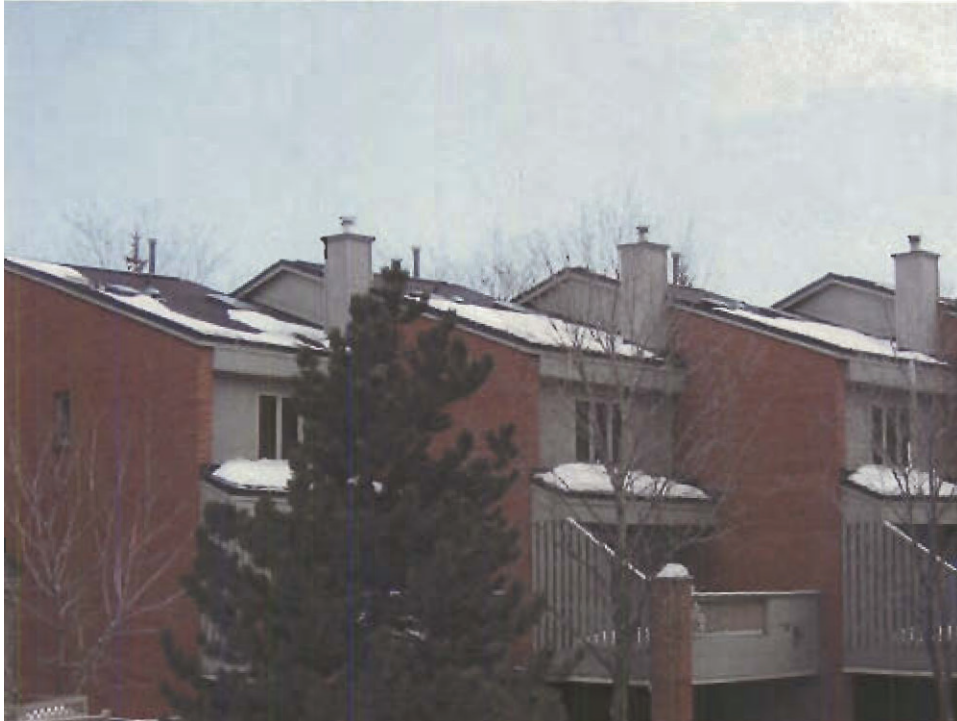
Photo 15: Site 1, Repaired Units, February 19, 2004

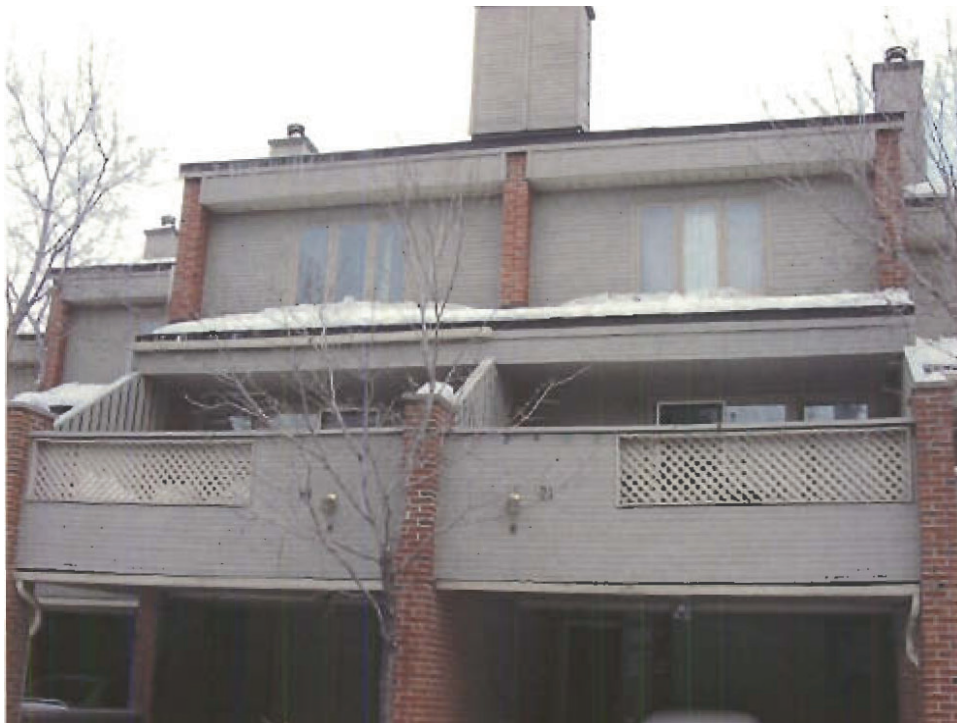
Photo 16: Site 1, Repaired Units, February 19, 2004

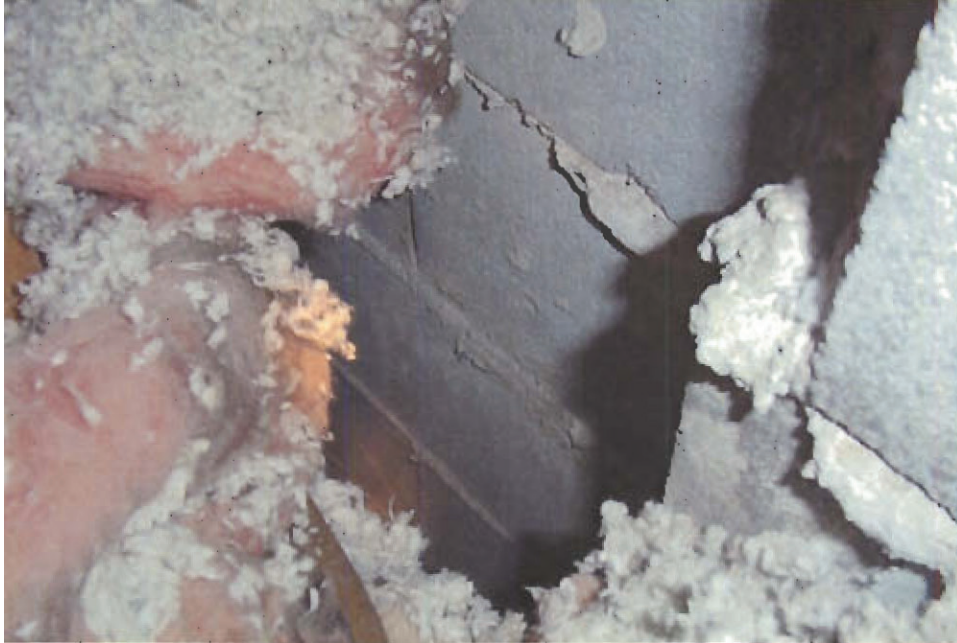
Photo 19: Site 2, Large Air Leakage Path at Party Wall

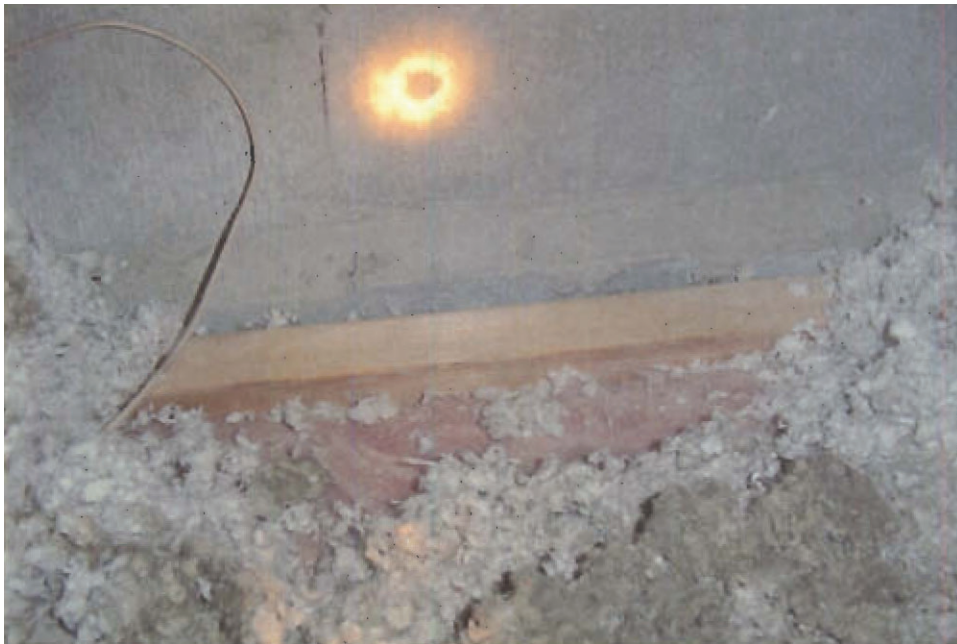
Photo 20: Site 2, Air Leakage Path at Party Wall

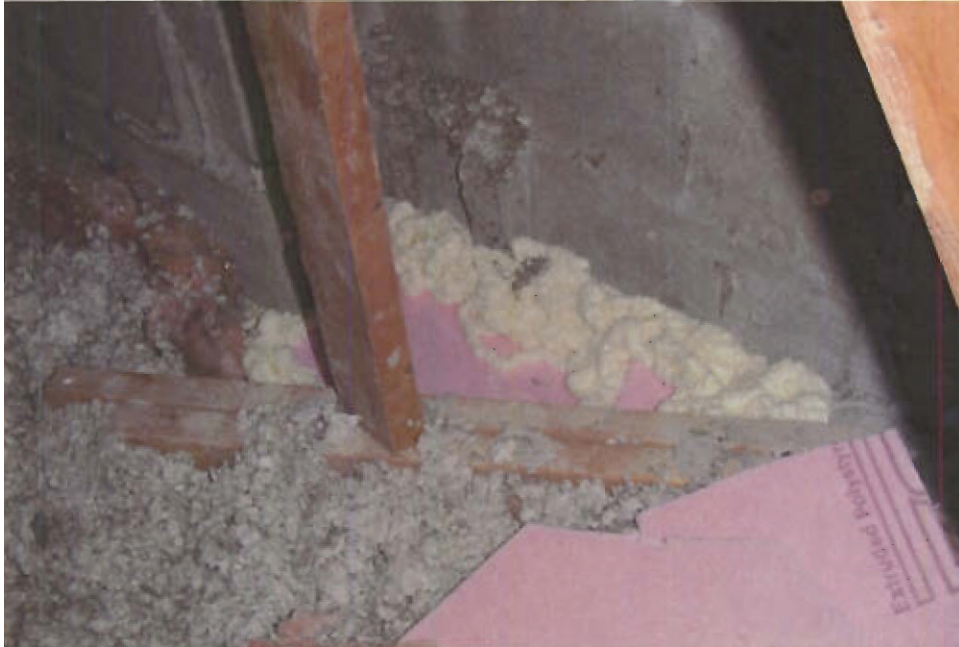
Photo 21: Site 2, Air Sealing Repairs at Large Air Leakage Path at Party Wall

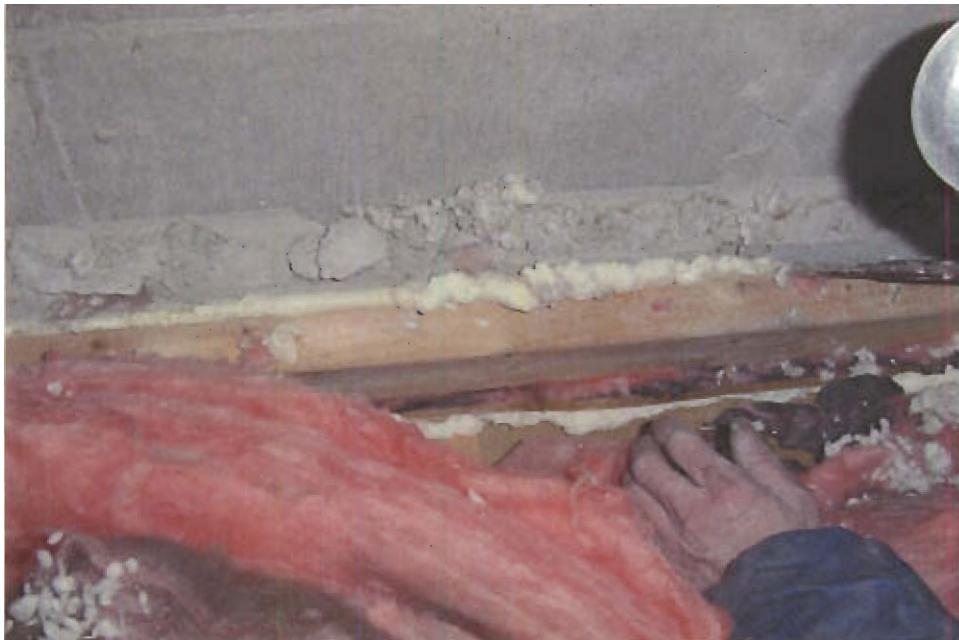
Photo 22: Site 2, Air Sealing Repairs at Party Wall

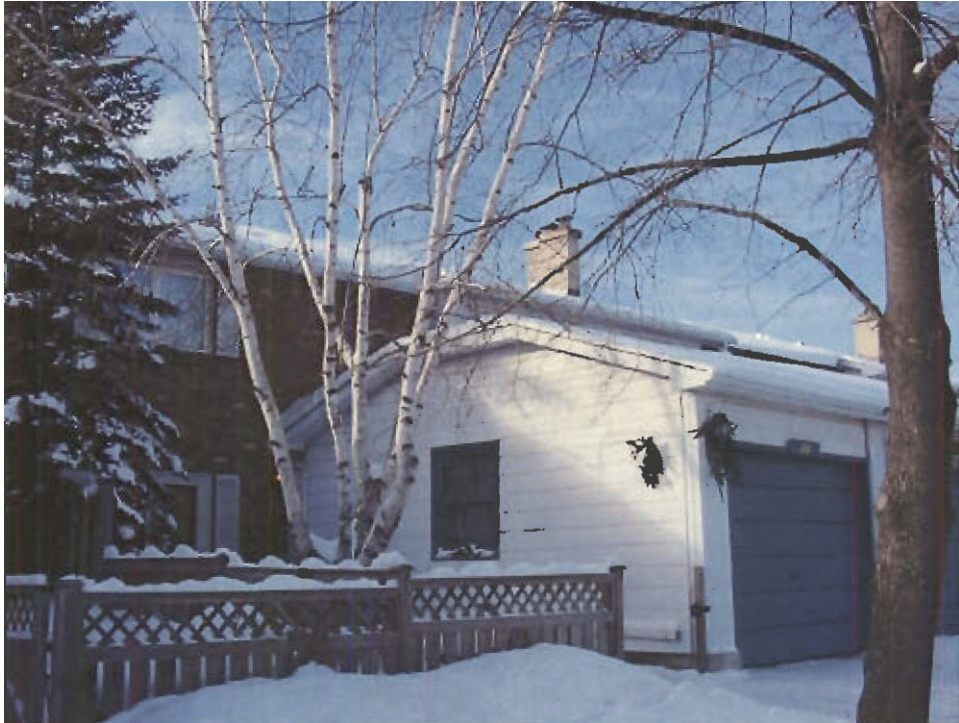
Photo 23: Site 2, Unrepaired Units, January 20, 2004

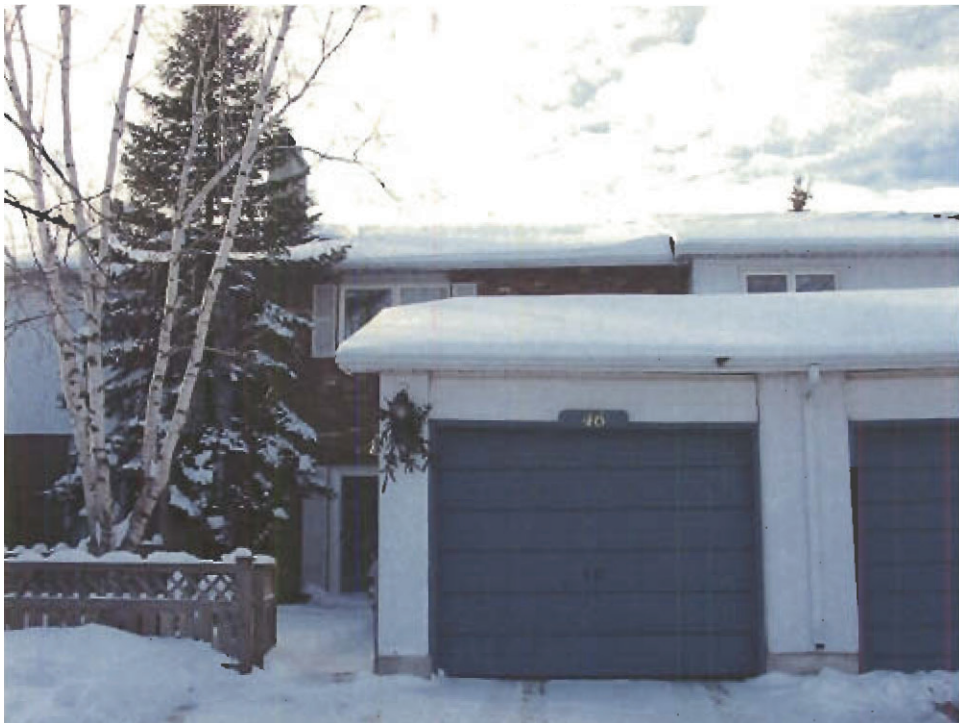
Photo 24: Site 2, Unrepaired Units, January 20, 2004

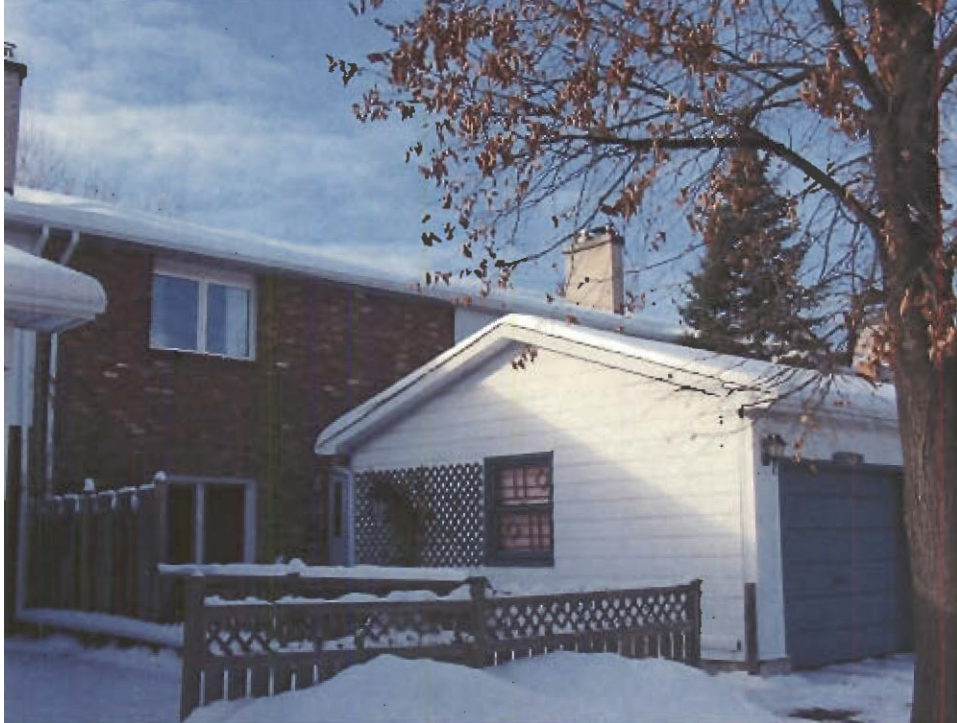
Photo 25: Site 2, Repaired Units, January 20, 2004

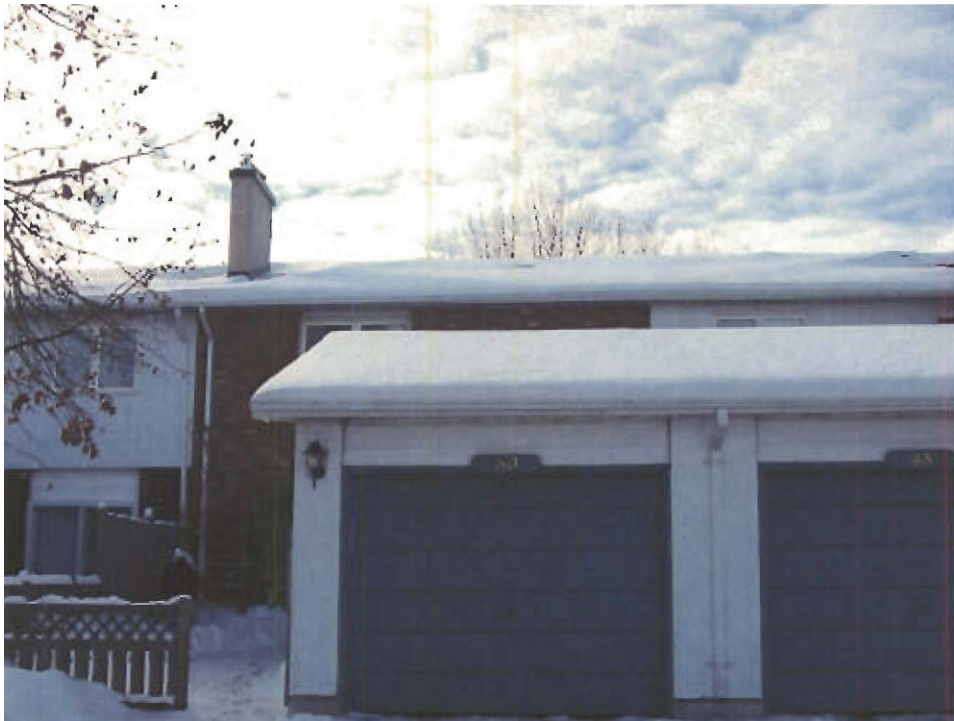
Photo 26: Site 2, Repaired Units, January 20, 2004

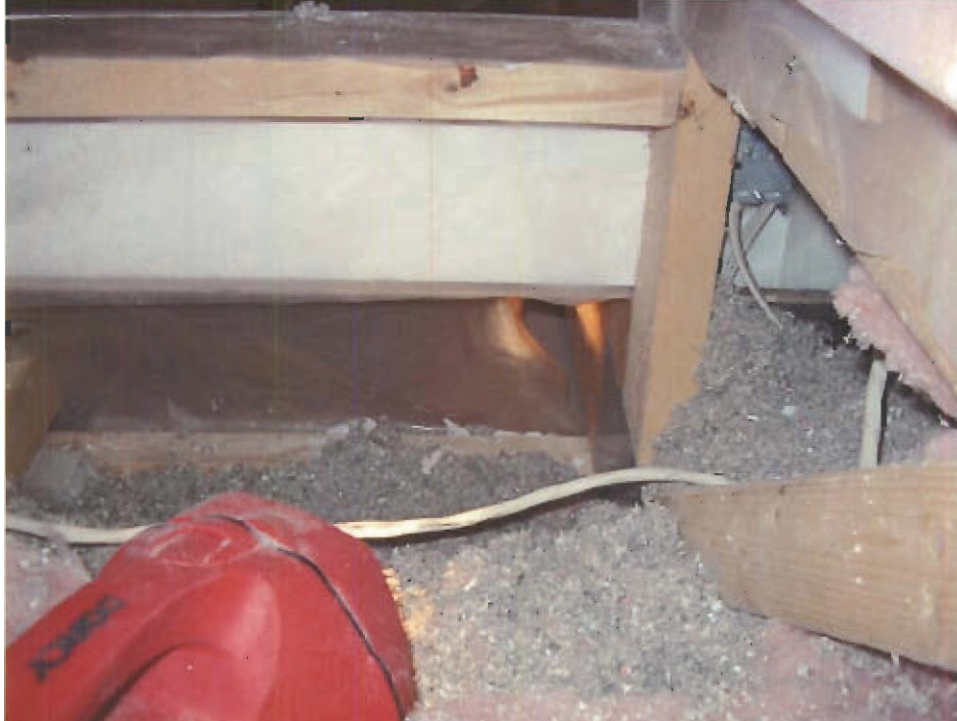
Photo 31: Site 3, Air Leakage Path at Base of Wall

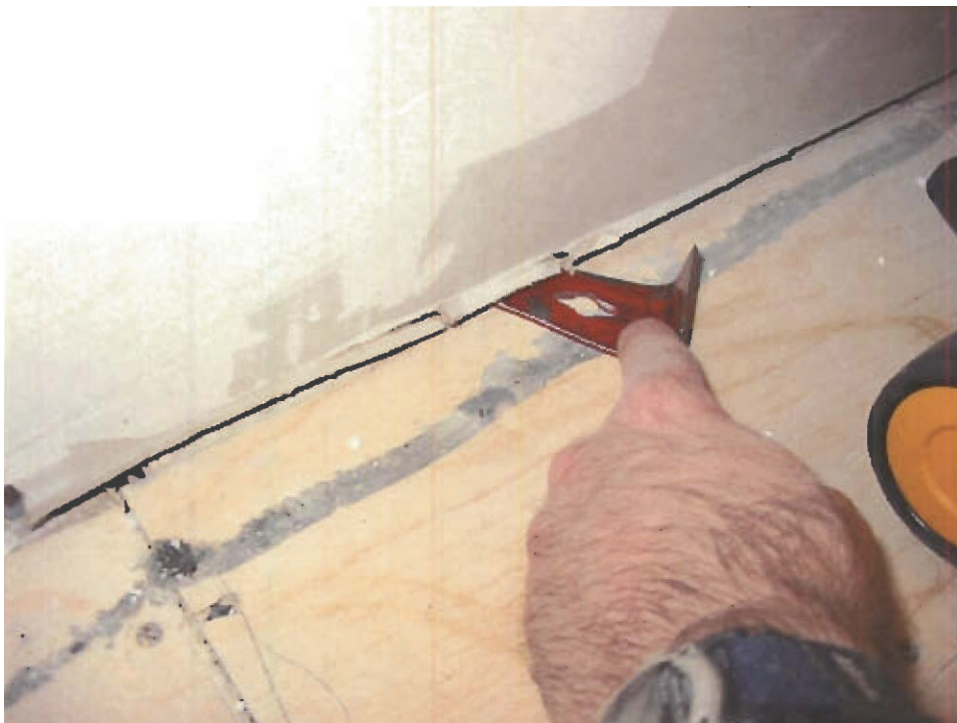
Photo 32: Site 3, Gap at Base of Knee Wall

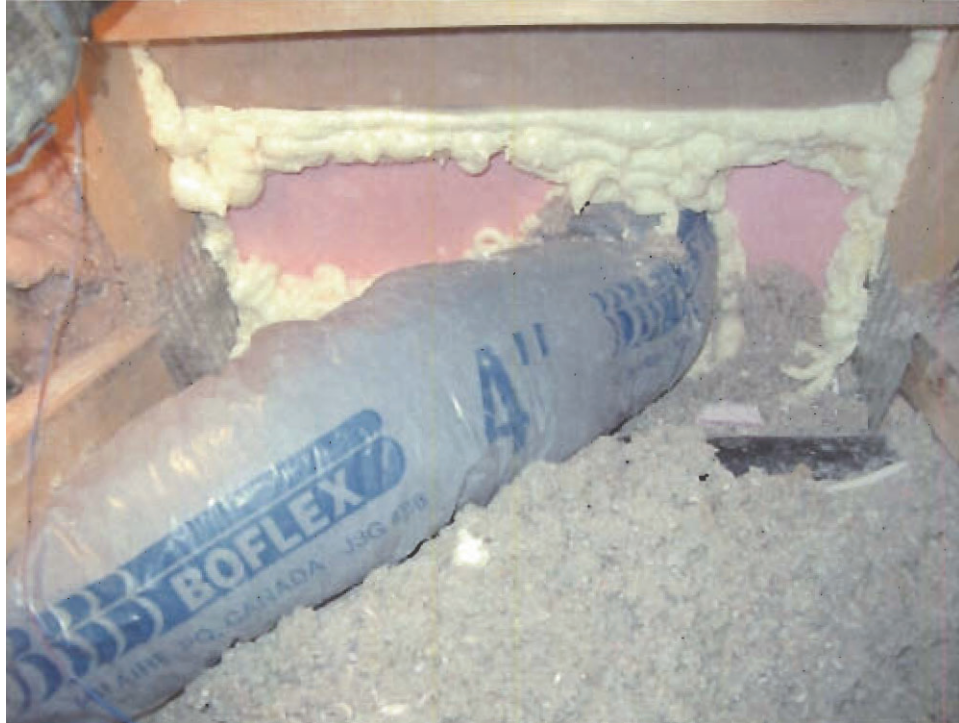
Photo 35: Site 3, Air Sealing

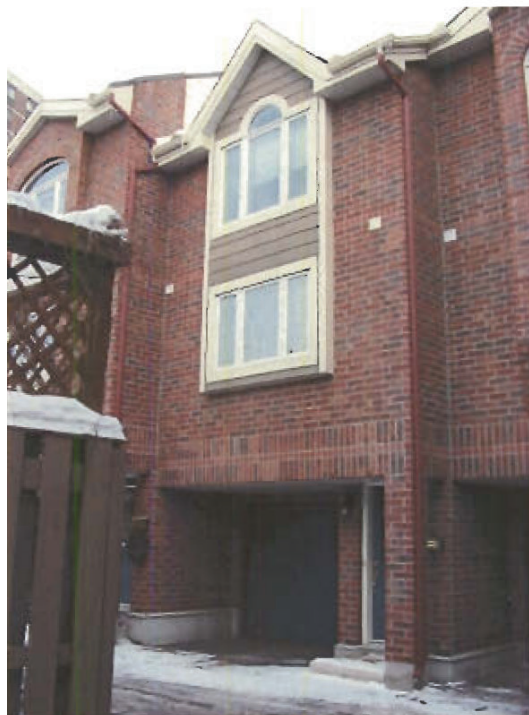
Photo 36: Site 3, Repaired Unit (front) January 20, 2004

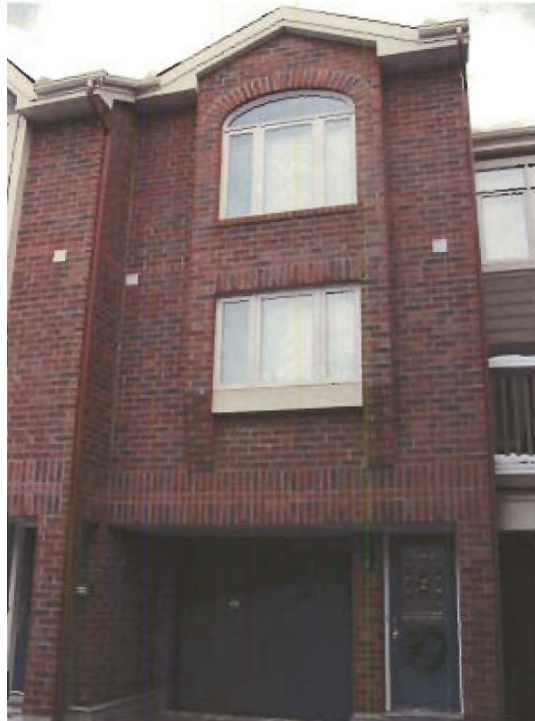
Photo 37: Site 3, Unrepaired Unit (front), January 20, 2004

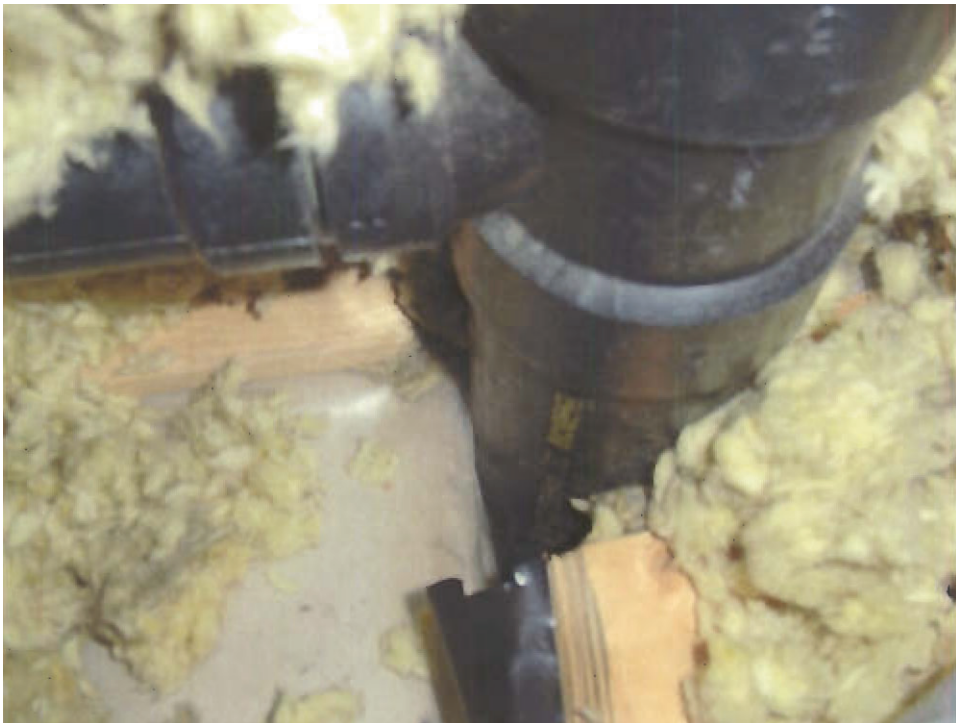
Photo 42: Site 4, Air Leakage Path at Plumbing Vent

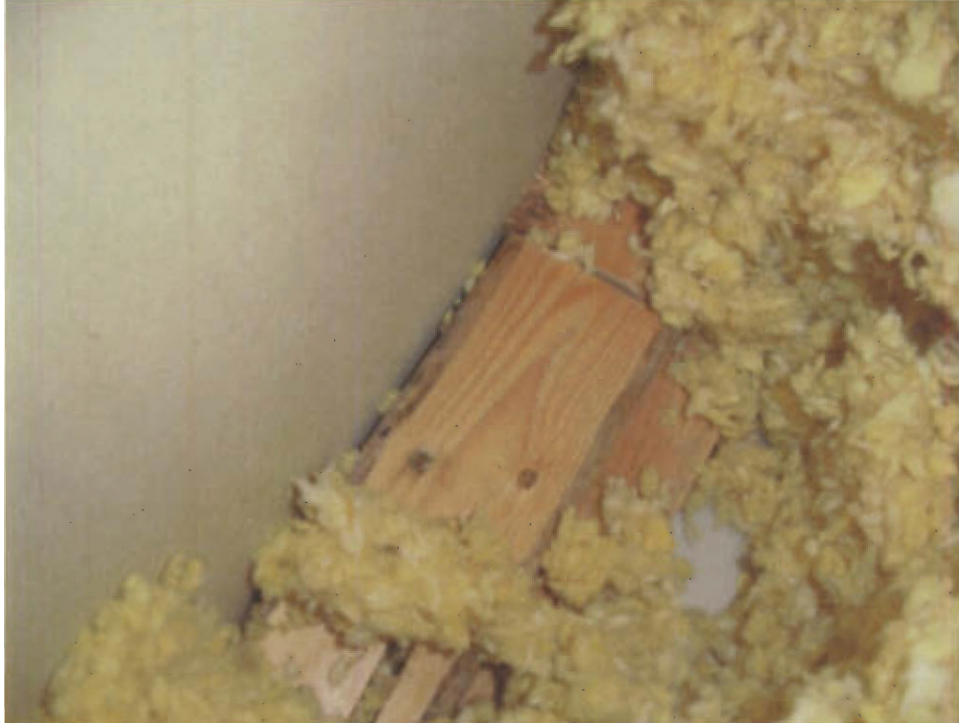
Photo 43: Site 4, Party Wall

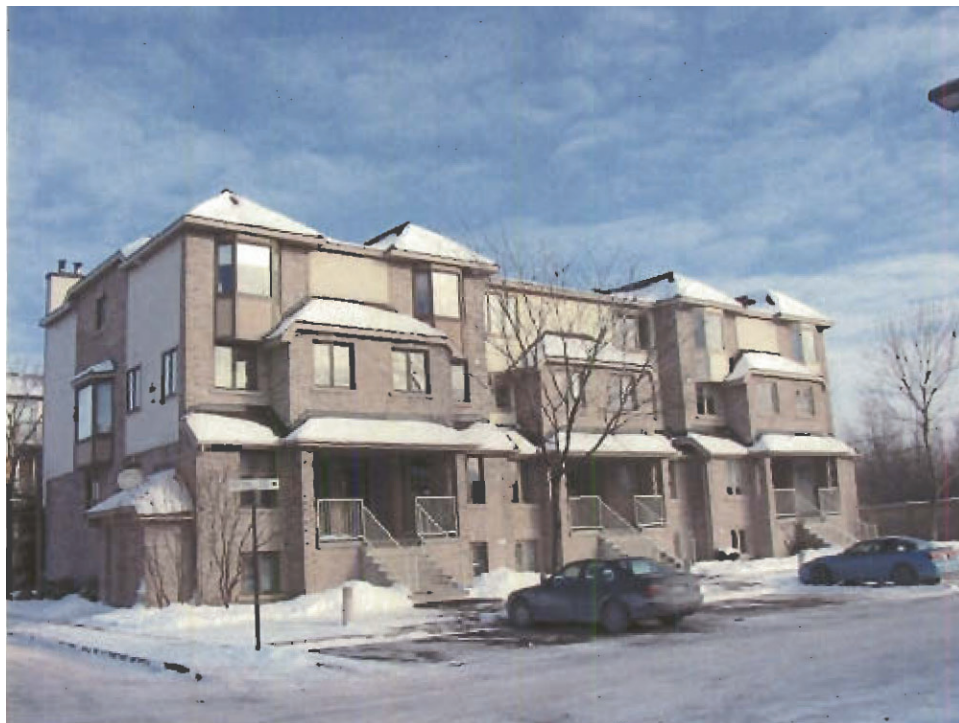
Photo 46: Site 4, Repaired Unit (front), January 20, 2004

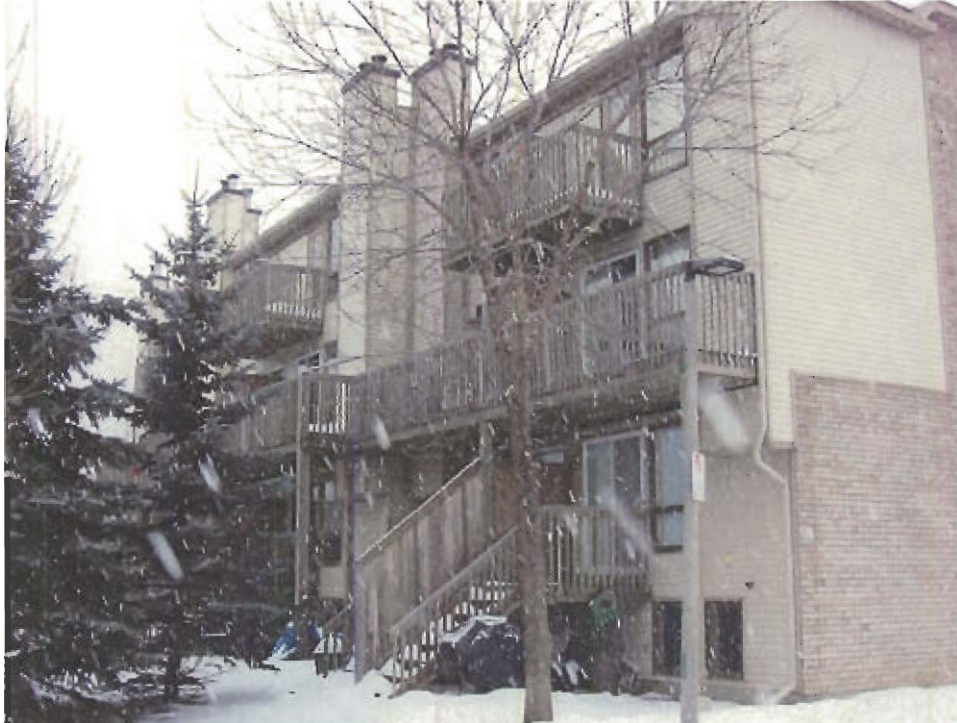
Photo 47: Site 4, Repaired Unit (back) January 20, 2004

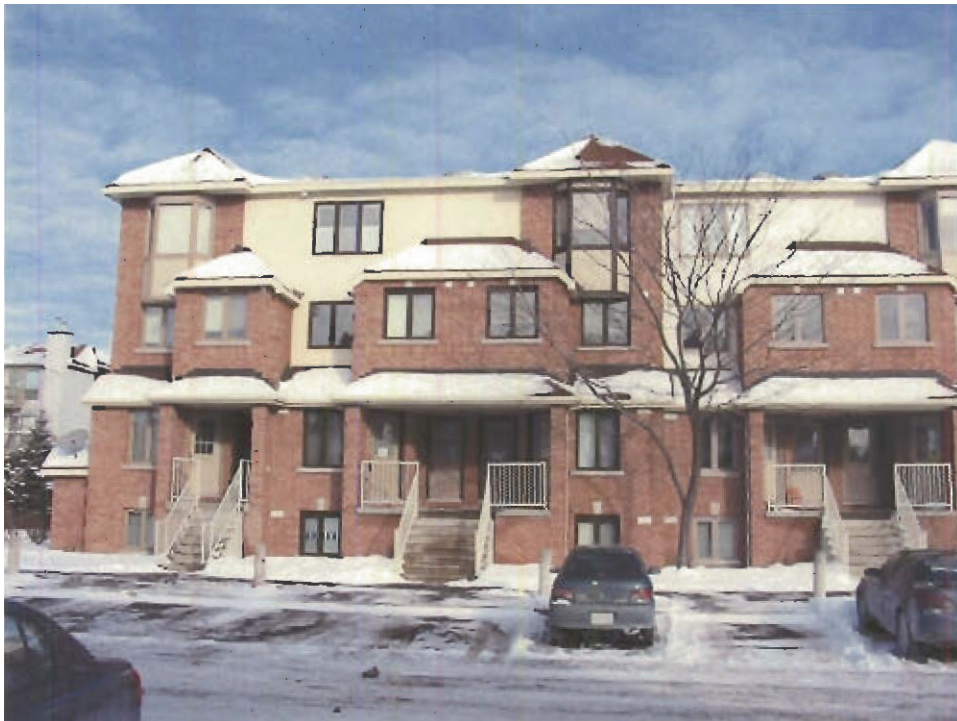
Photo 48: Site 4, Unrepaired Unit (front), January 20, 2004

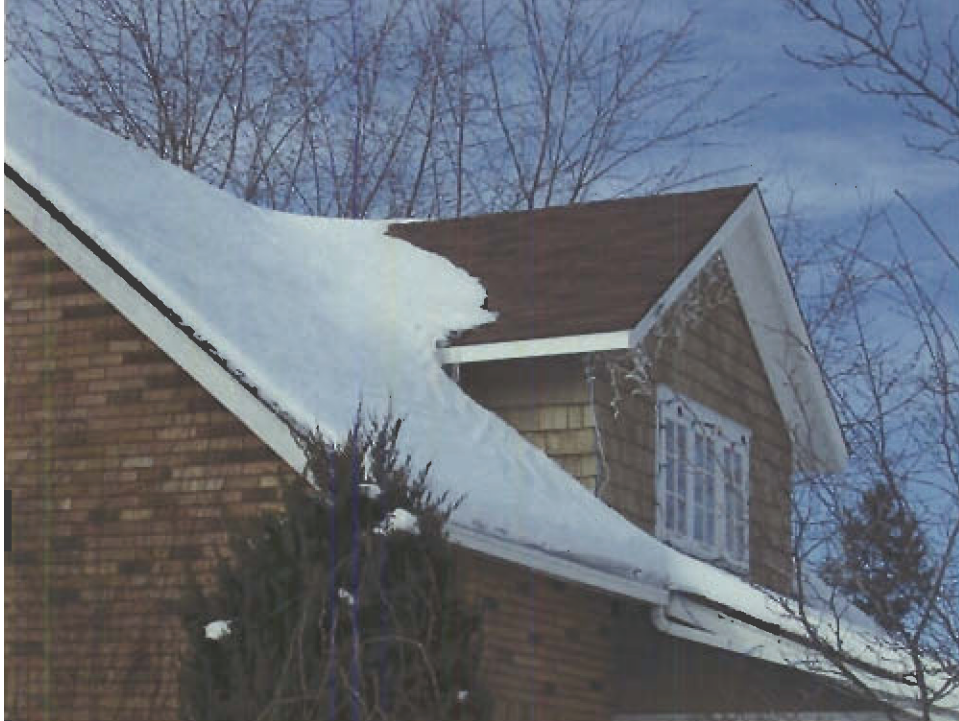
Photo 61: Manotick, Post Repair Snow Cover - Back

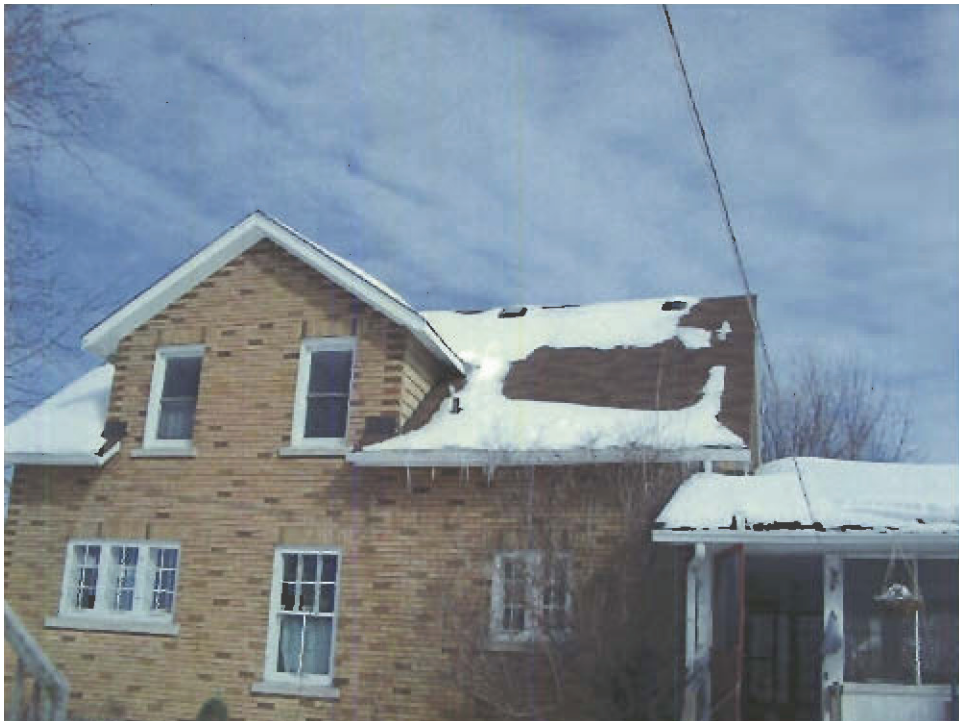
Photo 62: Manotick, Post Repair Snow Cover - Dormer

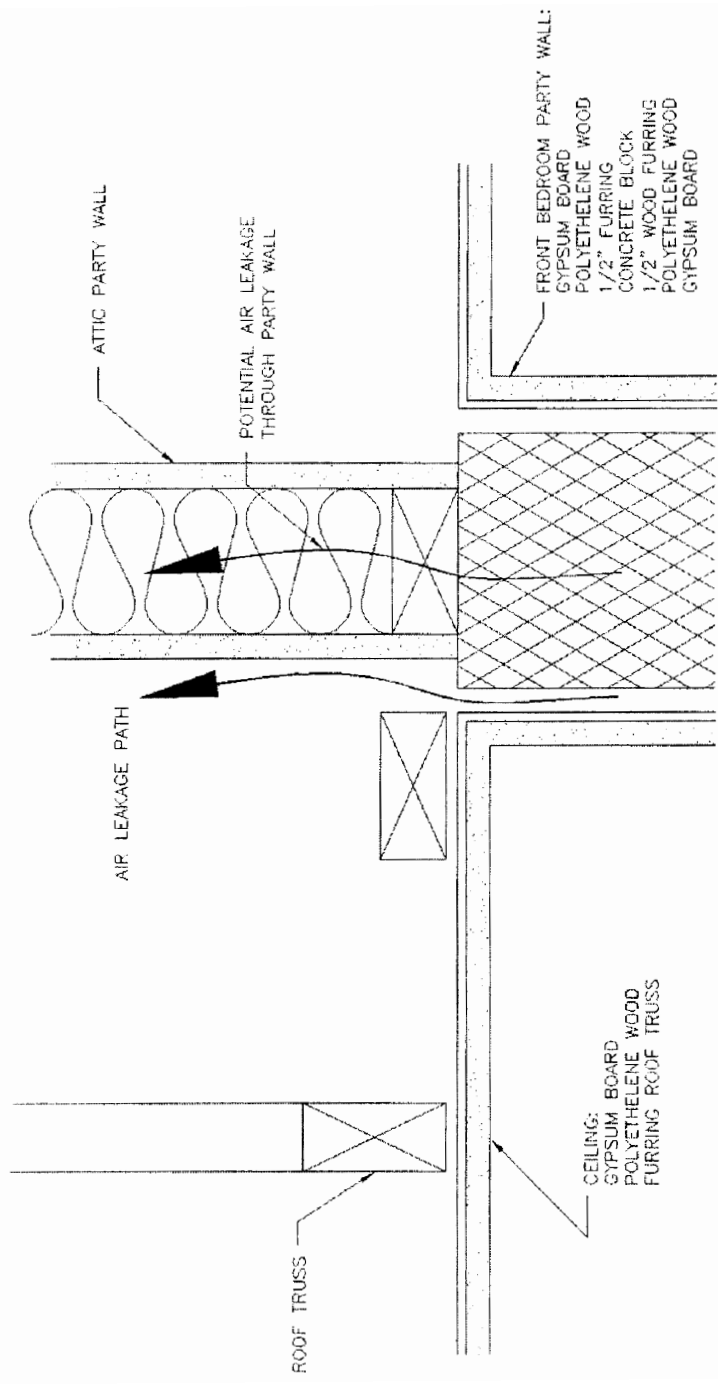
- We observed a 12 to 16 mm gap between the concrete block party wall and the gypsum wall board below the attic. This gap was created by the furring between the concrete block wall and the gypsum wall board.

Figure 3: Site 1, Air Leakage Path at Party Wall
