RESEARCH REPORT

ICE DAMMING FIELD RESEARCH:
ICE DAMMING SOLUTIONS

Ice Damming Field Research Ice Damming Solutions

Ottawa, ON

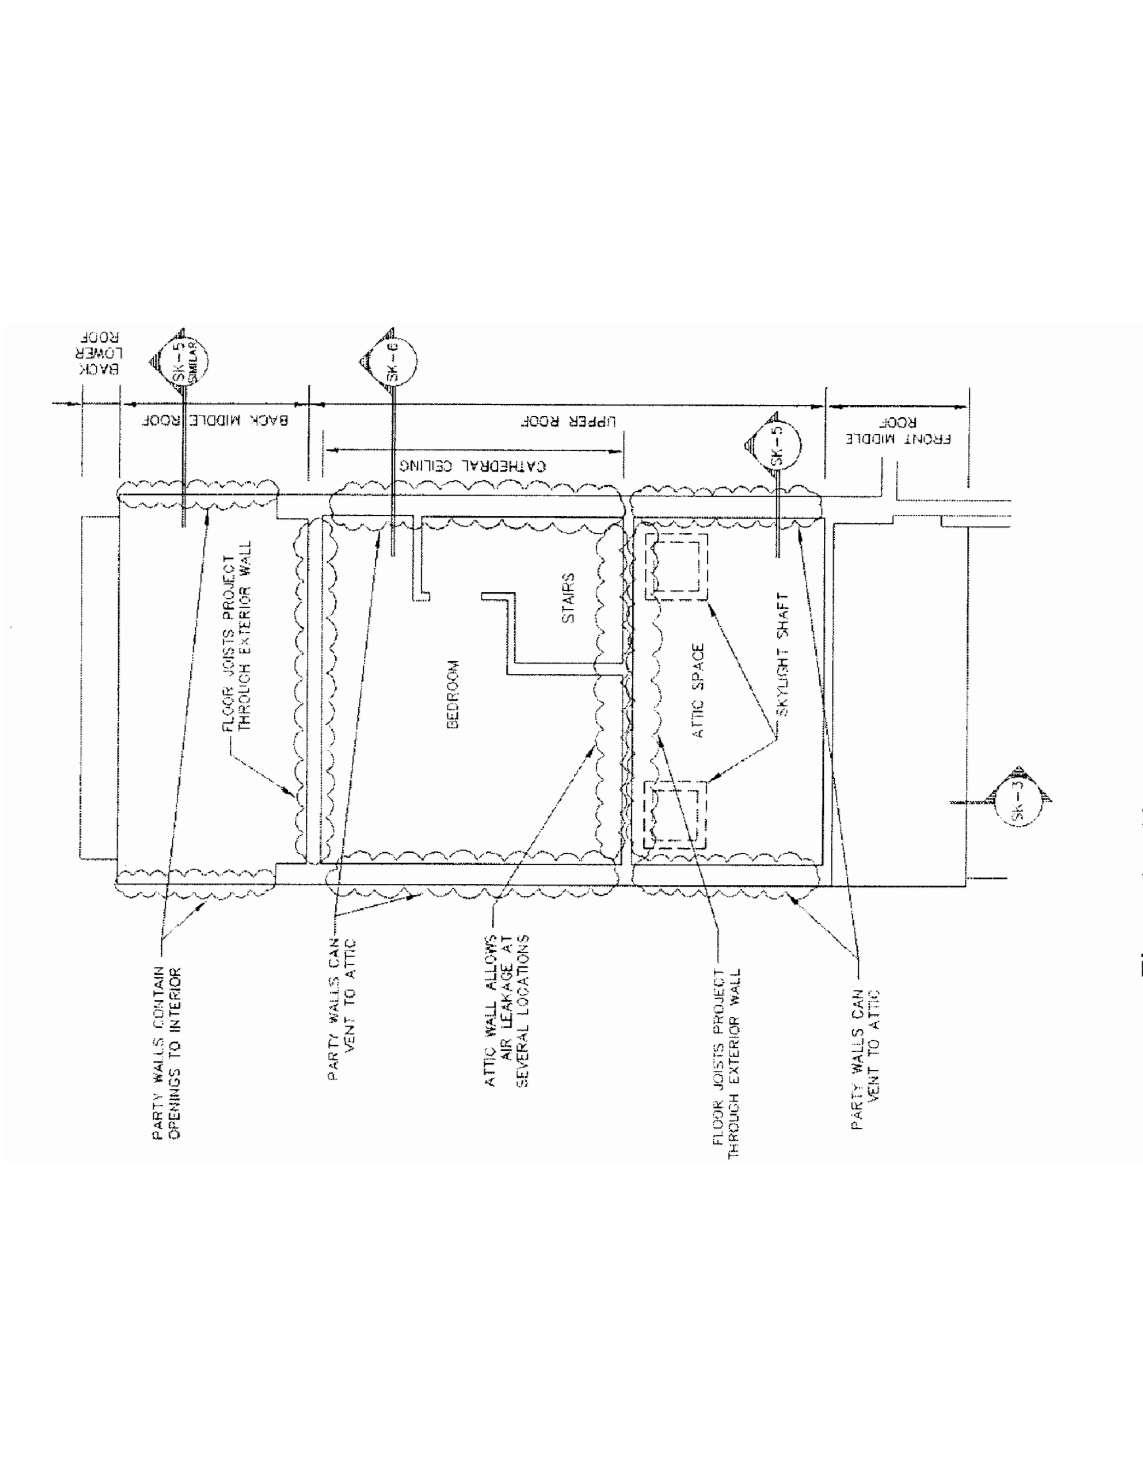
Within the attic spaces, we observed several large areas of potential air leakage, as shown in Figures 3 through 5 and described below:

Figure 4: Site 1, Problem Locations

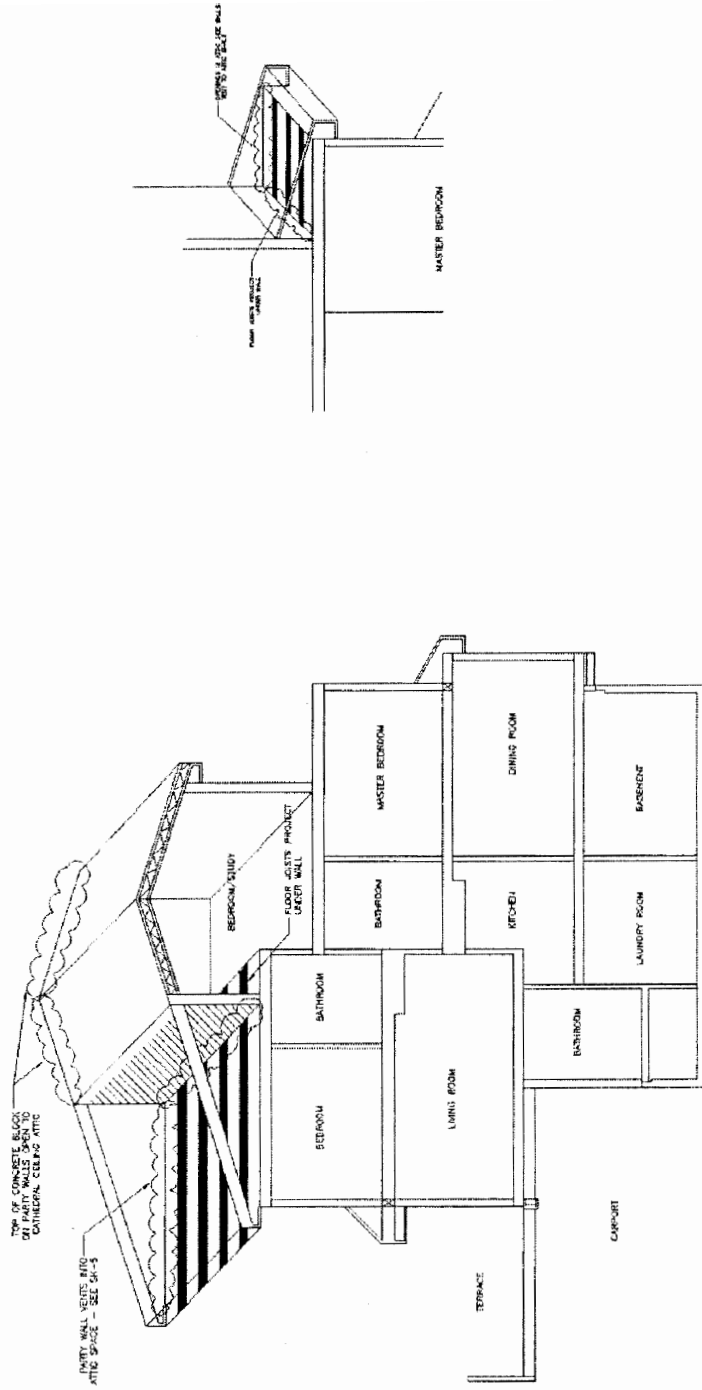
- We noted that the floor framing extending past the line of the uppermost interior room wall into the attic spaces was not sealed to prevent air leakage. A similar condition also existed at the rear middle roof. Effectively, this created a 200 mm deep hole that ran the entire length of the wall through which air could freely enter the attic space (as shown in Photo 5 and Figure 5).

Figure 5: Site 1, Problem Locations (Isometric)
