## Renovation Strategies for Brick Veneer Steel Stud Construction: Task I Brick Ties

**BRICK VENEER/STEEL STUD RENOVATION STRATEGIES FOR  
WALL CONSTRUCTION**

**TASK 1:  
BRICK TIES - OPTIONS FOR REMEDIATION**

M.A. Postma, E.F.P. Burnett  
Building Engineering Group  
University of Waterloo

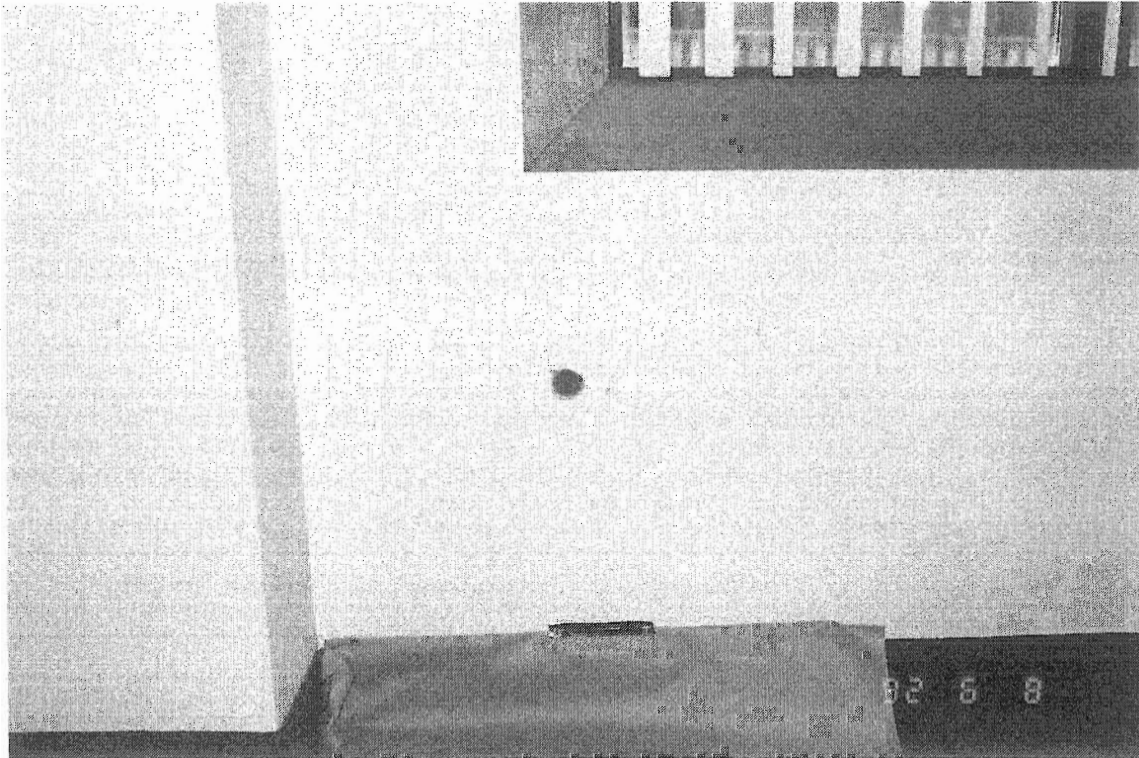
**Photo 5 - View of Finished INT1-Cintec Repair**

**Thermal Bridging** - In relative terms, this repair results in a high degree of thermal bridging.

**Weather Limitations** - There may be some limitations on installation in cold weather as the temperature of the grout is required to be 7 Celsius at the time of injection and has to be kept above 5 Celsius for twenty four hours following injection.

**Air Leakage** - No increase in air leakage should occur if the sock is manufactured so that the expanded sock effectively blocks the hole through the sheathing and steel stud.

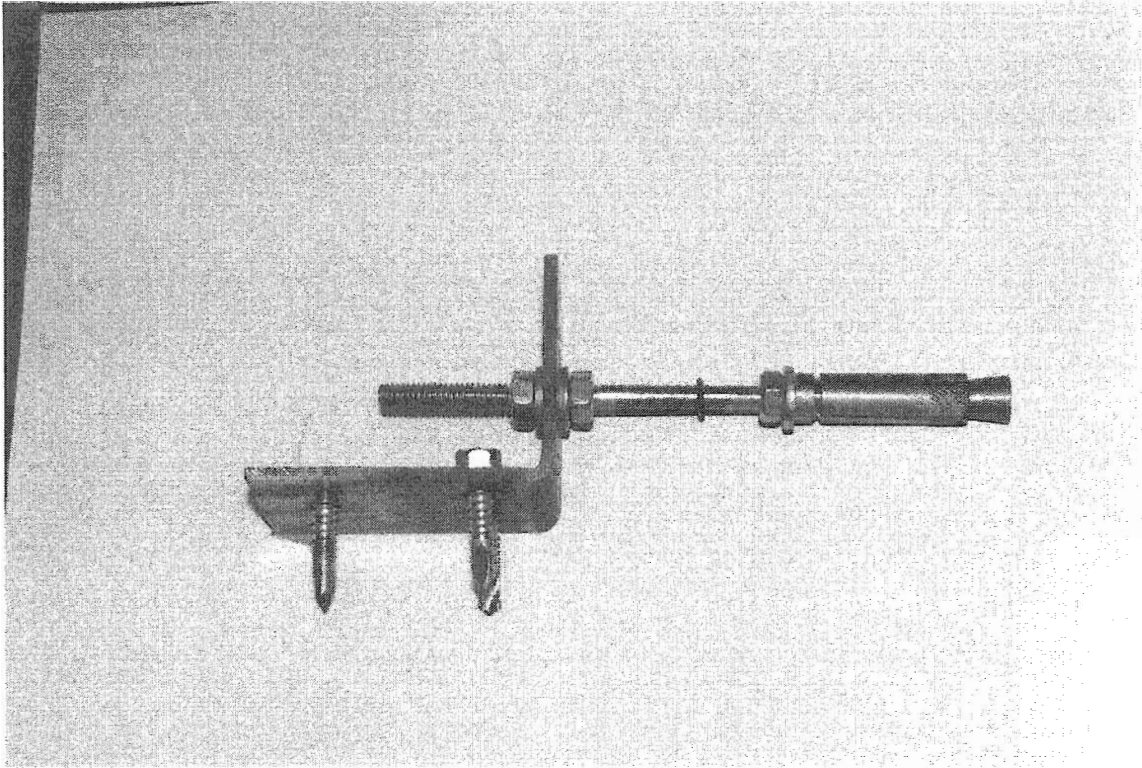
**Photo 7 - INT2 - Dur-O-Wal Side Mounting Bracket and Expansion Anchor**

**Thermal Bridging** - Relative to other tie systems, a significant amount of thermal bridging will occur at this connection as the threaded rod bridges the air cavity.

**Air Leakage** - As access to the stud space is required in this repair method any holes that are put through the sheathing could be sealed.

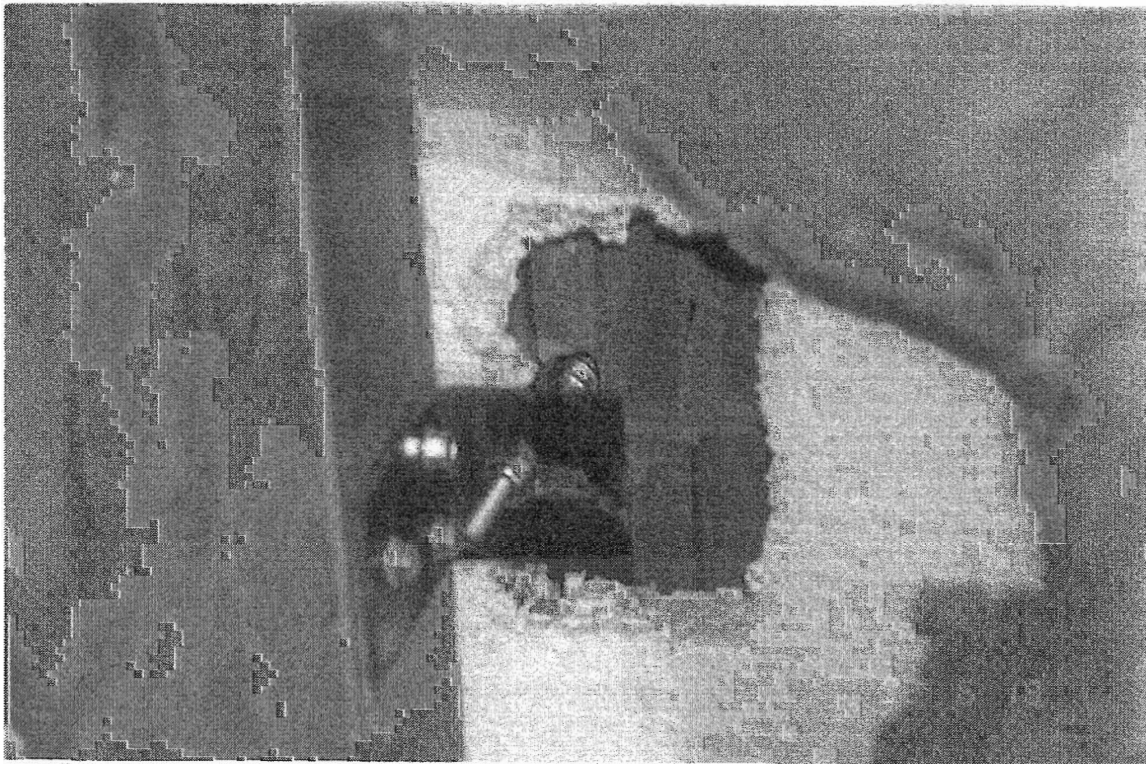
**Photo 8 - View of Installed INT2 - Dur-O-Wal Repair**

With the exception of INT2, the web mounted bracket, the repair methods demonstrated were all feasible. The use of repair method INT2 would only be practical if large amounts of the interior gypsum board were to be removed.

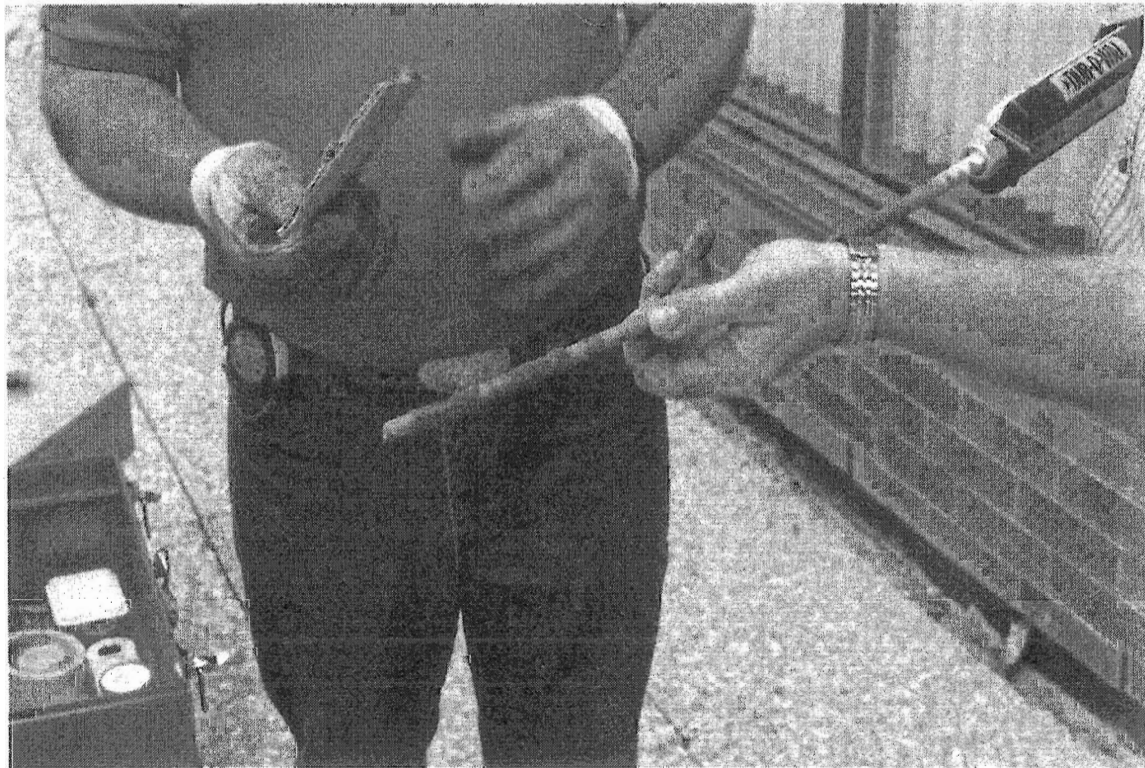
**Photo 9 - Epoxy Being Injected Into the Stainless Steel Mesh**

**Air Leakage** - The epoxy that protrudes out of the wire mesh screen will, to some degree, block the hole through the sheathing.

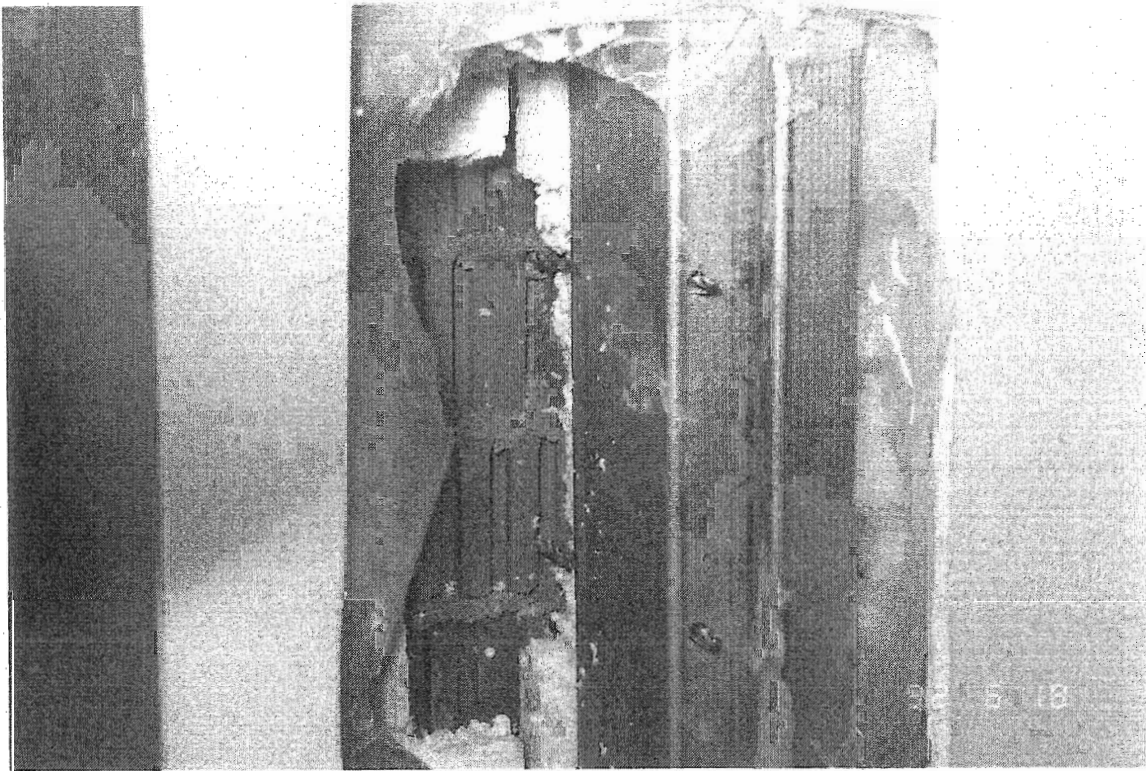
**Photo 11 - View of INT4 - Helifix HRT80 Repair**

**Thermal Bridging** - As the tie is continuous from the brick veneer to the inner flange of the stud a thermal bridge is created, although the small cross-sectional area of this tie limits this somewhat.

**Air Leakage** - The small hole in the steel stud and the exterior sheathing may increase slightly any flow of air between the stud space and the cavity.

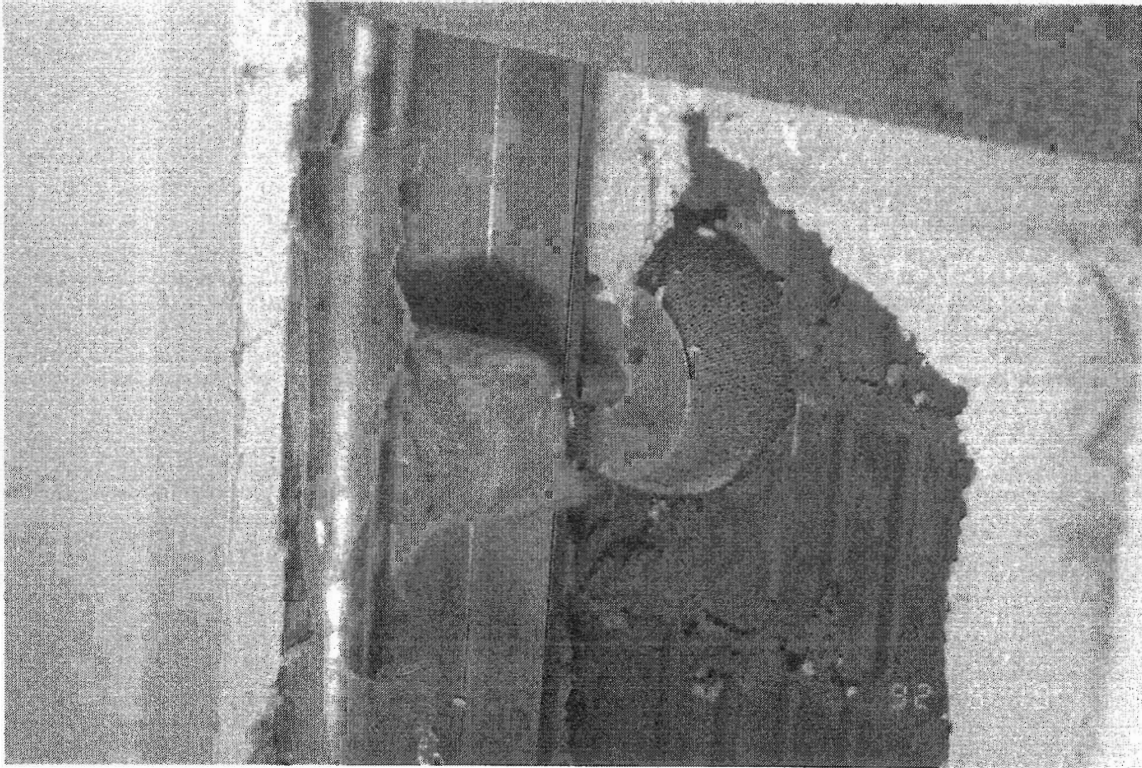
**Photo 13 - Interior View of EXT1 - Cintec Repair**

**Air Leakage** - No increase in air leakage should occur if the sock is manufactured so that the expanded sock effectively blocks the hole through the sheathing and steel stud.

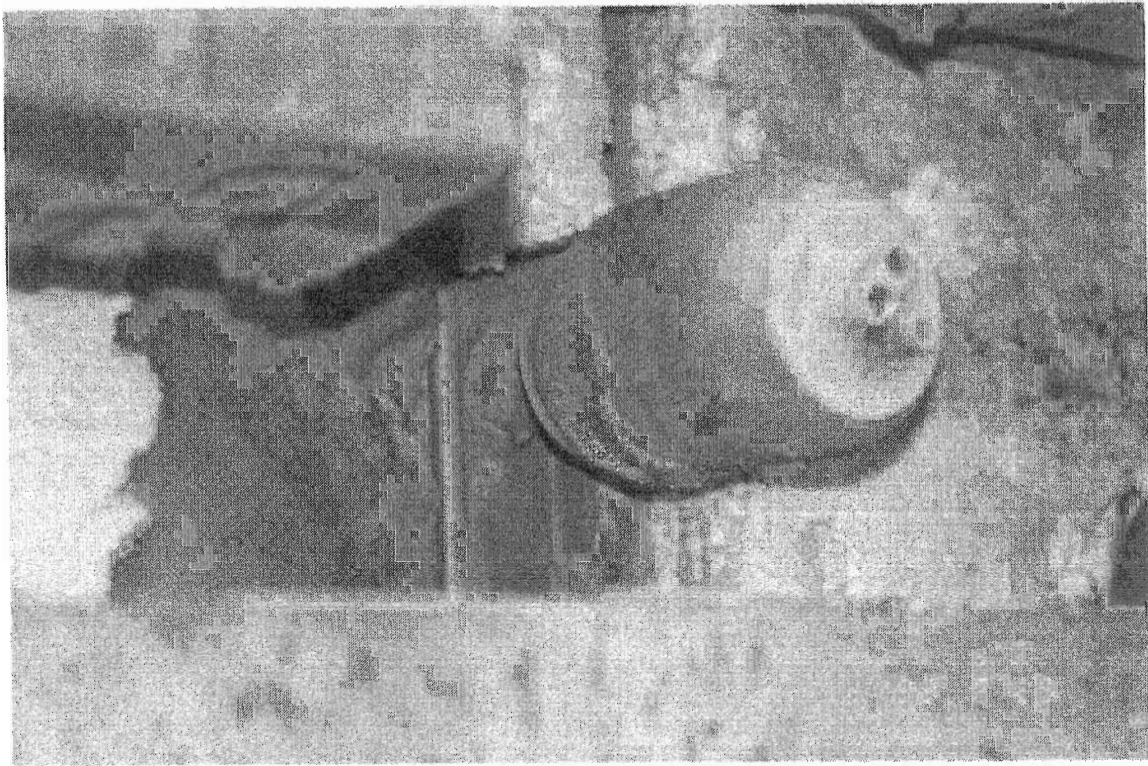
**Photo 14 - Exterior View of EXT1 - Cintec Repair**

All repair methods, with the possible exception of the larger Cintec repair (EXT1), are feasible and practical methods to tie brick veneer to steel stud. The large 65 mm dia. hole needed for the Cintec tie in repair method EXT1 is aesthetically unacceptable and expensive to do and repair. This repair is, however, suitable if existing ties have to be removed and replaced.

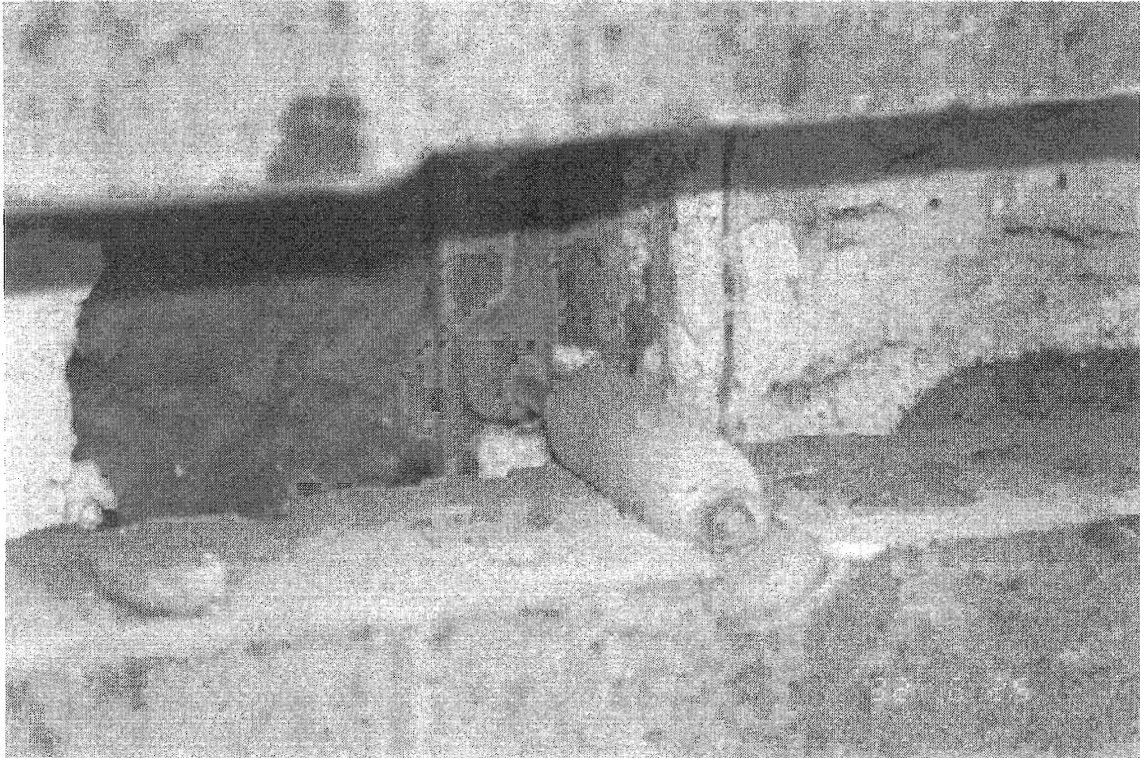
**Photo 15 - Exterior View of EXT2 -Cintec Repair System**

**Air Leakage** - No increase in air leakage should occur if the sock is manufactured to such a length that the expanded sock effectively blocks the hole put through the sheathing and steel stud.

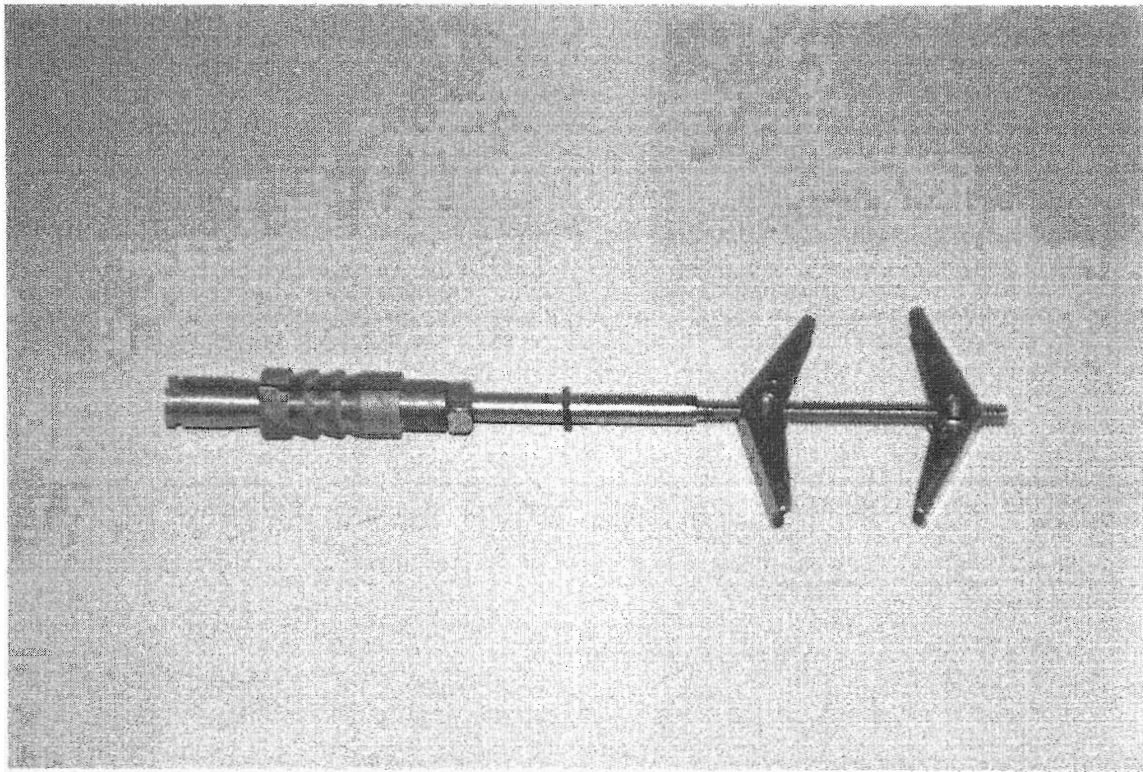
**Photo 17 - The EXT3 - Dur-O-Wal Toggle Clips and Expansion Anchor**

**Air Leakage** - If the toggle is used with compressible sheathing it is likely that a large hole in this sheathing will occur when tightening the toggles. This large passage is unacceptable as a potential passage for air has been created between the stud space and the cavity. When used on a rigid sheathing or directly on the flange of the steel stud this repair method would only slightly increase the potential for air flow between the cavity and the stud space

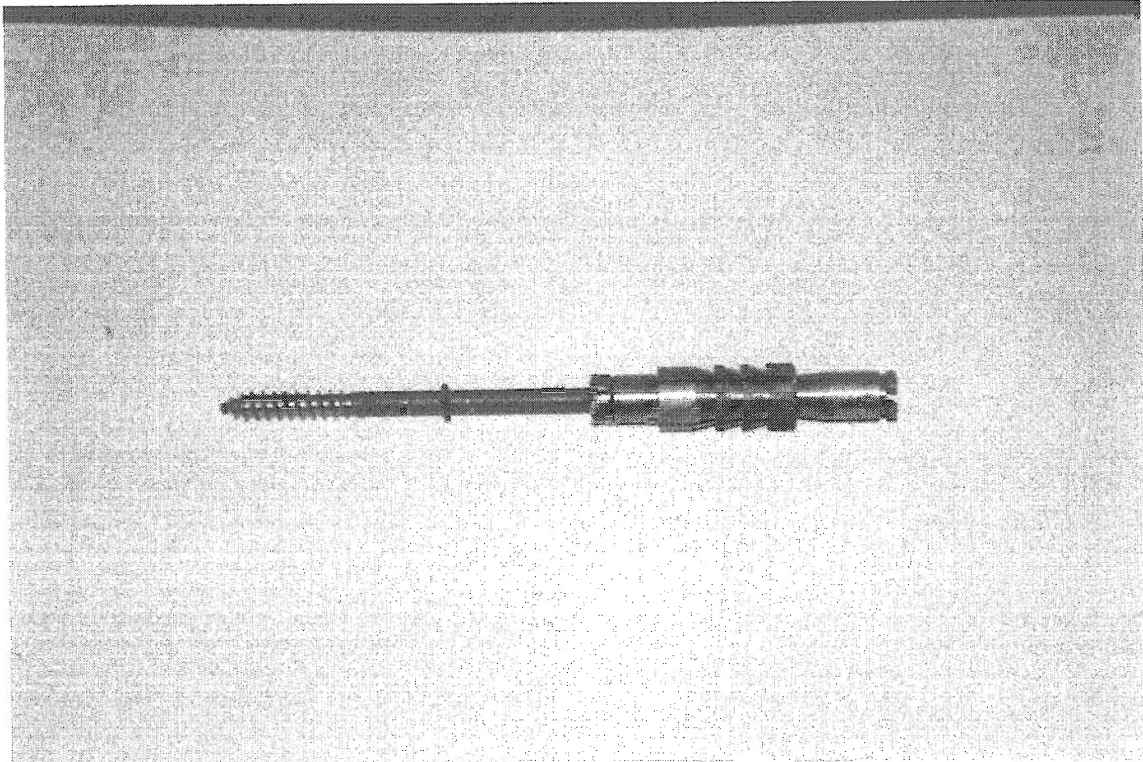
**Photo 19 - EXT4 - Dur-O-Wal Tie System**

**Air Leakage** - The potential for air flow between the stud space and the cavity will be slightly increased by the 3/8" hole put in the sheathing. Both the tie and the bushings should seal this hole to some extent.

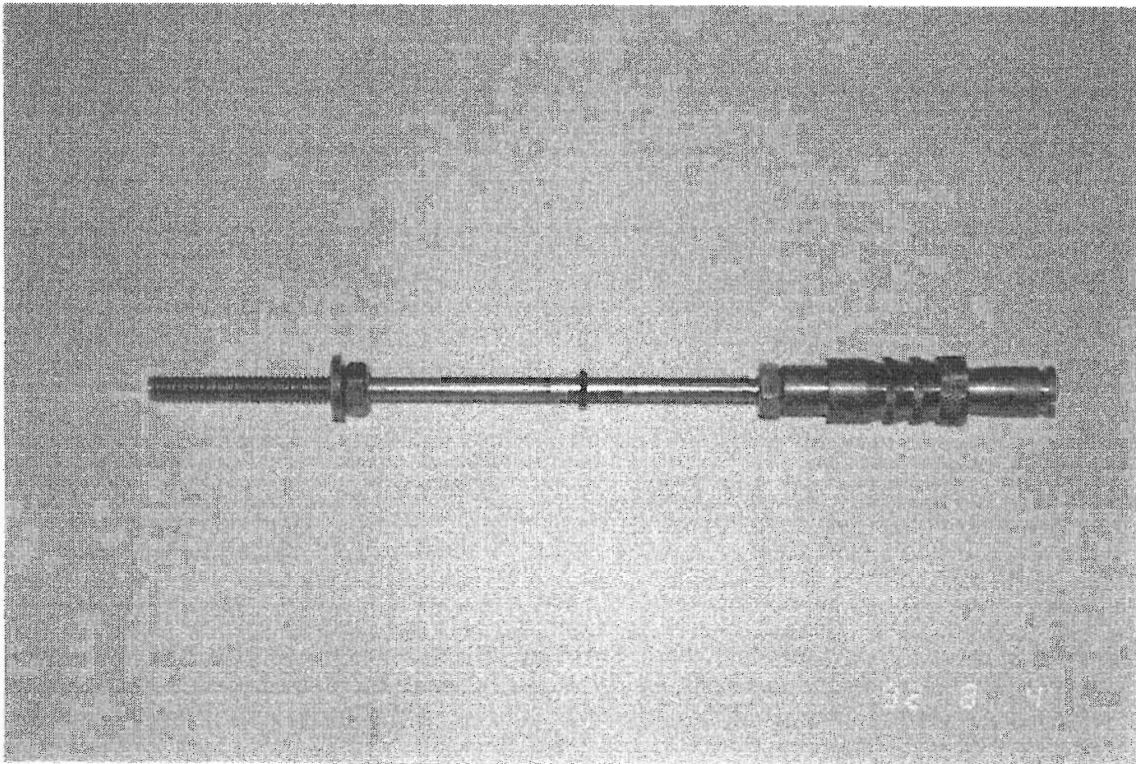
**Photo 21 - EXT5 - Dur-O-Wal Tie System**

**Air Leakage** - The potential for air flow between the stud space and the cavity will be slightly increased by the 3/8" hole put in the sheathing. The tie and the washer should seal this hole to some extent.

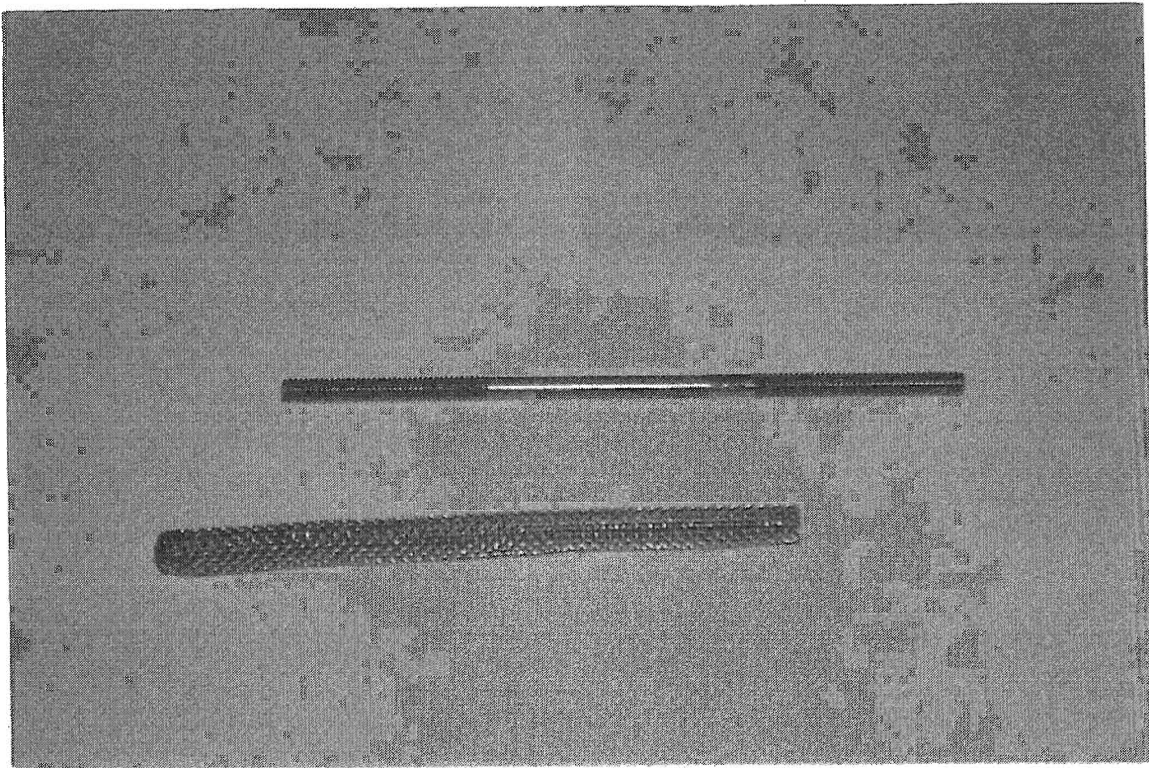
**Photo 23 - Components of the EXT6 - Dur-O-Wal Repair System**

**Air Leakage** - The epoxy should seal the hole in the sheathing and the flange of the steel stud so that only a small increase in the potential for air flow between the cavity and the stud space will result.

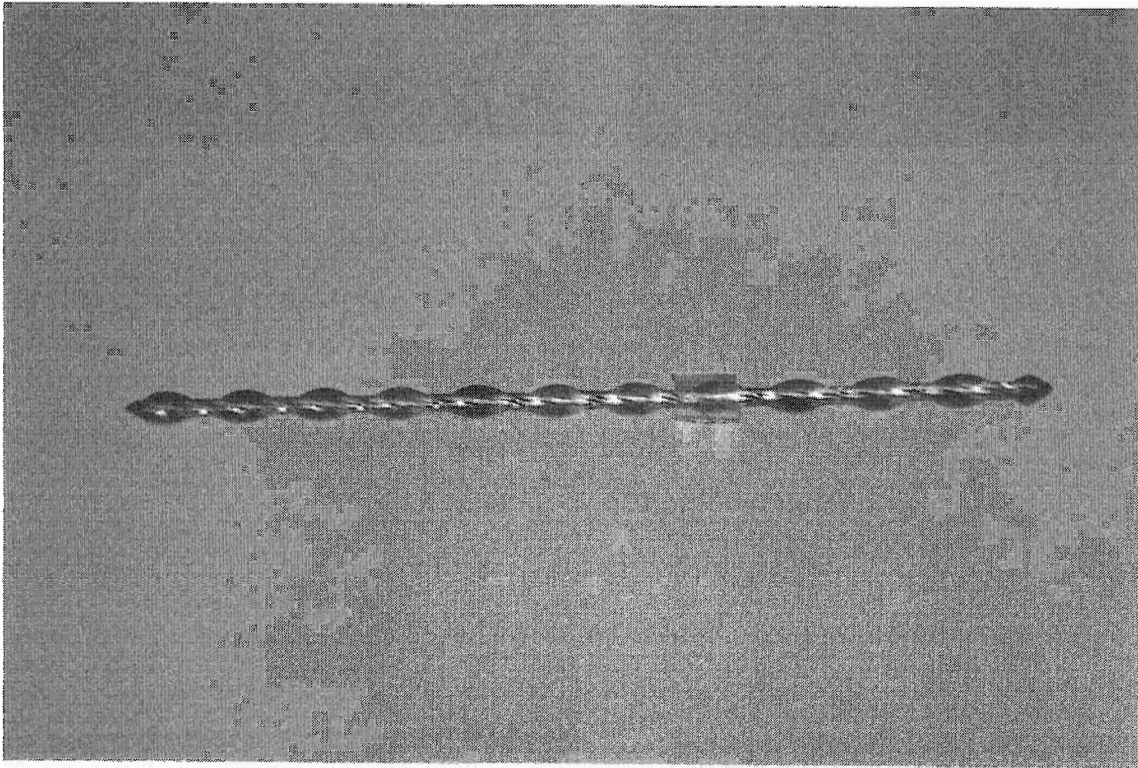
**Photo 25 - Helifix HRT80 Tie and Plastic Washer**

**Air Leakage** - The small hole in the steel stud and the exterior sheathing may increase slightly any flow of air between the stud space and the cavity.
