## Moisture in Straw Bale Housing Nova Scotia

## Final Report, November 1998

Submitted by: S.H.E. Consultants  
RR #3, Comp. 308 Wolfville, NS B0P 1X0  
phone/fax: 902.542.3518  
email: sheconsl@istar.ca  
Shawna Henderson, Principal Investigator

Submitted to: Don Fugler, Research Division  
Canada Mortgage & Housing Corporation  
National Office  
700 Montreal Road Ottawa, ON K1A 0P7

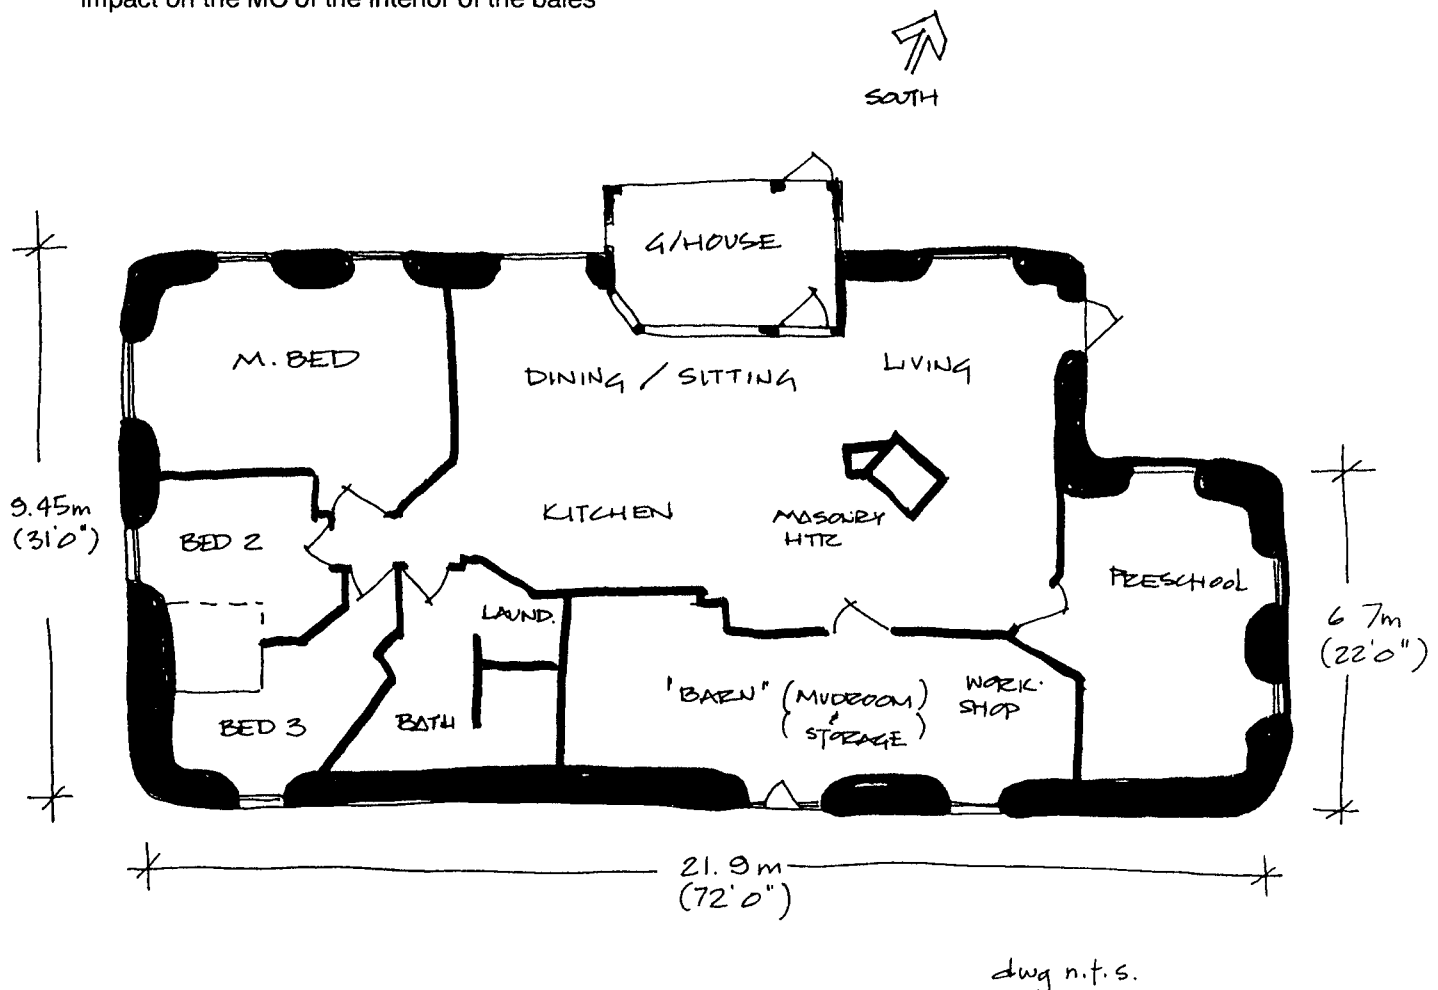
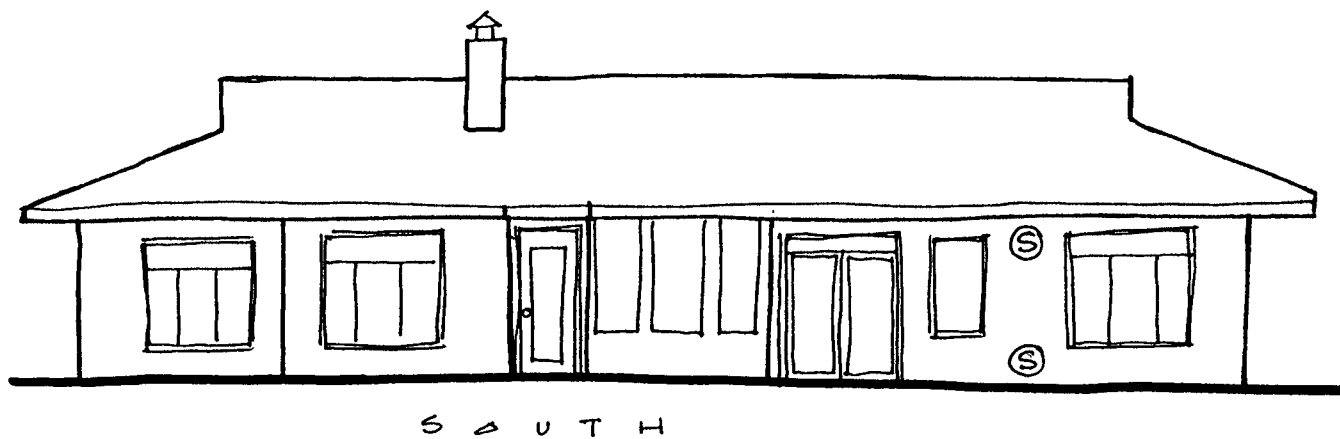
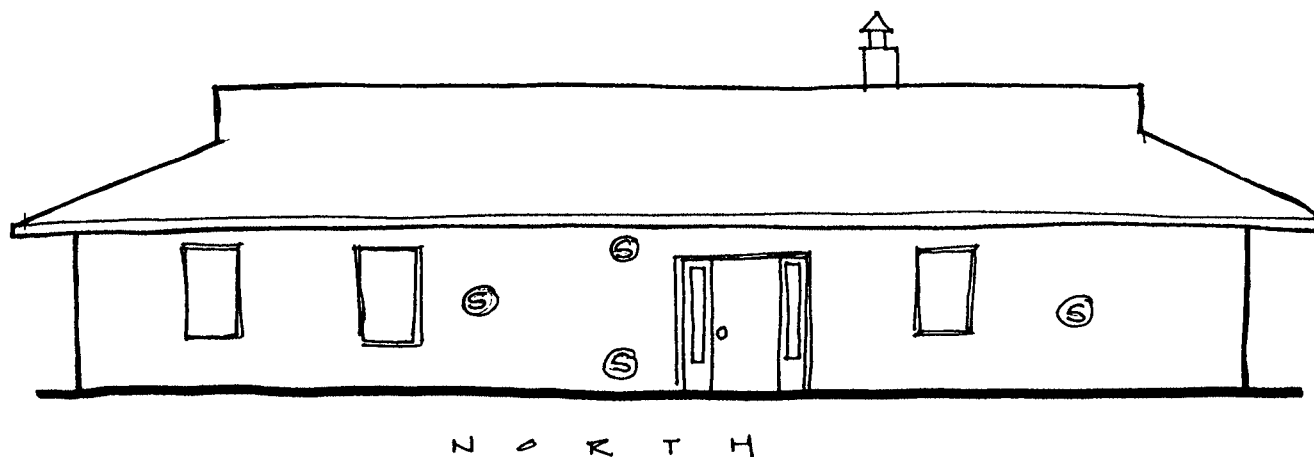
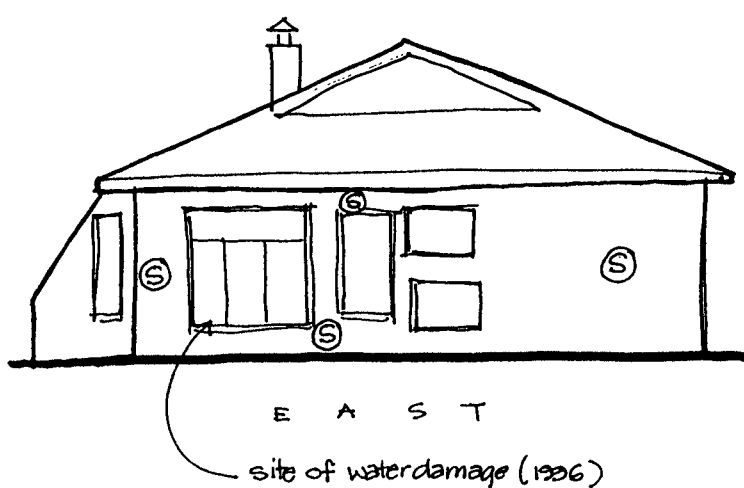
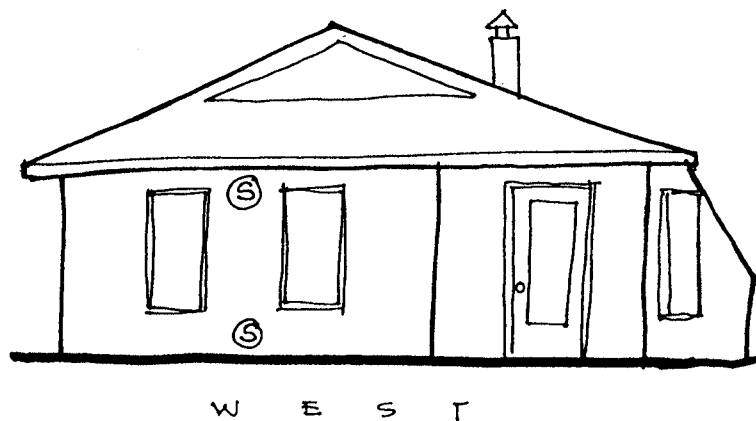
# NSPSB01 (St. Margaret's Bay)

Moisture content readings in NSPSB01 varied slightly higher than the average except in May, increasing in variation from average (to + 1%) over the period of December through March. However, the trend in this house reflects the overall trend of the bale walls increasing in MC over the warm weather months, and decreasing over the heating season. On average, the walls to the W were driest (9.6%) while walls to the E were wetter (10.9%). One anomalous reading was taken in the E (17%) in July.

The two string bale walls of this house are covered in 50 to 75mm (2 to 3") of concrete stucco, applied in three coats over the straw and 75mm (3") square galvanized fencing (less expensive than stucco wire). The scratch coat (inside and out) had lime to portland ratio of 1:2; the brown coat was a 1:1 ratio, and the finish coat was 2:1 lime. Walls were then painted with no VOC latex paints.

The interior of this house was re-painted just before July readings were taken, which may have had a small impact on the MC of the interior of the bales.

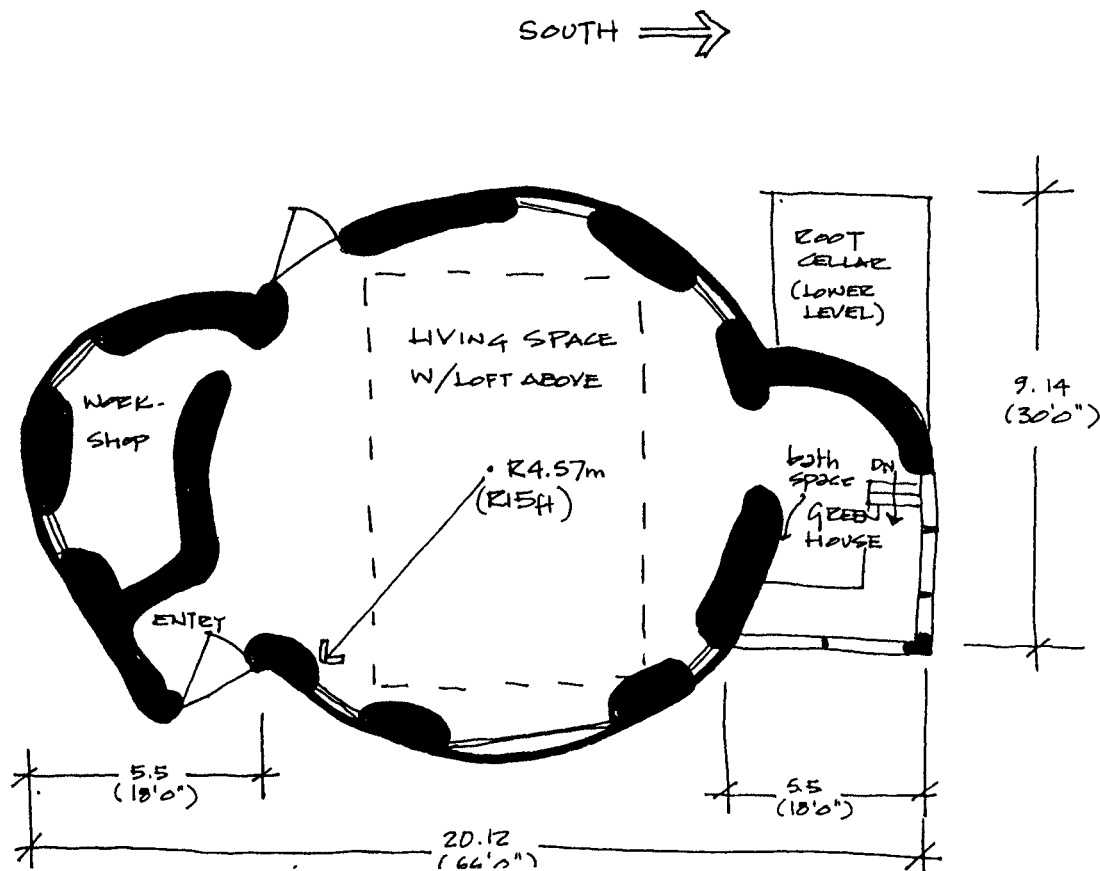
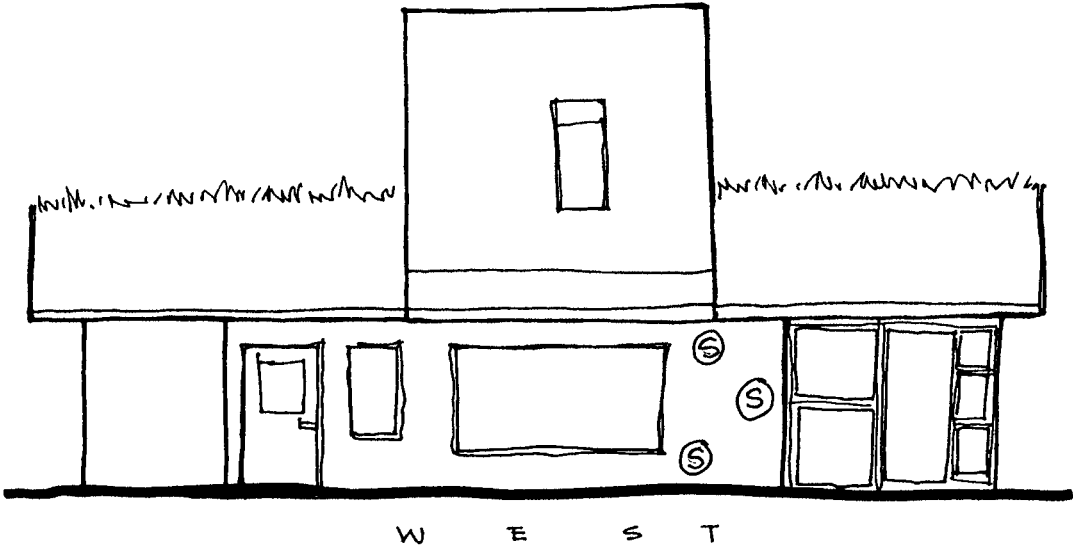
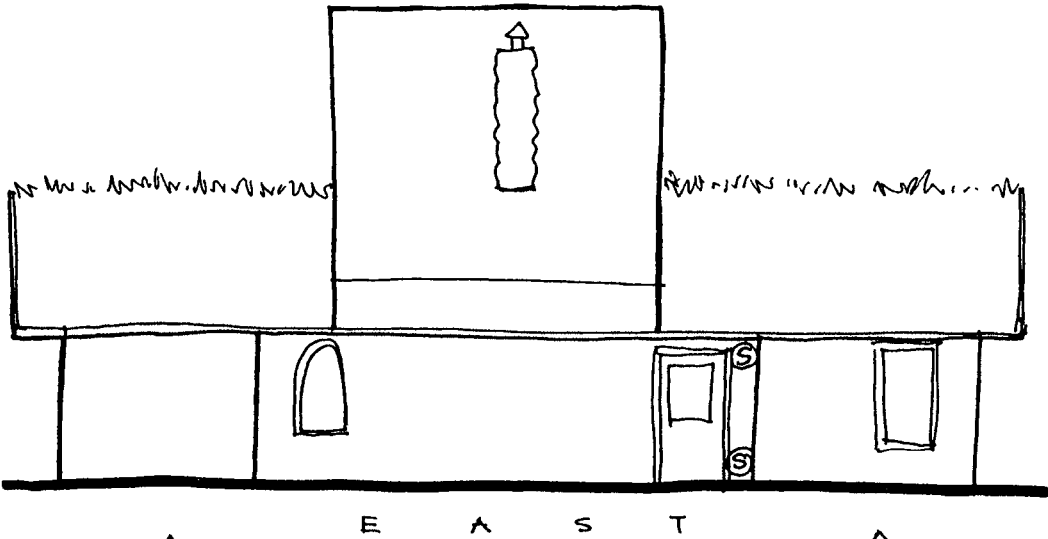
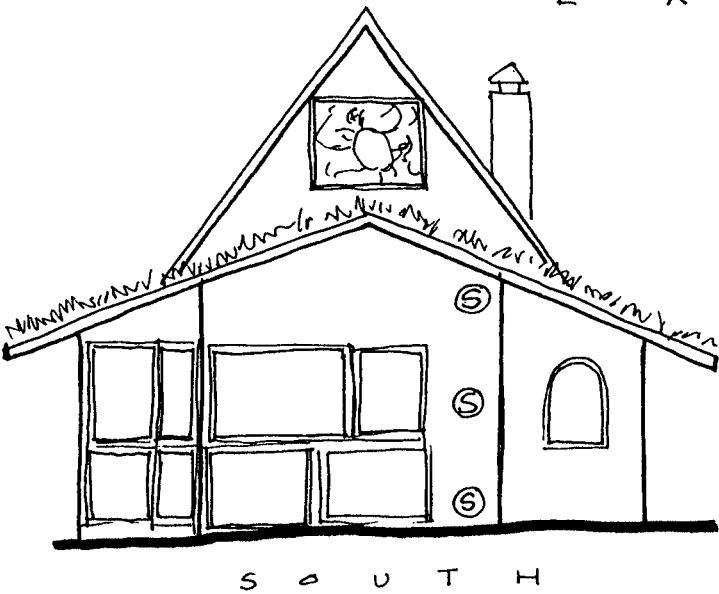
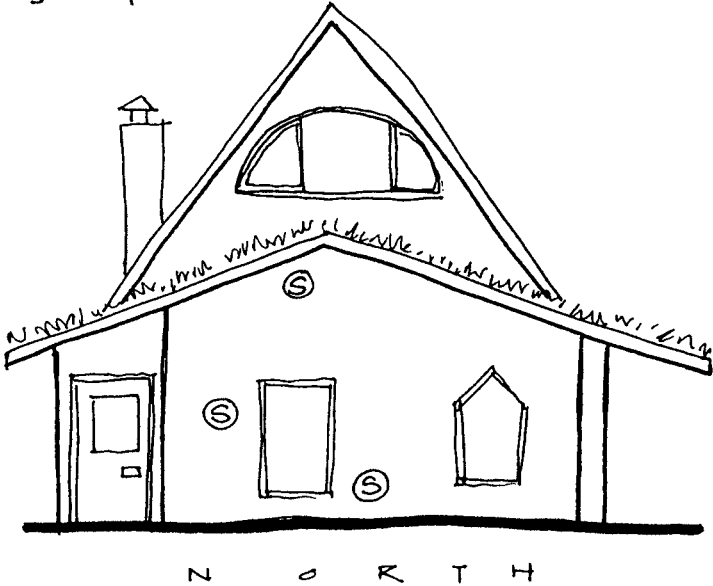
NSPSB02 (Walton)

NSPSB02 was the most recently built of the houses in the study. The plastering activity that went on during the first half of the study period showing up as roughly one percent higher than the average readings for the months of May through September and then evening out to a closer to average reading for the remainder of the study period. On average, the walls to the N were driest (9.7%) while walls to the W were wetter (10.2%).

- Seal off dirt floor in greenhouse area by laying down 6mil poly sheeting and covering it with a protective layer of sand where it will be left exposed (most of floor will eventually be covered with a finished wood floor)
- Seal off root cellar from living space with heavier duty weatherstripping at door, silicone caulking at floor joists and other connections.

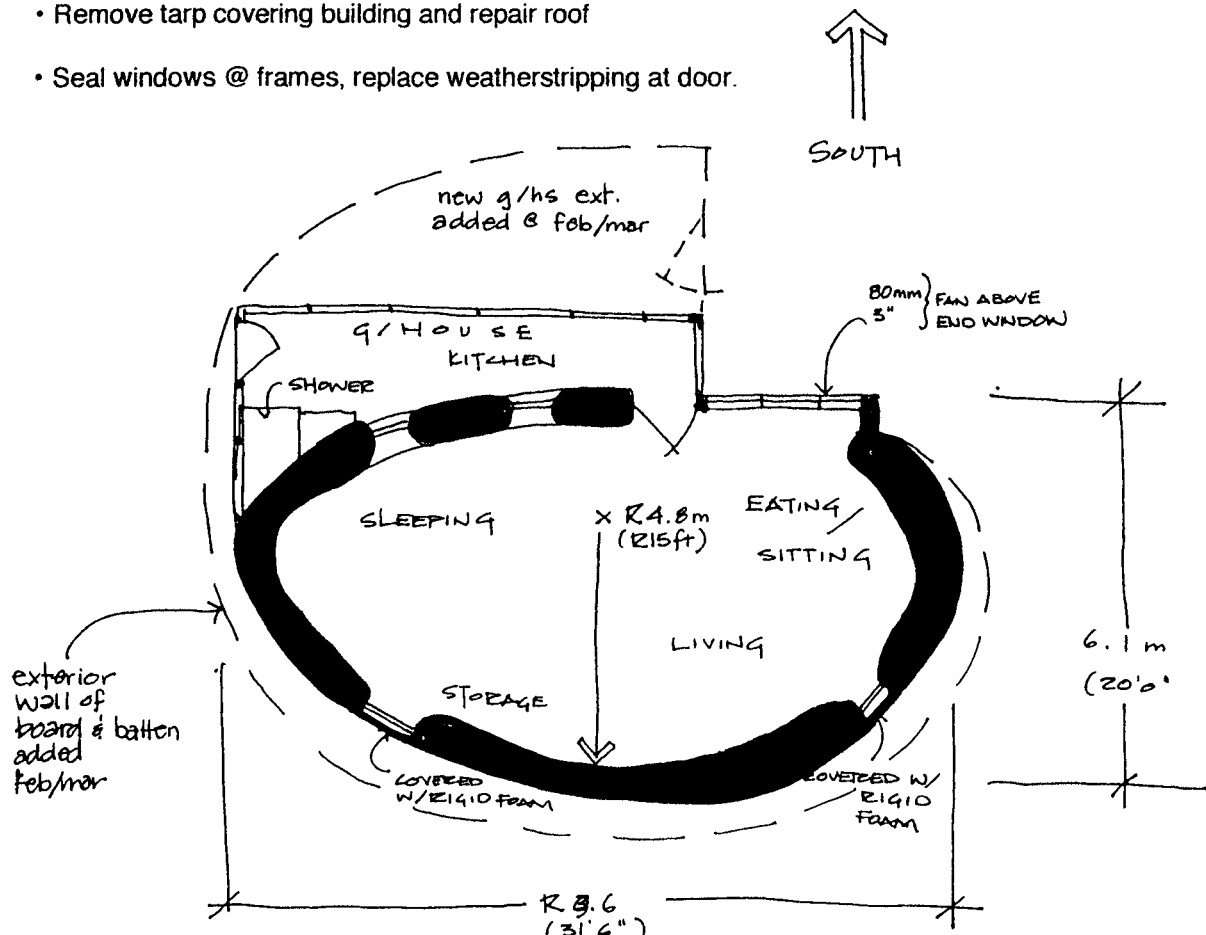
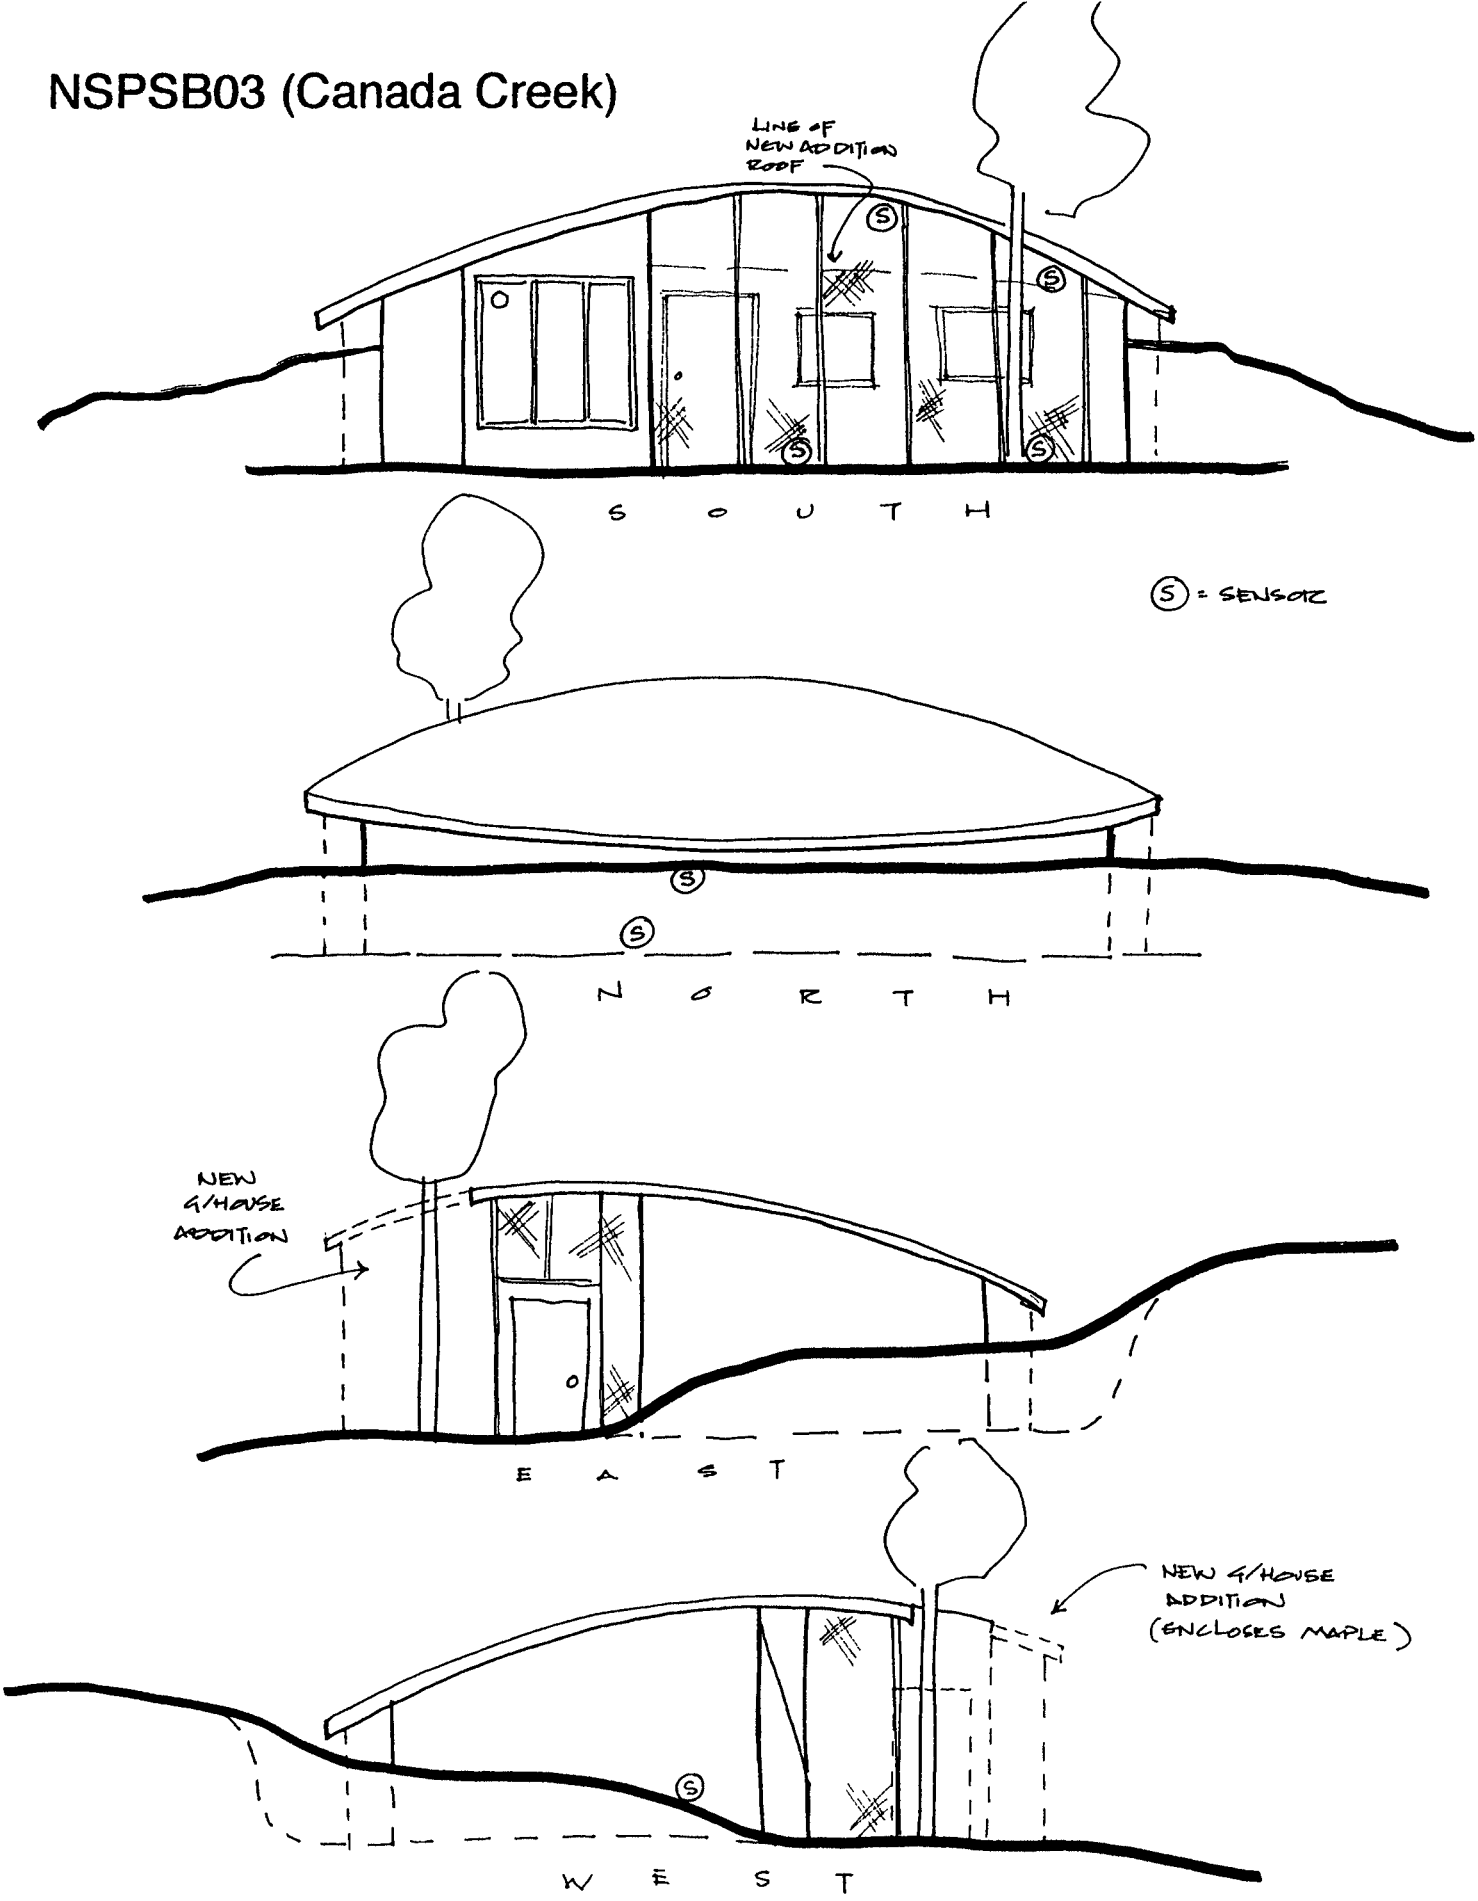
NSPSB03 (Canada Creek)

The moisture content reading in May for NSPSB03 were higher than average (+ 2.2%). One reading was well above the others (19%), at a location known to have been subject to leaking from the roof. This went down rapidly to meet the average readings for July through November, and then rose again above average levels for Dec/Jan and March readings (+1.5%). This is probably accounted for by the removal of an oversized tarp that was used to protect the leaking roof which was removed in June. This, combined with the operation of a small 75mm (3") 50l/s (100cfm) fan most likely account for the drying trend in this house while the MC in the walls of the other three houses was going up through July. On average, the moisture content in the bale walls to the N and S was equally distributed (10.5%).

This load-bearing studio was built over the period of September to December 1993. The walls were left open for a long period of time, and some water damage was seen before the roof went on. The building was not lived in year round until 1997, when a family of three (now four) moved in. Before this, it was rented out through the framing seasons and used sporadically through the winters. The building is shaped like an eye, with the 'corners' to the E and W. A bank of windows is located to the western end of the S face and a light frame greenhouse that serves as a kitchen and shower area (as well as a greenhouse) is attached to the eastern end of the S face. The N side is a deeper curve (almost a half circle), with a 120mm (48") berm around it that stands off by about 120mm (48").

Sensors were placed close to areas indicated by homeowner to be 'known' leakage areas.

- Remove tarp covering building and repair roof
- Seal windows @ frames, replace weatherstripping at door.

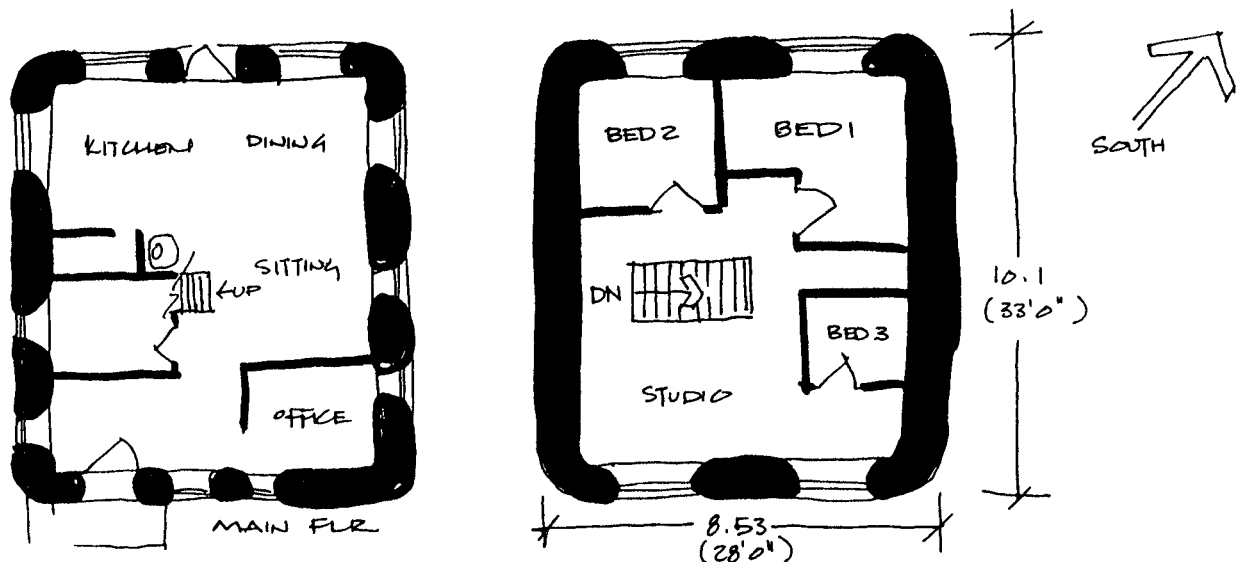
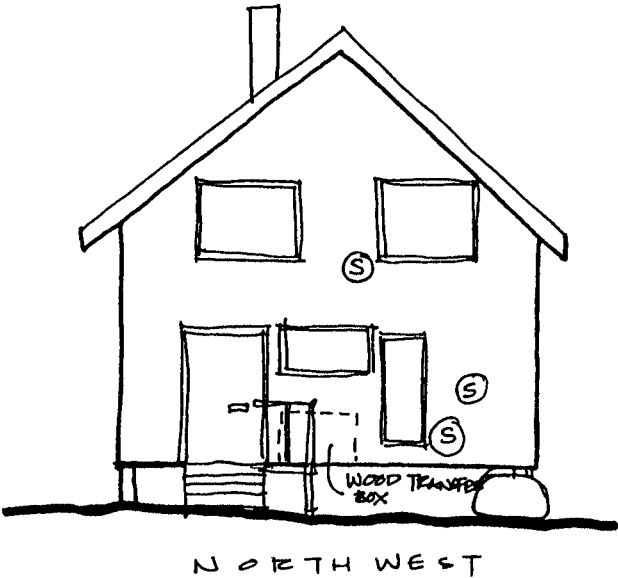
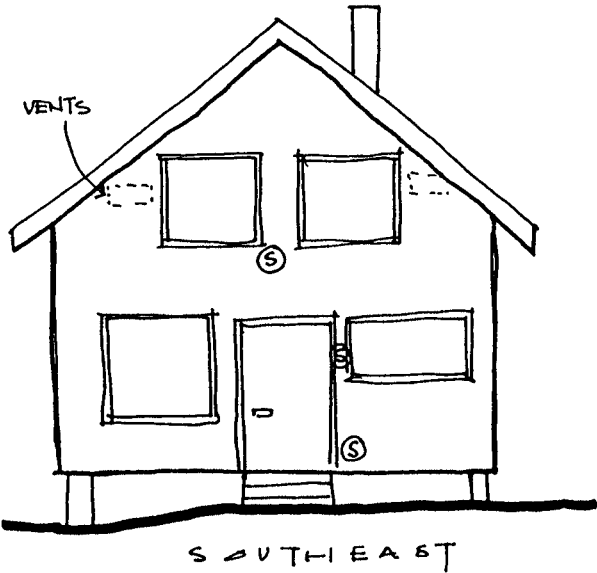
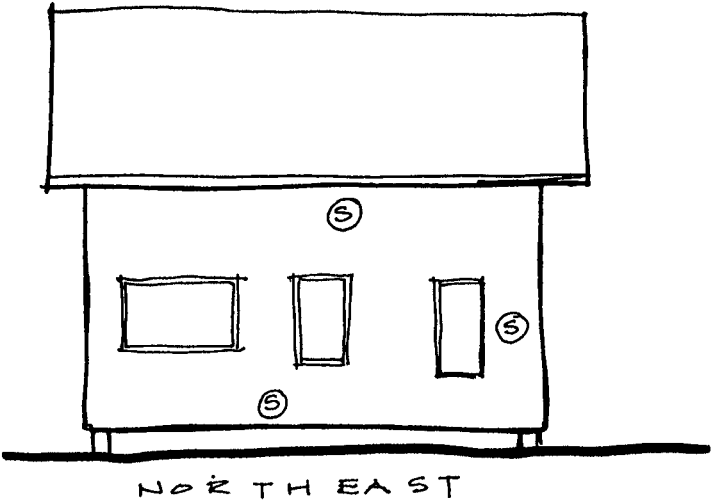
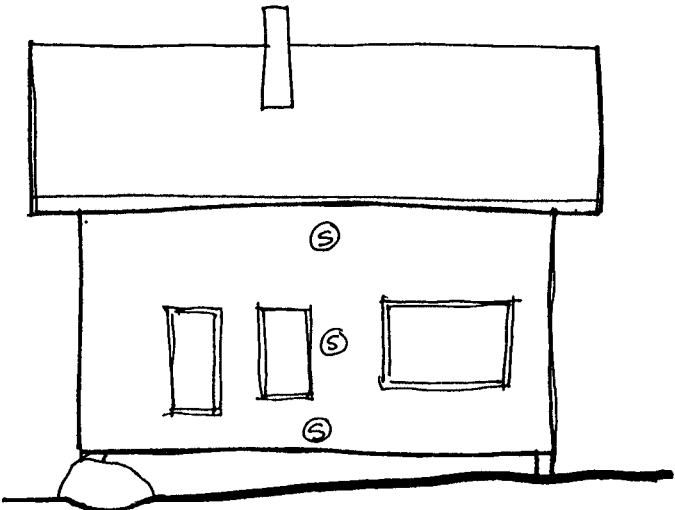
NSPSB04 (Ship Harbour)

The house with the consistently lowest overall MC (NSPSB04) is also the oldest of the four houses. This house differs from the other three in that it is built on a pole foundation, with half bales set into a 'cradle' in the floor joists (see discussion of individual houses). The other three houses are variations of slab-on-grade foundations (insulated monolithic raft, frostwall with poured slab, shallow frost protected footing with poured slab and straw insulation under). On average, the walls to the E,NE were driest (6.9%) while walls to the N,NW were wetter (8.6%).

There has been some noticeable rot and black 'goo' in a few areas of the under the floor straw, partially because there is not an effective vapour/air barrier under the straw. A polyethylene film is in place, but it is not sealed nor is it continuous. The area under the post foundation was used as a storage area, reducing air flow under the house and decreasing the drying conditions there. This has been cleared out somewhat, so the increased air flow should help dry the bottom of the house.

One sensor was located in the immediate area of a known leaky water pipe to monitor the performance of the wall in proximity to the presence of water on the interior of the wall.

During the course of the study, the house experienced a small but dramatic fire at the front entrance area. The fire started during attempts to thaw a frozen water pipe and took out the first 600 to 1000mm (24 to 36") of the first few joists under. The fire was contained, the straw in the floor smouldered and blackened but didn't catch fire. However, due to water damage during the fire fighting process, the half-bales had to be removed and fibreglass batts were set in place instead. There was not damage to the surrounding straw bale walls.

- A heavier weight poly film could be laid directly on the ground below the house and covered with a layer of sand for protection. This would potentially reduce the dampness 'trapped' below the house via wet, poorly drained soil, although the bottom of the bales would still be subject to more extreme swings in moisture levels and temperatures, which could result in the continuation of moisture problems in the floor.
- Weatherstripping/air sealing at various places: door frames, window frames, wood transfer box and summer ventilation windows.
