A Study of Recurring Mold Problems on the Roseau River Reserve, Manitoba

by
Bill Boles
Boles Construction

May 13, 1998

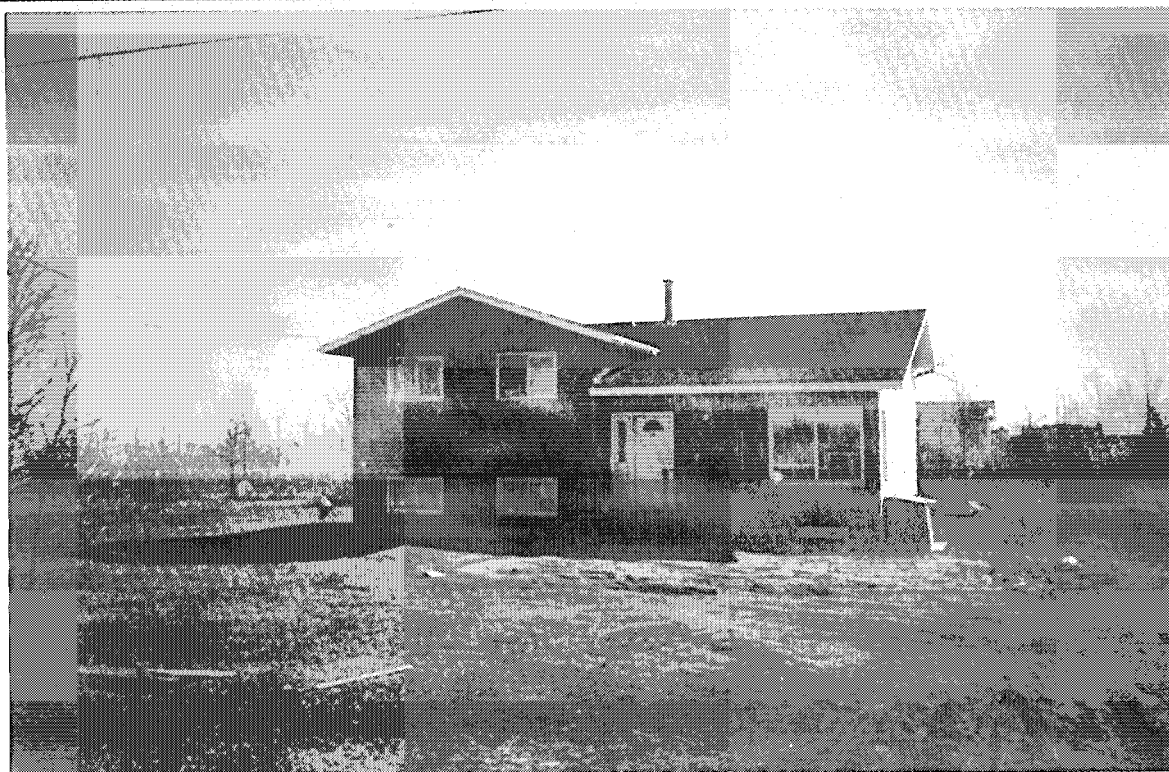
Figure 1:
House A-39, Front

- the site: flat, poorly drained
- the house: wood frame split level with shallow poured concrete foundation
- poor grading adjacent to the foundation wall
- wood siding on the front is unfinished and discoloured
- pre-finished hardboard siding on 3 sides buckled in places; missing some corners, waterstained
- no eavestroughs
- fresh air intake to return air trunk of furnace partly clogged with dust on the bug screen
- exhaust duct hood on the roof
- single panes broken in 2 triple glazed windows

- forced air system: only a few returns, room doors not undercut
- older carpet in most main floor rooms
- visible mold in the caulking at the edge of every window and in the caulking at the rear of the main bathroom vanity
- measured relative humidity: basement 51%; kitchen 49%; bathroom 48%
- occupants smoke in the house

1. For the home occupant: follow the general guidelines for homeowners listed in this report and in relevant CMHC literature. In particular, ban smoking in the house.
2. Clean up the small areas of visible mold according to the CMHC booklet *Clean-up Procedures for Mold in Houses*. (See primary recommendation listed under General Recommendations.)
3. Remove as much carpet as possible. The carpets retain moisture and stale odours while providing a haven for dust mites and mold. The area covered by carpet in the house is significant. Ideally, take it all out. Practically, start with areas of high occupancy, such as the bedrooms. Plywood subfloors with hard surface finish flooring are preferable to carpet. (See higher cost recommendation #2).
4. Clean dust from the bug screen on the fresh air intake to the return air trunk of the furnace. (See higher cost #1).

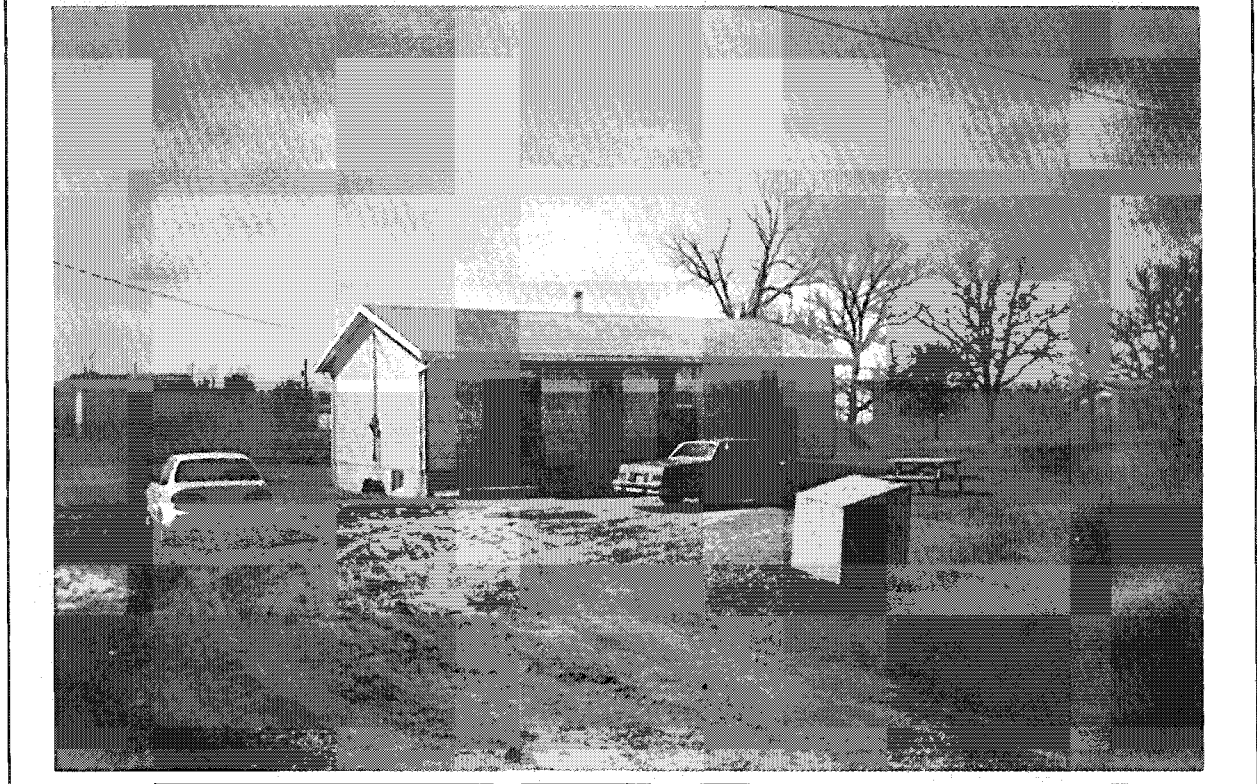
Figure 2:
House A-33, Front, East

- flat, poorly drained site
- poor grading against the foundation walls
- downspouts direct water against the foundation
- exterior stucco finish deteriorating in places
- two windows have broken panes
- dryer exhaust hood; no other air exhausts or intakes

- evidence of mold on drywall at base of wall under dining room window
- condensation between panes of kitchen window
- recirculating range hood
- slight mold in caulking at edge of windows
- measured relative humidity: basement 57%; kitchen 58%; bathroom 55%

1. Follow the general guidelines for homeowners listed in this report and in relevant CMHC literature. In particular, ban smoking in the house.
2. Patch any foundation snap-tie holes, wall cracks or floor cracks from the inside.

3. Install a retrofit rubber backwater valve in the basement floor drain. Disinfect the floor drain periodically with a bleach and water solution.
4. Investigate the patch of deteriorated drywall at the base of the dining room wall under the window. Clean up any mold.

5. Patch the deteriorated stucco and caulk around windows and doors to prevent water leakage.
6. Extend the eavestrough downspouts away from the foundation wall.

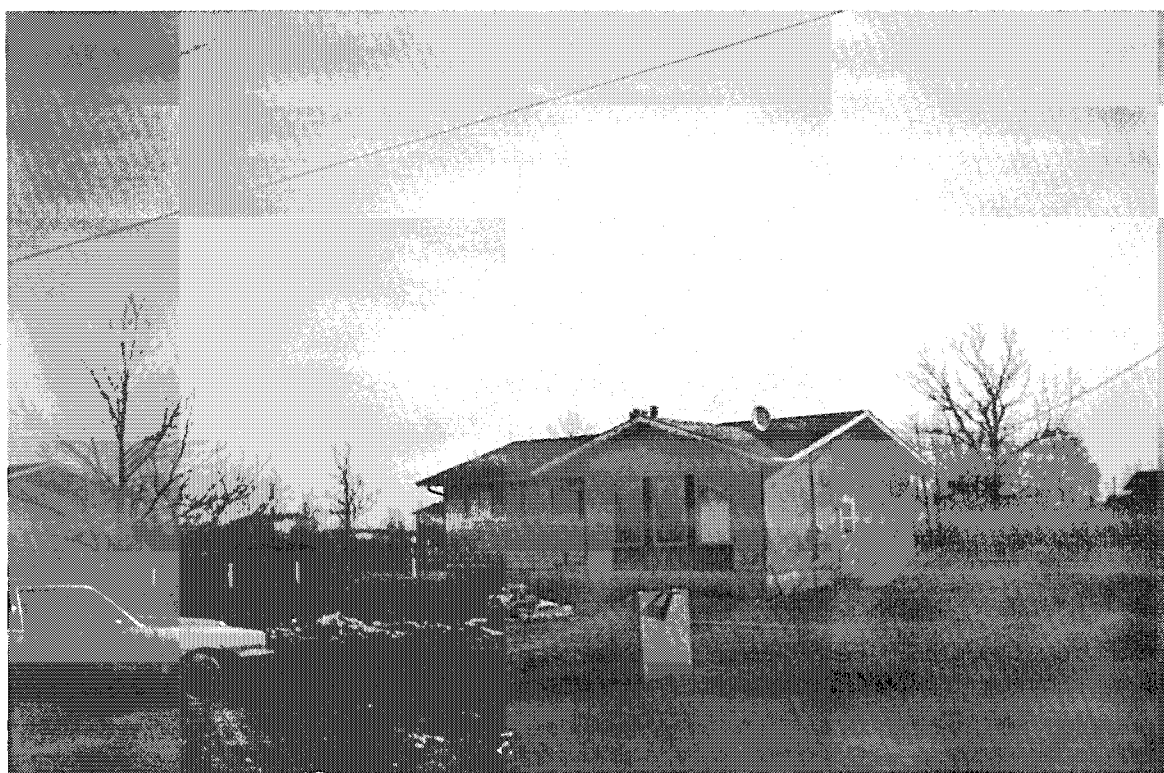
Figure 3:
House A-41, Front

- flat, poorly graded site
- poor grading against the foundation walls
- eavestrough downspouts direct water against the foundation
- the exterior stucco has deteriorated along the bottom edge
- two basement windows are broken
- no drip cap over side entrance door
- shingles have lifted or are missing from two places on the roof
- dryer exhaust hood; no other air exhausts or intakes

8. Investigate the black floor sheathing under the toilet. If the toilet flange is leaking, repair it. Clean up any visible mold.
9. Repair the exterior siding to prevent water leaks. Patch the stucco where it has deteriorated. Patch the rough concrete sill under the basement window. Install a drip cap over the side entrance. Caulk around all windows and doors.

11. Vent the kitchen range hood directly outside, as listed in general recommendations.
12. Extend the eavestrough downspouts away from the foundation.
13. Replace the dryer flex duct with aluminum duct. Seal all joints with aluminum duct tape.

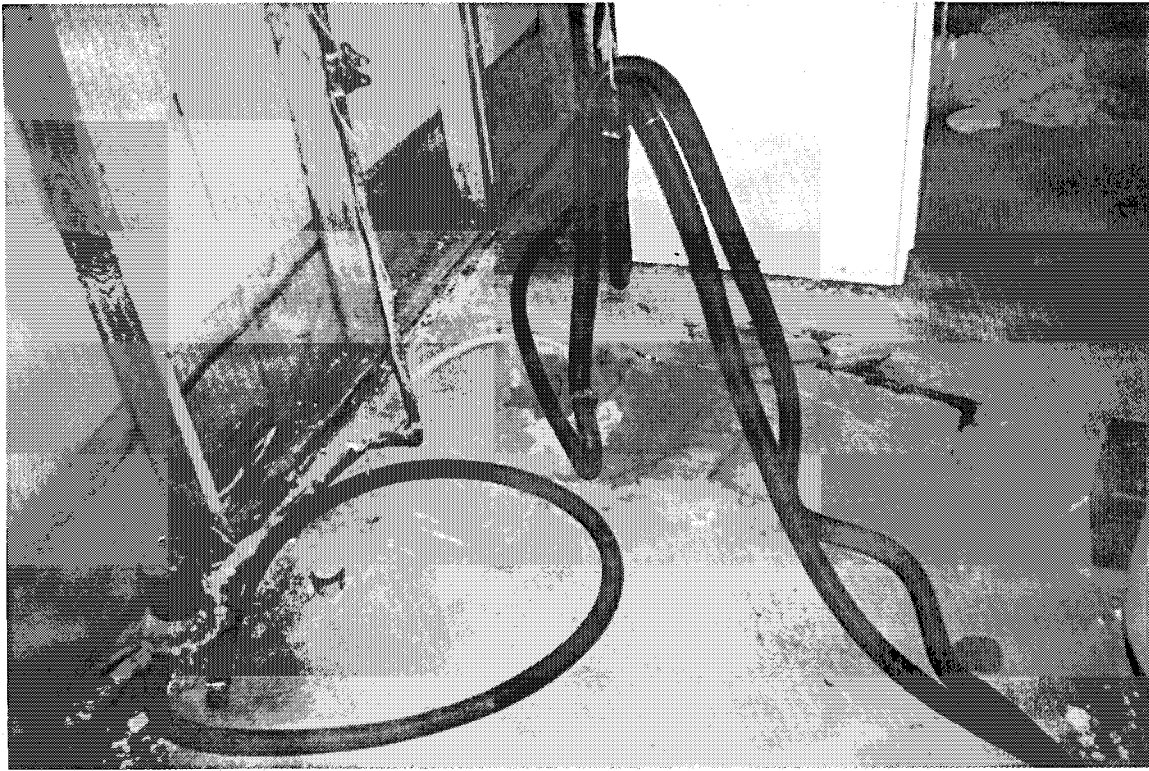
- basement floor about 5 feet below grade
- lower half of basement fibreglass insulation and drywall stripped out, presently unfinished
- lower part of exposed basement framing is wet and black. Moisture meter readings indicate: studs at midpoint 12%; bottom plate 19%.
- boards in the concrete floor have been cemented over (old sump pit?). Visible board is saturated with water.
- open hole through rim joist (location of former sump discharge?)
- poorly sealed air/vapour barrier at rim joist; missing insulation
- open floor drain used as washer discharge
- dryer: long winding flex duct

Figure 4:
House A-41, Constricted Water Hose, Sump Pit Cemented Over, Black Framing

1. Follow the general guidelines for homeowners listed in this report and in relevant CMHC literature. In particular, ban smoking in the house.
2. Remove the saturated wood which is partly buried in the basement floor. Clean up any mold following the CMHC booklets *Clean-up Procedures for Mold in Houses* and *Toxic Mold Clean-up Procedures*.
3. Strip out and discard the wet framing which has been exposed along the bottom half of the foundation wall. Thoroughly clean the concrete wall and floor with a bleach cleanser according to the above booklet. (See primary recommendation in General Recommendations.)
4. Repair the roof. Replace any missing shingles.
5. Patch any foundation snap-tie holes, wall cracks or floor cracks from the inside.

2. Install a new sump pit and pump connected to the underslab drainage tiles. If no drainage under the slab exists, install perimeter drainage tile under the floor on the inside of the foundation wall (higher cost).
3. Raise and slope the grade immediately adjacent to the foundation.
4. Upgrade the bathroom exhaust fan and install sheet metal duct directly to the outside as noted in general recommendations. (See higher cost #2).
5. Dehumidify the basement as required (particularly in summer) with a portable dehumidifier.
6. Seal the air/vapour barrier over the fibreglass insulation in the joist spaces along the rim joist.
7. Undercut necessary room doors to provide return air delivery to the central returns. Run the furnace fan as continuously as possible to provide better air circulation.

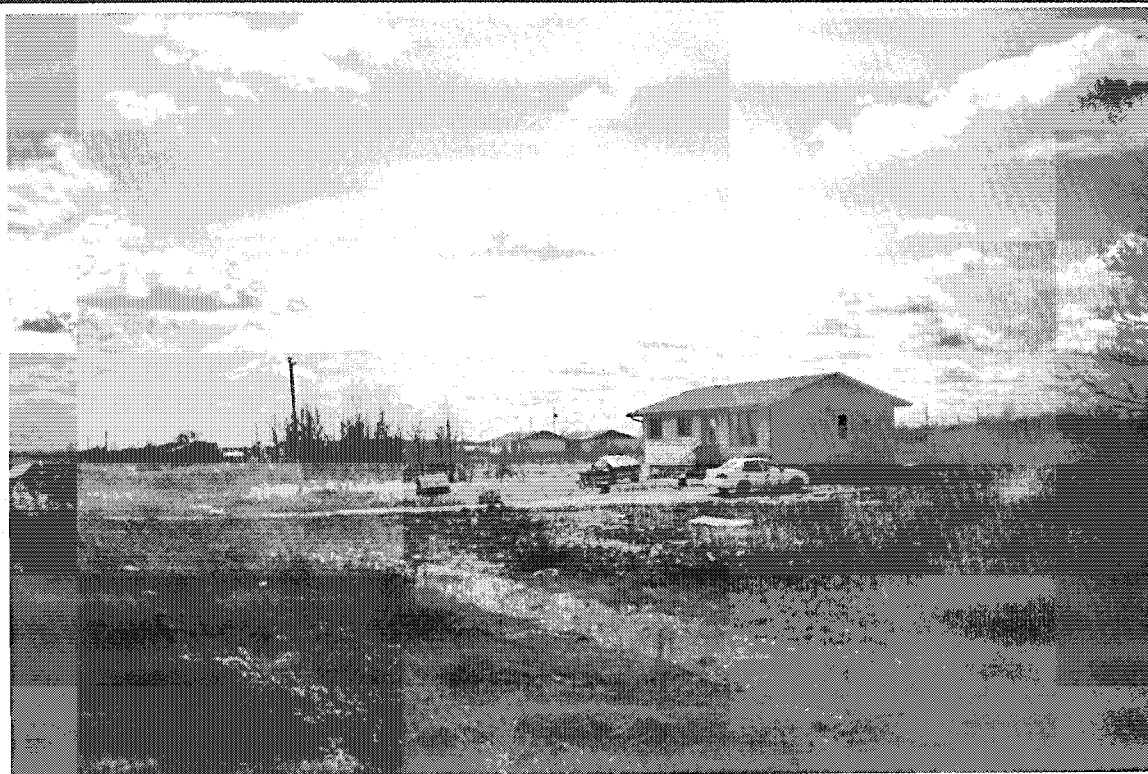
Figure 5:
House B-134, North-east

- significant air leakage through unused dryer vent penetration
- dryer flex duct constricted

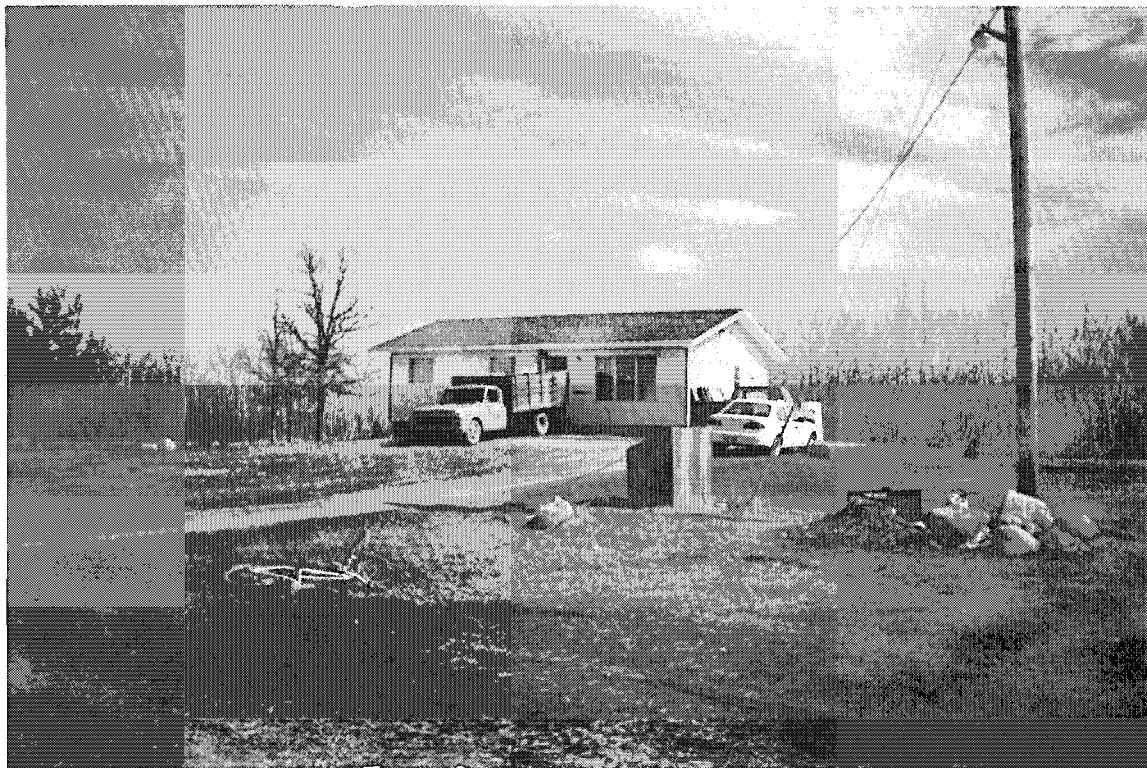
Figure 6:
House G-16, Front

- Severely mold contaminated, previous remediation for mold
- PWF basement, floor 1.5 m (5 feet) below grade

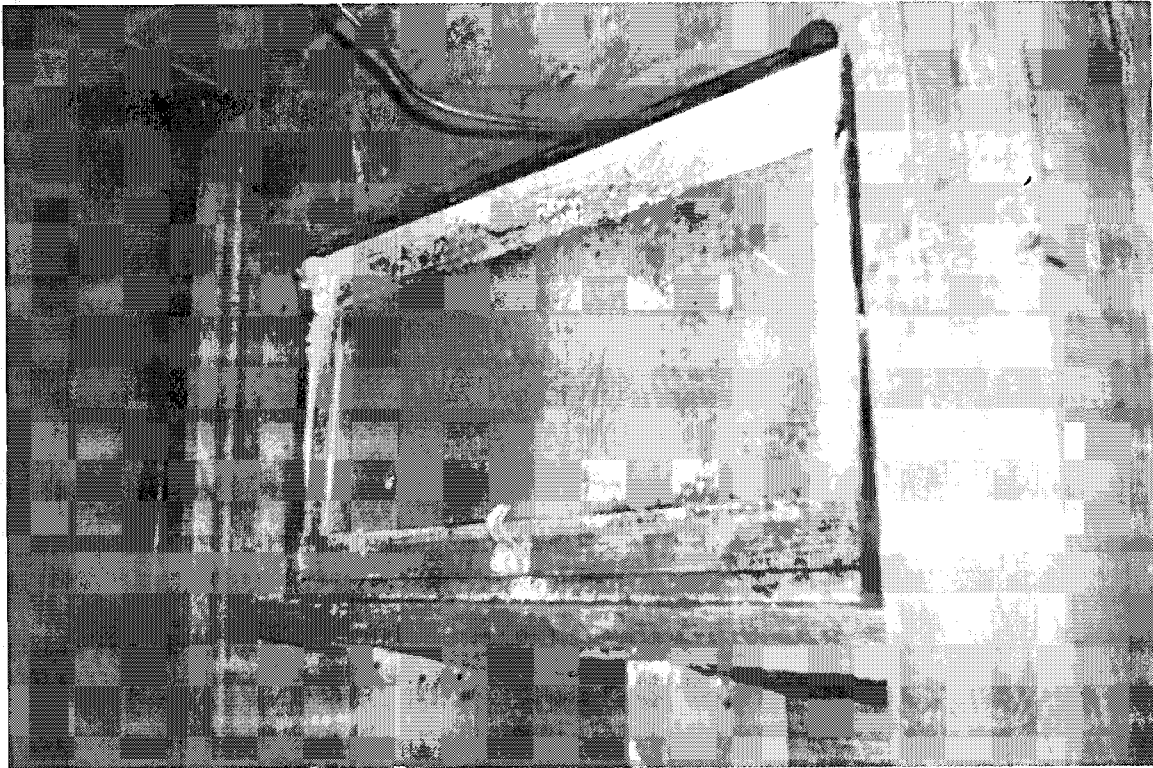
Figure 7:
House G-16, Basement Window Mold

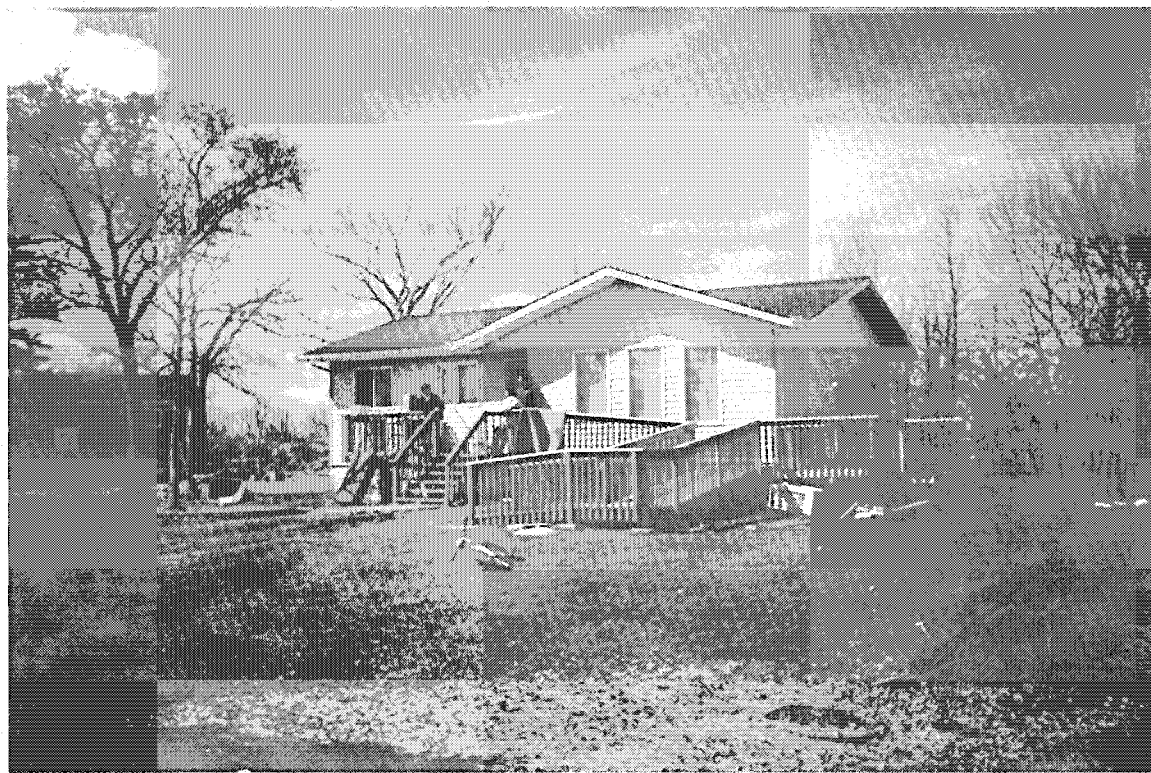
Figure 8:
House B-116, Front

- Basement subject to flooding, basement floor 1.5 m (5 feet) below grade
- Previous mold remediation

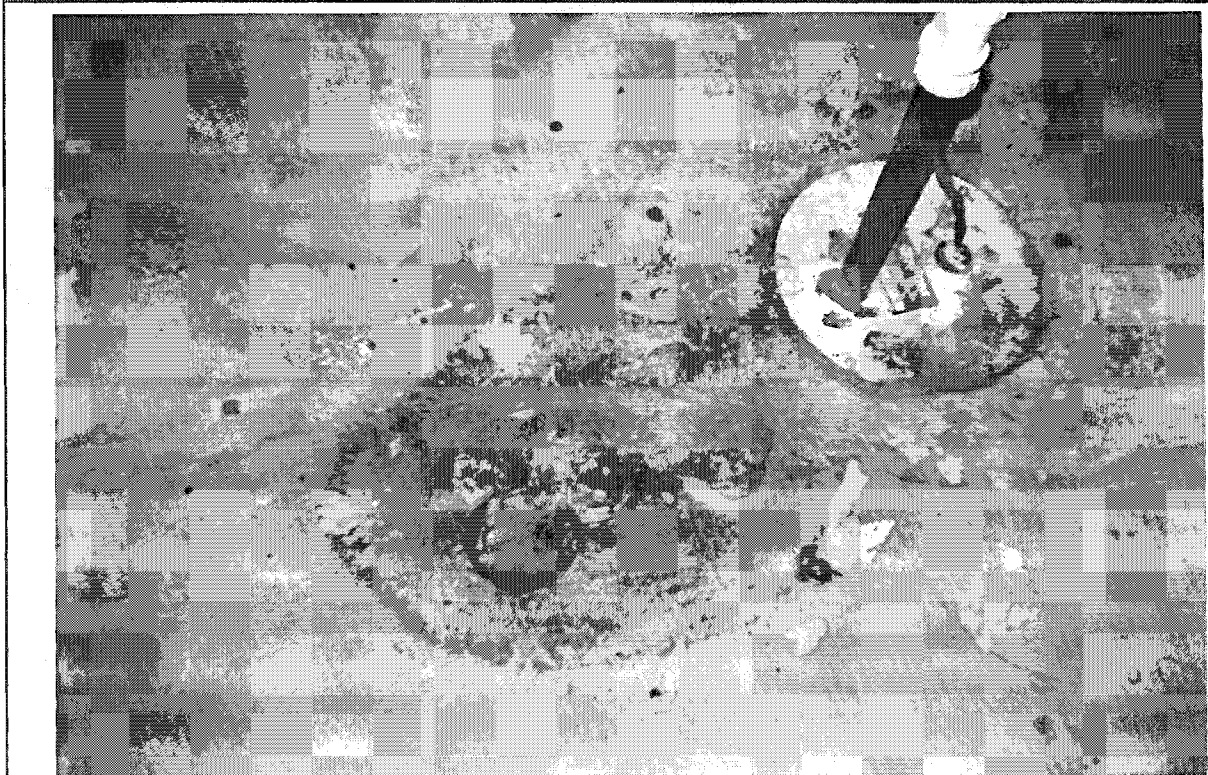
Concern about the presence of sewage, mold and the problem created by the high water table, is the perspective from which the following recommendations should be considered.

Figure 9:
House B-116, Basement Floor Drain

1. Evacuate. The presence of sewage in the floor drain is a serious sanitation issue. As well, there is continuing presence of an undefined amount of mold.

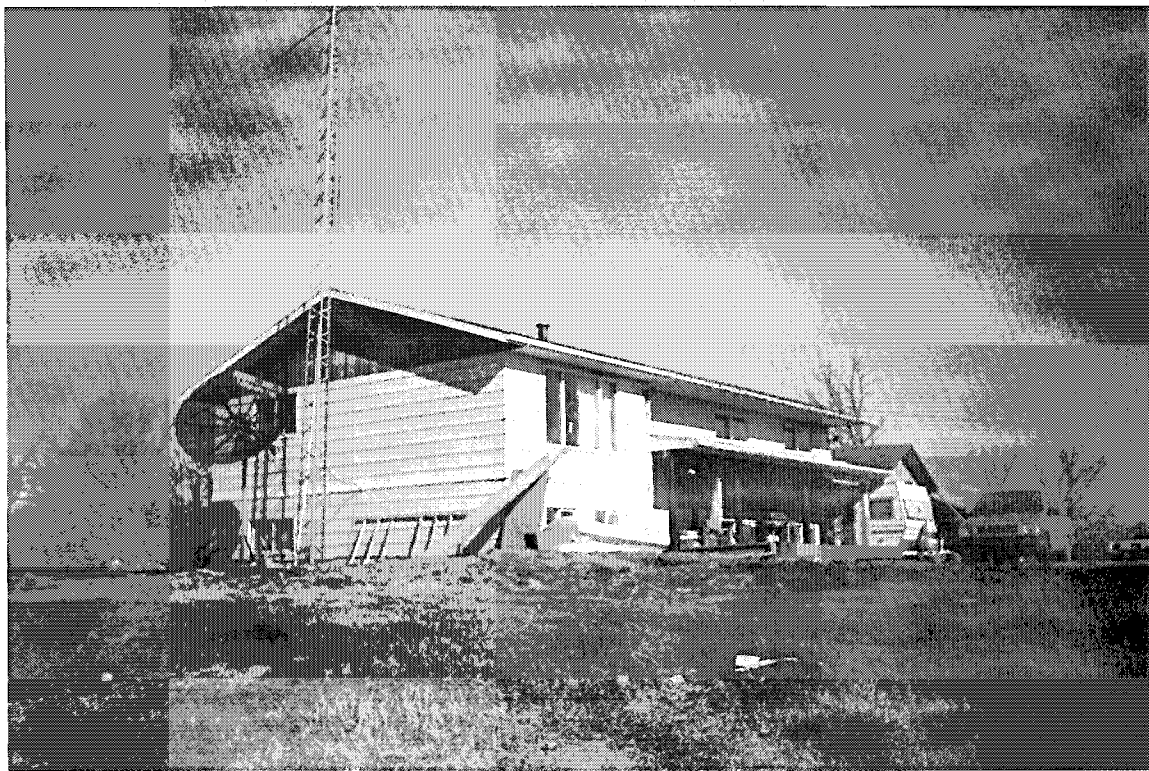
Figure 10:
House D-50, South-east

- Original *Stachybotrys chartarum* contamination due to roof leak
- Shallow foundation, basement floor less than 1m (3.3 feet) below grade
- Outside the dike, flooded April, 1997
- Identified as *Stachybotrys chartarum* contaminated again in December 1997
- Further remediation in winter/spring 1998

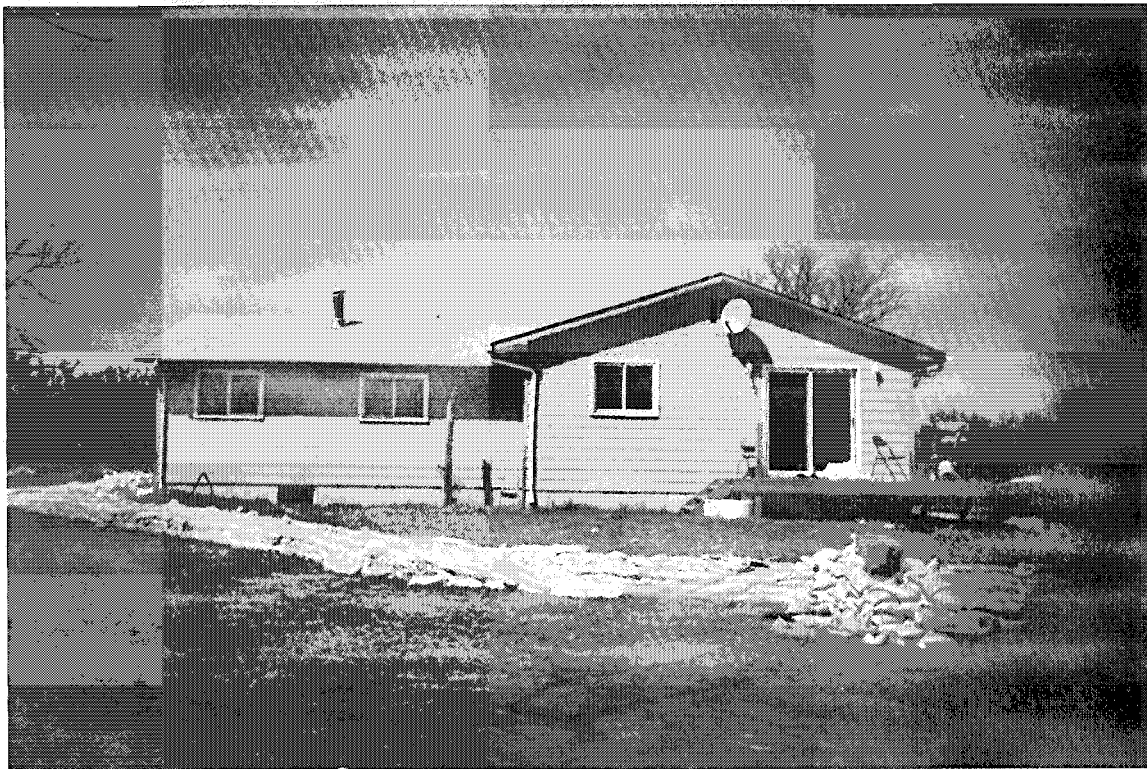
Figure 11:
House D-1, South

- Outside the dike, flooded to the underside of the floor joists, April, 1997
- Extensive renovations, summer, 1997
- Identified as contaminated with *Stachybotrys chartarum*, January, 1998
- Mold remediation February, 1998
