Performance Monitoring of a Brick Veneer/Steel Stud Wall System Phase 4 Results - Revision 1

**OTTAWA, ONTARIO
JANUARY 23, 1998
REVISED DECEMBER 2, 1999**

**SUBMITTED BY: KELLER ENGINEERING ASSOCIATES INC.
1390 PRINCE OF WALES DRIVE, SUITE 107
OTTAWA, ONTARIO
K2C 3N6**

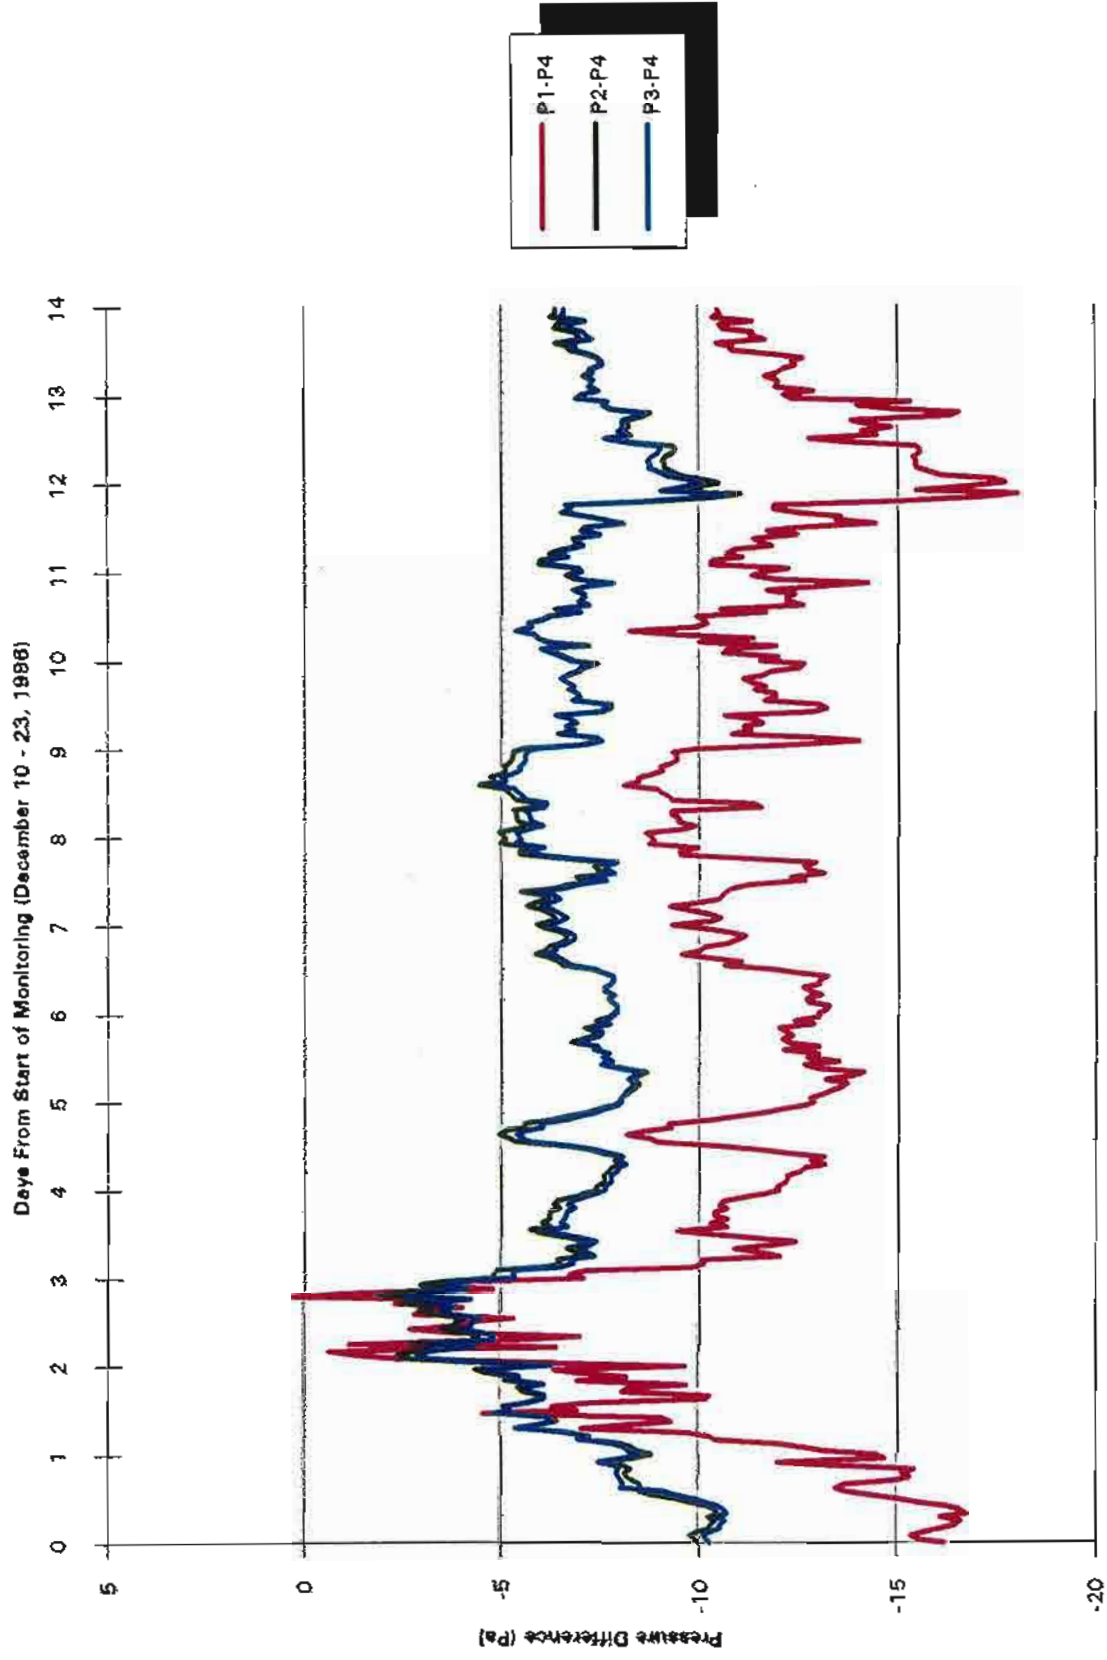
Fig. 9 Hourly Average Pressure Differences Across Test Wall

Sample hourly average and daily average pressure differences across the test wall are shown in Figs. 9 and 10. The pressure data for all time periods are similar as those found in Phases 2 and 3. The findings regarding air pressure are:

1. The air barrier is fairly effective, showing a significant air pressure difference P3-P4 (see Figs. 9 and 10).
2. Pressure equalization of the cavity is only partially effective, as evidenced by the fact that changes in wind pressure do cause a change in both P1-P4 and P2-P4, but the change is greater in P1-P4. Also, there is a significant change in pressure across the brick veneer, P1-P2, which is represented by the space between P1-P4 and P2-P4 (see Fig. 10).

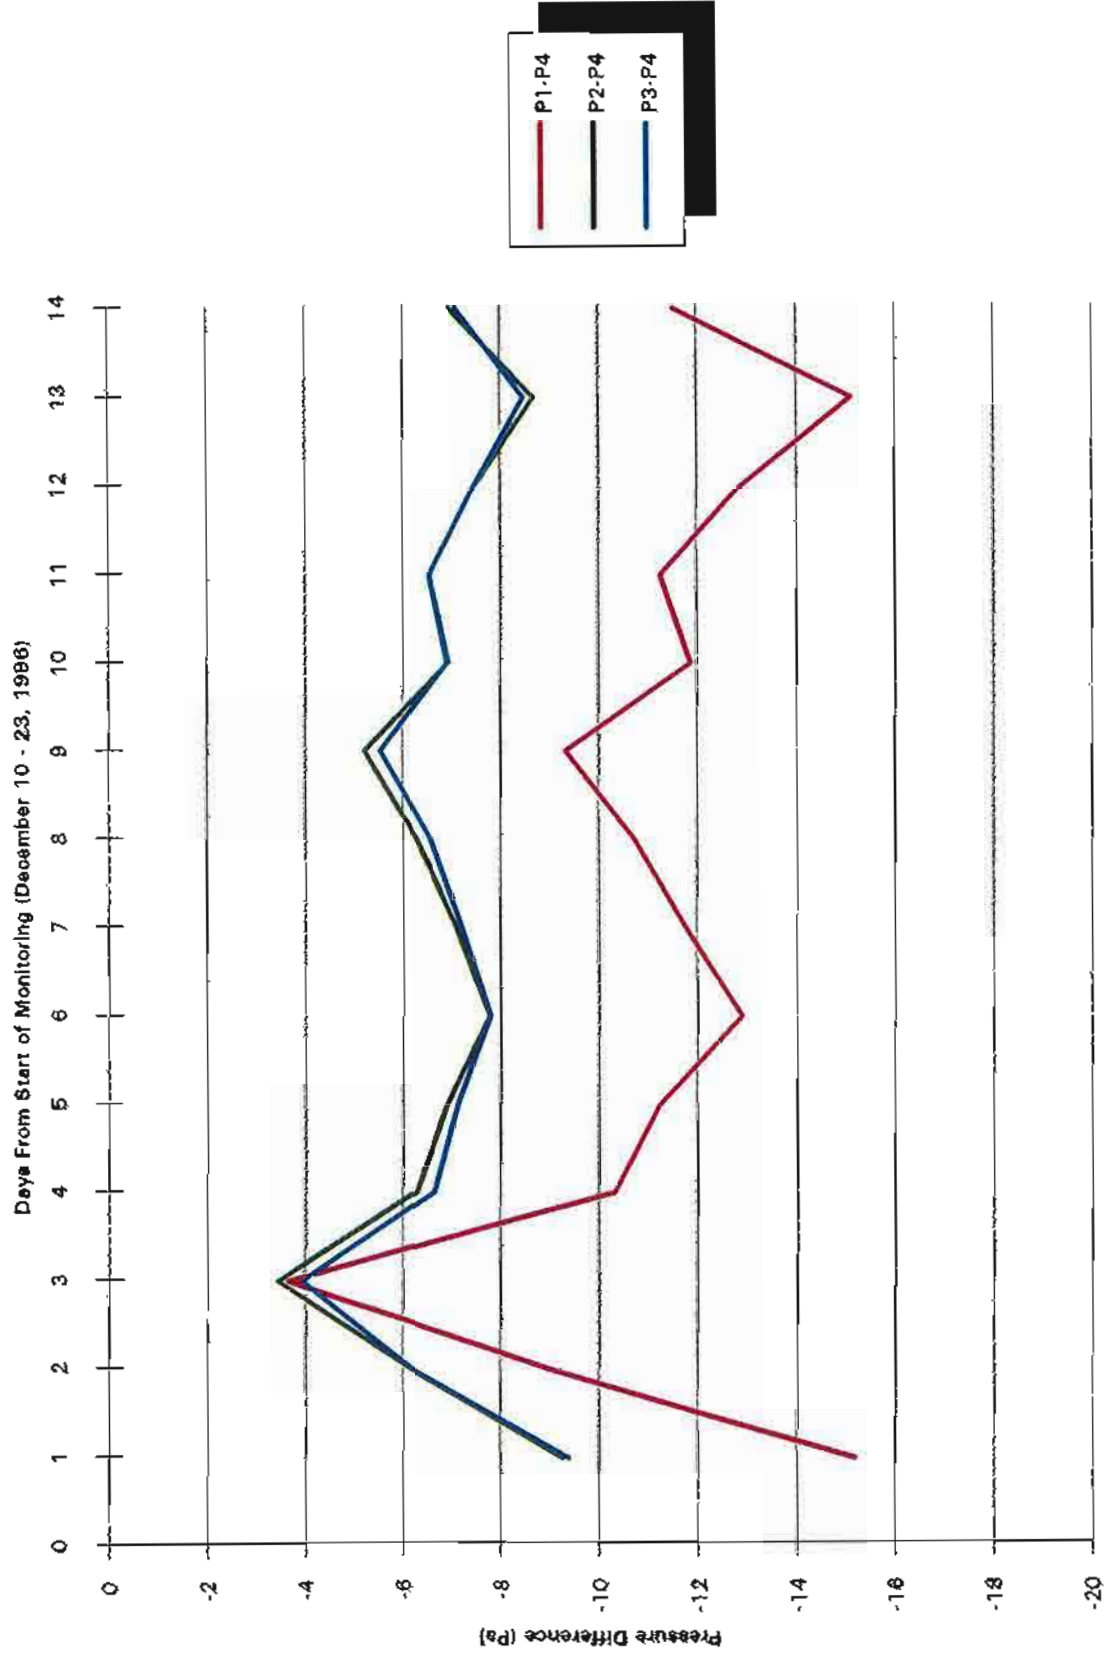
Fig. 10 Daily Average Pressure Differences Across Test Wall

4. The large P1-P2 also is an indication of air leakage through the backup wall, since air leakage partially releases pressure on the backup wall, causing the brick veneer to resist more pressure. However, P1-P2 alone does not prove that air leakage exists, but rather the reduced thermal performance of the wall under higher suction winds and the findings of previous inspection openings indicate that air leakage does exist.

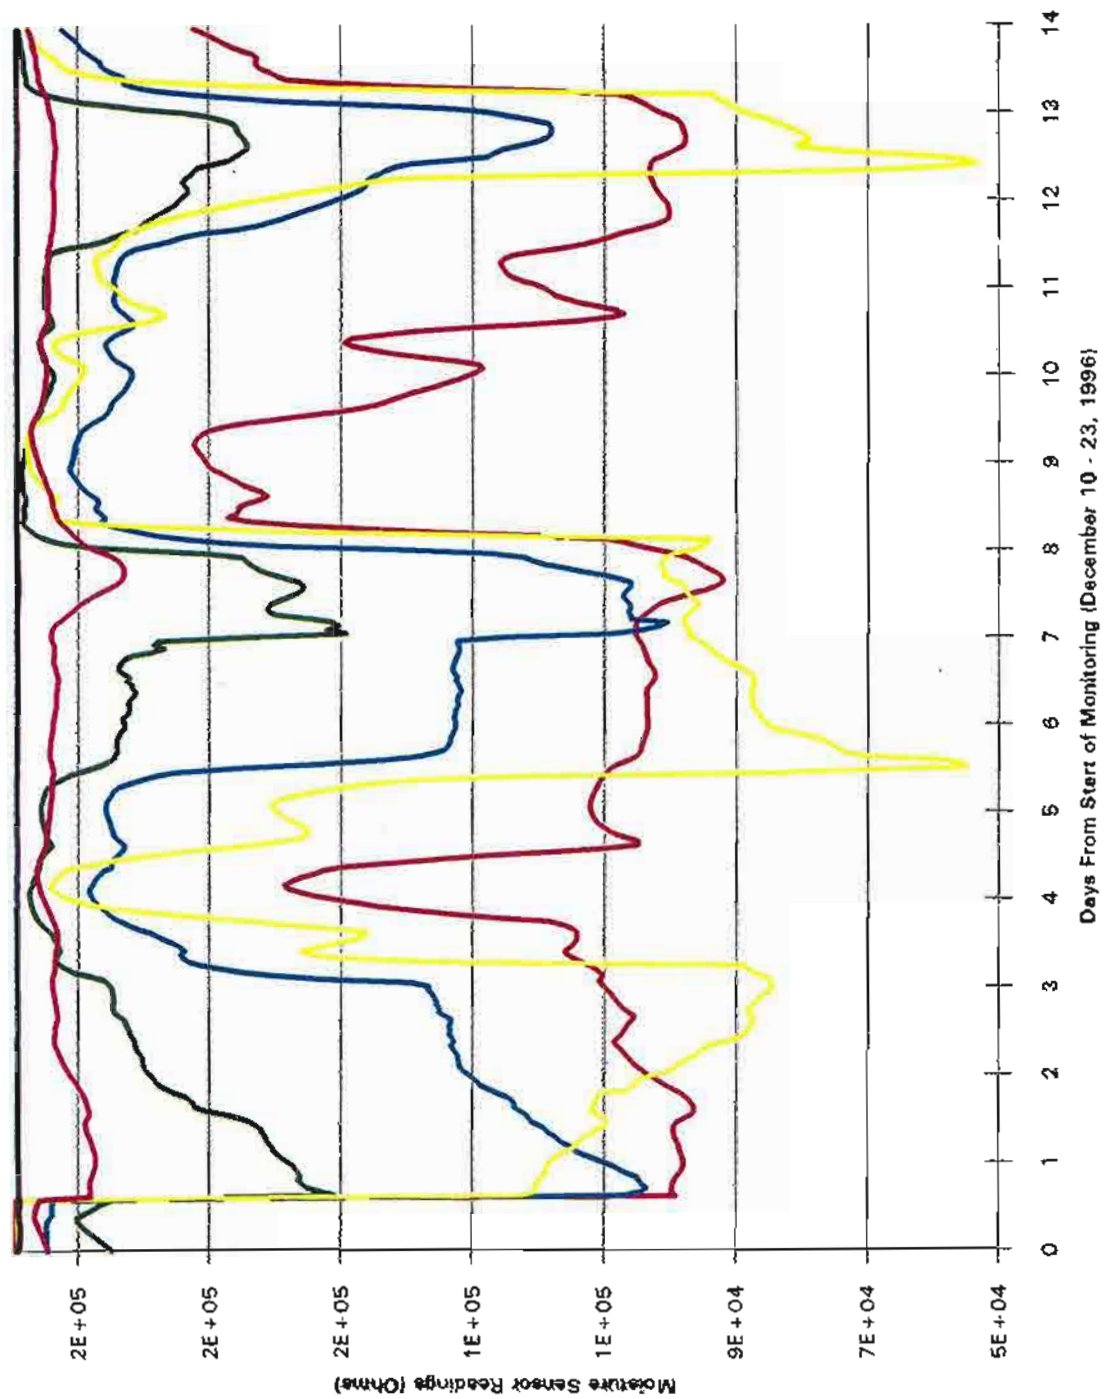
Fig. 11 Moisture Sensor Readings

Sample wetness of the brick surface at monitoring points M1, M2, M3, M4, M5 and M6 is shown in Fig. 11. Note that the electrical resistance moisture sensors in the test wall were not calibrated to determine the specific moisture content in the brick, rather, their readings indicate relative wetness. Higher resistance readings indicate drier conditions and, conversely, lower readings indicate wetter conditions. Note that freezing of water in the brick during cold weather will result in higher readings, giving a false indication of the brick being drier and, therefore, this point must be kept in mind when reviewing the graphs.

5. The interior of the brick veneer at the floor slab level (M2) is usually wet in the fall, winter and spring. The amount of wetness in the brick in this region during dry but cold weather indicates that condensation is a significant source of moisture.

7. The interior of the brick veneer at the roof level (M4) is usually wet to very wet during fall, winter and spring, but this area does dry out during summer weather. The extreme wetness of the brick veneer in this region during dry but cold weather indicates that condensation is the main source of moisture during cold weather. During precipitation occurrences, the sensor now becomes very wet, very quickly. This indicates that the new vent holes at the top of the wall allow more water to enter the cavity than was previously the case but drying speed is not improved.

8. The moisture sensor at the bottom of the cavity (M5) is mostly dry but wetted somewhat during precipitation, indicating that precipitation reaches the bottom of the cavity. However, since M5 is not significantly wetted, this indicates that most

9. The moisture sensor on the bottom track of the backup wall (M6) is dry almost all of the time. It is sometimes dampened slightly in cold weather. This dampness indicates that condensation within the backup wall sometimes affects this sensor. The fact that M6 normally remains dry, even during severe precipitation, indicates that the cavity functions properly in most instances.

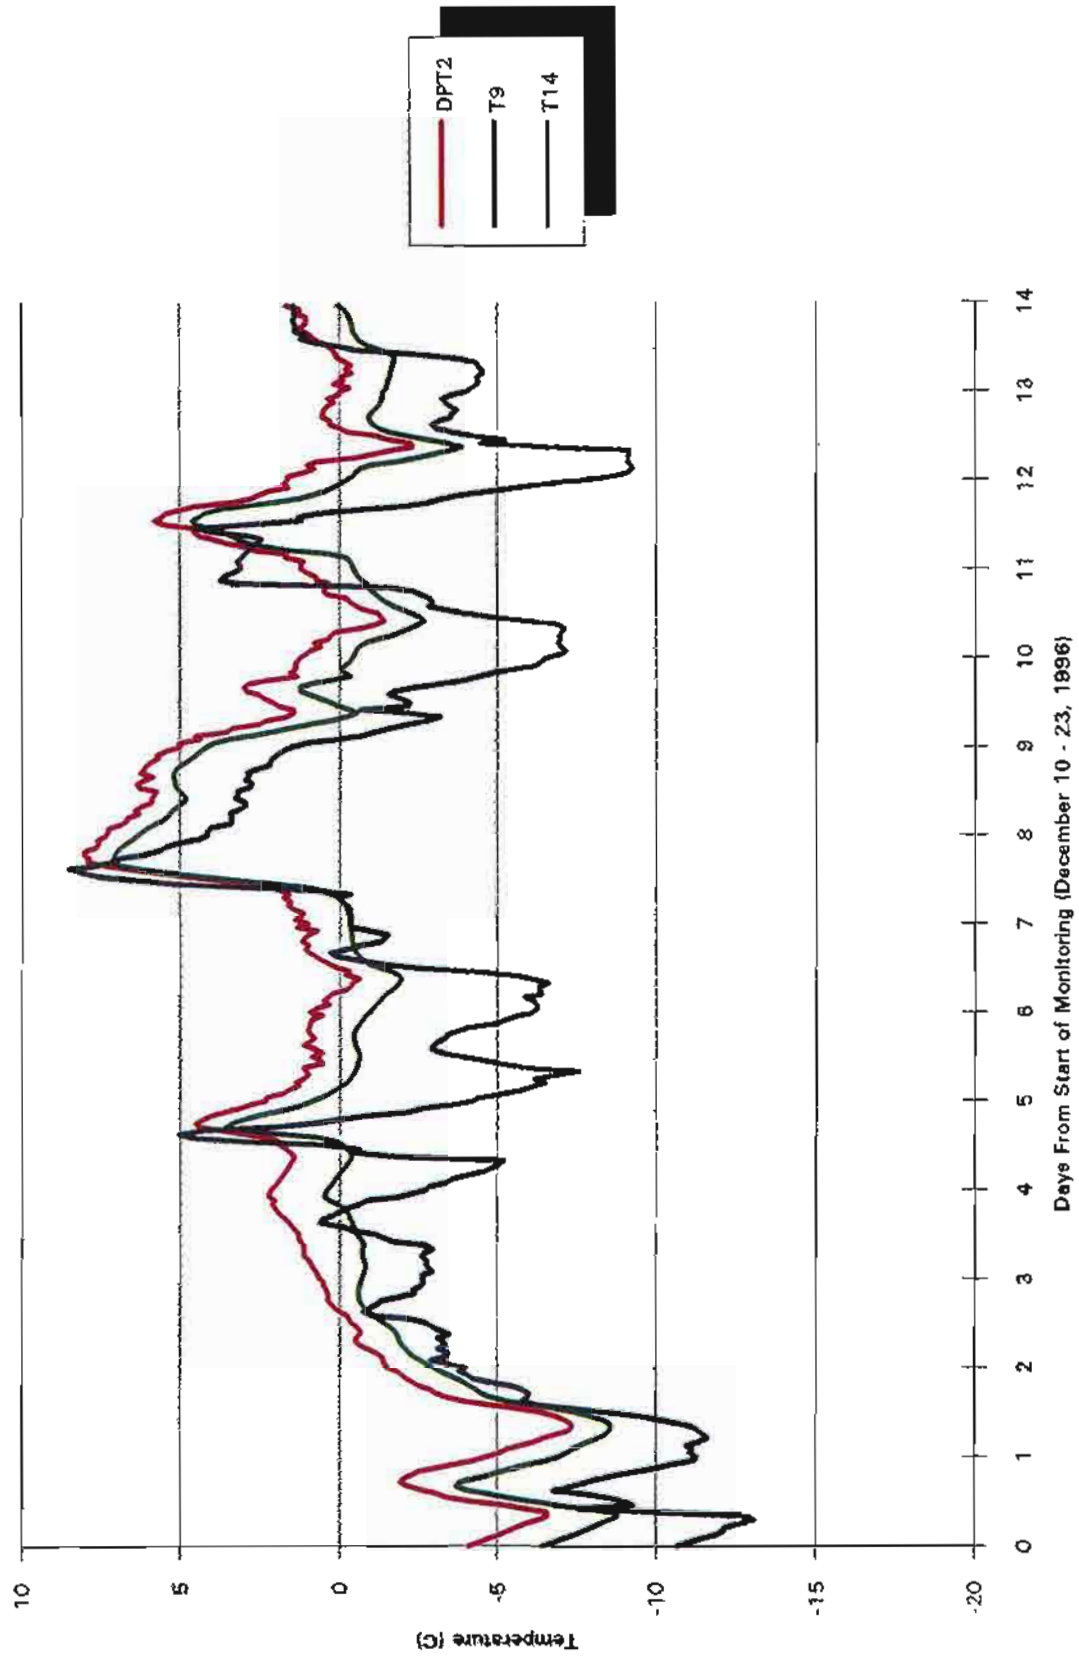
Fig. 12 Comparison of the Surface Temperature on the Interior Face of the Brick Veneer to the Dew Point Temperature of the Cavity Air

Reviewing all moisture related data, including plots such as those in Figs. 12 and 13, the findings are as follows:

12. Precipitation is the main cause of wetting of Sensors M1 to M5. During cold weather, condensation is the main source of moisture at M4 and it is a significant source at M2.

13. Except during the summer, water vapour levels within the cavity were very high in comparison to exterior conditions. The high water vapour content not only caused condensation to occur regularly, but drying of the back face of the brick veneer was hindered until late spring.

14. The primary source of moisture in the cavity air is the leakage of moist interior air into the cavity.
