Transport  
Canada

TP 185E  
Issue 4/2011

# AVIATION SAFETY LETTER

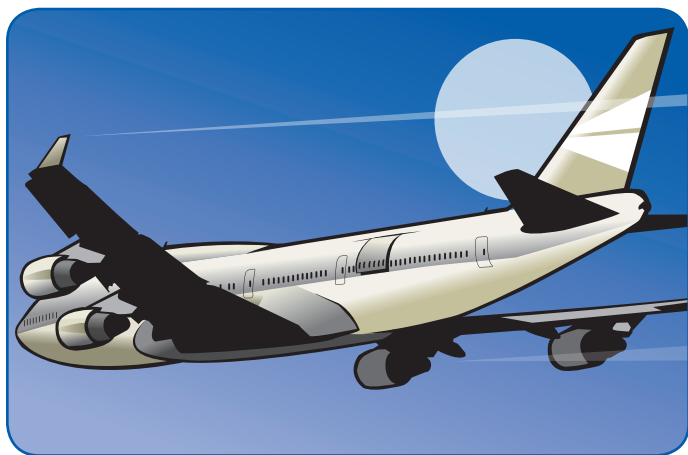
Subsequently, the door came open in flight and the flight crew had to make an emergency landing. The AMT, being a “company man” and trying to get the aircraft out on time, committed what is known as a situational violation. A situational violation occurs when an AMT, typically with good intentions, deviates from a procedure to get the job done.

*A door came open in flight as a result of a desire to get the aircraft out on time.*

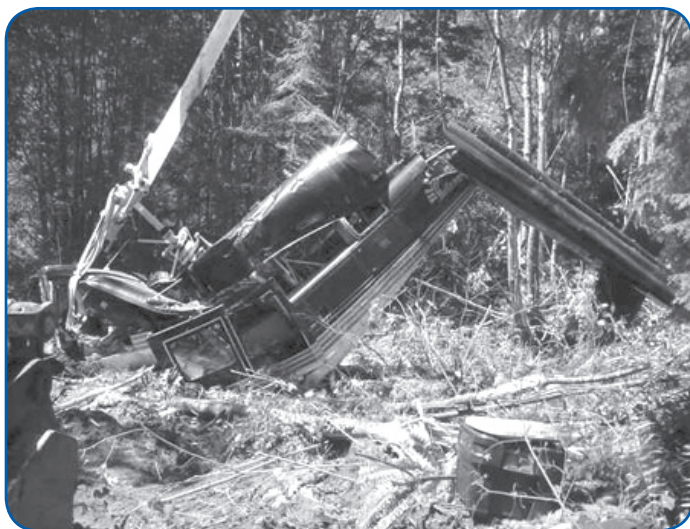
On July 2, 2007, a Bell 214B1 helicopter was carrying out heli-logging operations in Ramsay Arm, B.C. At about 08:00 PDT, the helicopter was in a 200-foot hover and starting to pick up the 11<sup>th</sup> load when the two pilots noted a loud growling sound from within the helicopter. Immediately, the flying pilot discontinued the lift and released the load from the longline hook. He then flew the helicopter back towards the nearby service area to have the noise investigated. About 20 sec later, just as the helicopter entered a high hover above the service landing site, the growling noise stopped, the low oil pressure warning lights for the two tail rotor gearboxes illuminated, and the helicopter rotated quickly to the right. The pilot was unable to stop the rotation using the tail rotor control pedals and the helicopter made two or three 360° turns to the right. The pilot rolled off the throttle on the collective stick and attempted to land in trees adjacent to the service area. The helicopter descended upright and struck several trees before landing hard on the uneven terrain. The flying pilot, seated in the left hand seat, was seriously injured and the co-pilot received minor injuries. The helicopter was substantially damaged during the landing and there was no fire. The emergency locator transmitter activated at impact and survived the crash.

*Bell 214B1 wreckage*

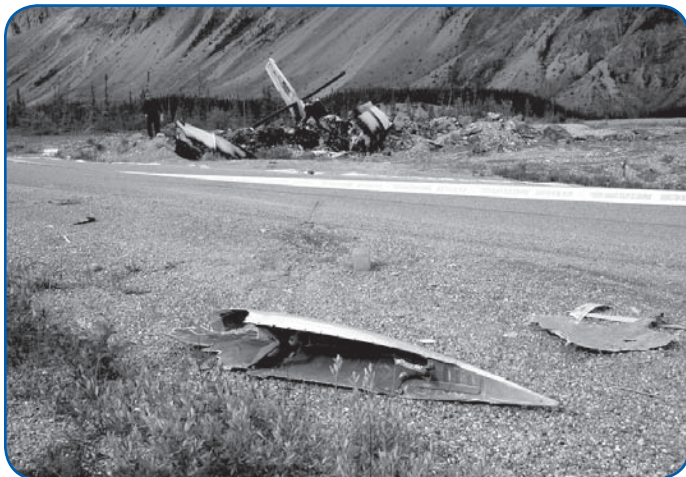
On July 8, 2007, at approximately 12:35 PDT, a de Havilland DHC-6-100 Twin Otter was taking off from a gravel airstrip near the Northern Rockies Lodge at Muncho Lake on a visual flight rules flight to Prince George, B.C. After becoming airborne, the aircraft entered a right turn and the right outboard flap hanger contacted the Alaska Highway. The aircraft subsequently struck a telephone pole and a telephone cable, impacted the edge of the highway a second time, and crashed onto a rocky embankment adjacent to a dry creek channel. The aircraft came to rest upright approximately 600 ft from the departure end of the airstrip. An intense post-impact fire ensued and the aircraft was destroyed. One passenger suffered fatal burn injuries, one pilot was seriously burned, the other pilot sustained serious impact injuries, and the other two passengers received minor injuries.

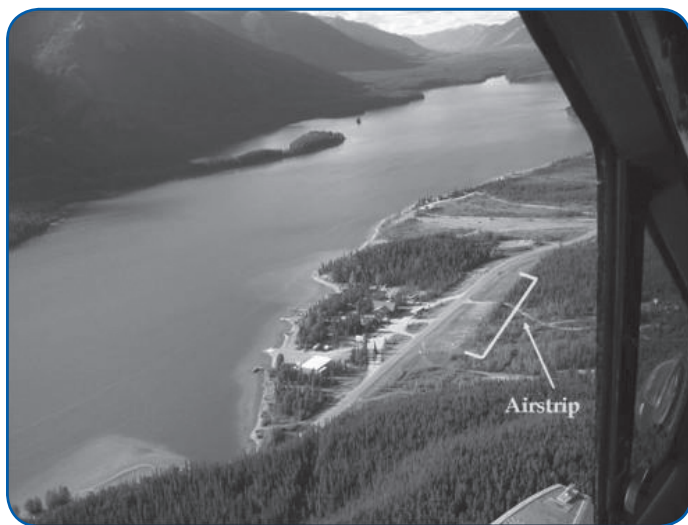
Despite regular use of the lodge airstrip and recognition by the owner that take-off weights were a critical consideration in these operations, there was no standard operating procedure (SOP) for Twin Otter short-field operations. An applicable SOP would have formalized and set the non-MPS limits for short field operations, thereby reducing the risk associated with lodge airstrip operations.

*Lodge airstrip in direction of takeoff*

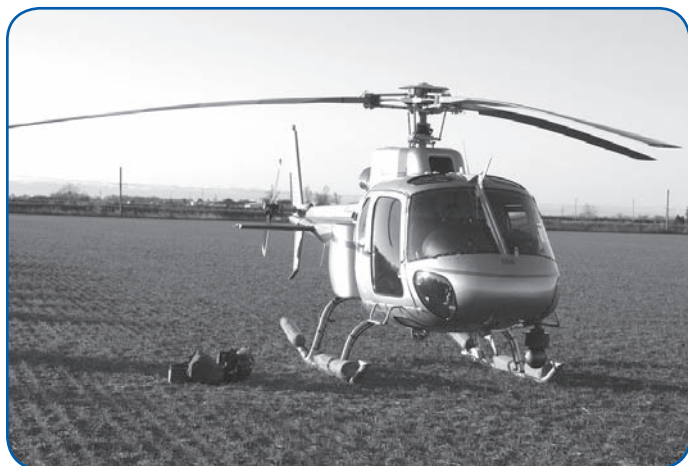
Turbomeca Arriel 2B) had failed and the pilot commenced an autorotation landing into a farm field. During the descent, the pilot transmitted a mayday call and activated the emergency locator transmitter. The helicopter landed without further incident. There were no injuries and the helicopter was not damaged. The pilot completed the shutdown checklist and switched off the battery.

*AS 350 sitting in the field after the successful autorotation with no damage at all. Great job by the pilot!*

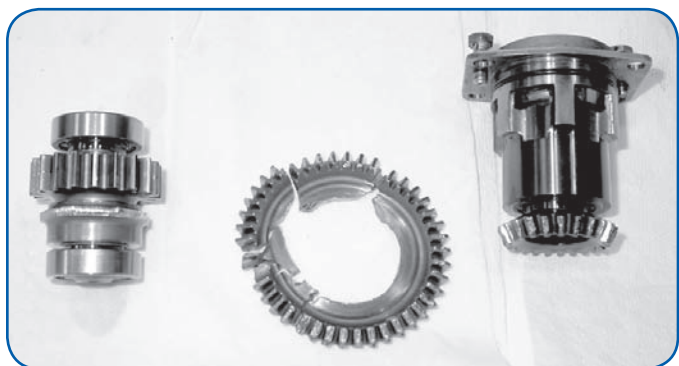
An examination of the engine determined that the 41-tooth bevel gear (part number 0292127330) had fractured due to high-cycle fatigue cracking. The gear was installed during engine manufacture and had accumulated a total of 1 644 hr since new. Metallurgical examination (TSB Laboratory report LP 005/2008) of the bevel gear revealed numerous fatigue cracks radiating from the roots of many of the gear teeth. Circumferential fatigue cracks were also observed in the rim of the gear. There were no relevant manufacturing flaws found in the gear that could contribute to the failure.

*Fractured 41-tooth bevel gear shown with other parts from the accessory gearbox*

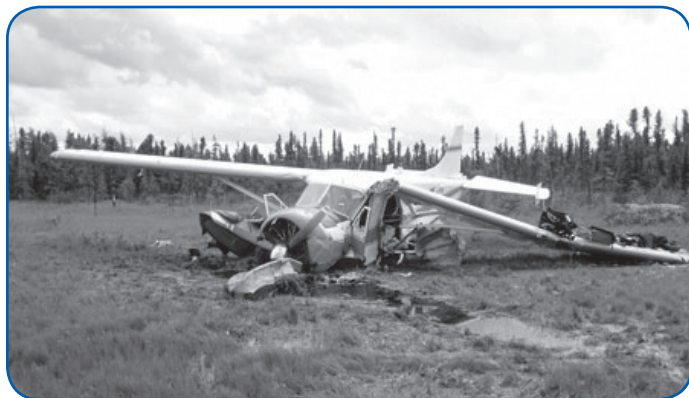
crashed in a bog. The pilot and four of the occupants were seriously injured; two occupants received minor injuries. The aircraft was substantially damaged, but there was no post-impact fire. The impact forces activated the onboard emergency locator transmitter.

*The damaged aircraft after the accident*

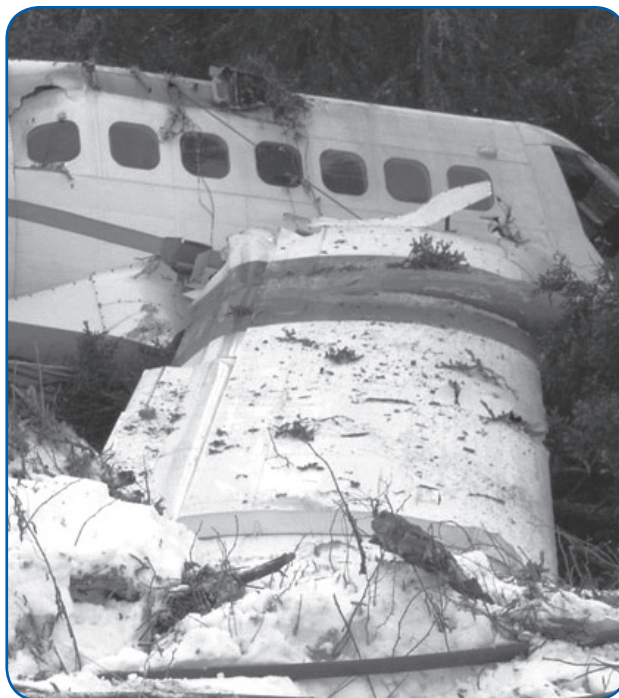
On February 4, 2009, a ski-equipped de Havilland DHC-6 Series 100 was taking off from a ski strip east of and parallel to Runway 36 at La Ronge, Sask. After the nose ski cleared the snow, the left wing rose and the aircraft veered to the right and the captain, who was the pilot flying, continued the takeoff. However, the right ski was still in contact with the snow. The aircraft became airborne briefly as it cleared a deep gully to the right of the runway. The aircraft remained in a steep right bank and the right wing contacted the snow-covered ground. The aircraft flew through a chain link fence and, at approximately 09:15 CST, crashed into trees surrounding the airport. The five passengers and two crew members evacuated the aircraft with minor injuries. There was a small fire near the right engine exhaust that was immediately extinguished by the crew.

1. Contamination on the wings of the aircraft was not fully removed before takeoff. It is likely that asymmetric contamination of the wings created a lift differential and a loss of lateral control.
2. Although the operator was not authorized for short takeoff and landing (STOL) takeoff on this aircraft, the crew conducted a STOL takeoff, which reduced the aircraft's safety margin relative to its stalling speed and minimum control speed.
3. As a result of the loss of lateral control, the slow STOL take-off speed, and the manipulation of the flaps, the aircraft did not remain airborne and veered right, colliding with obstacles beside the ski strip.
