Transport
Canada

Feedback

Canadian Aviation Service Difficulty Reports

TP 6980E
(9/2011)

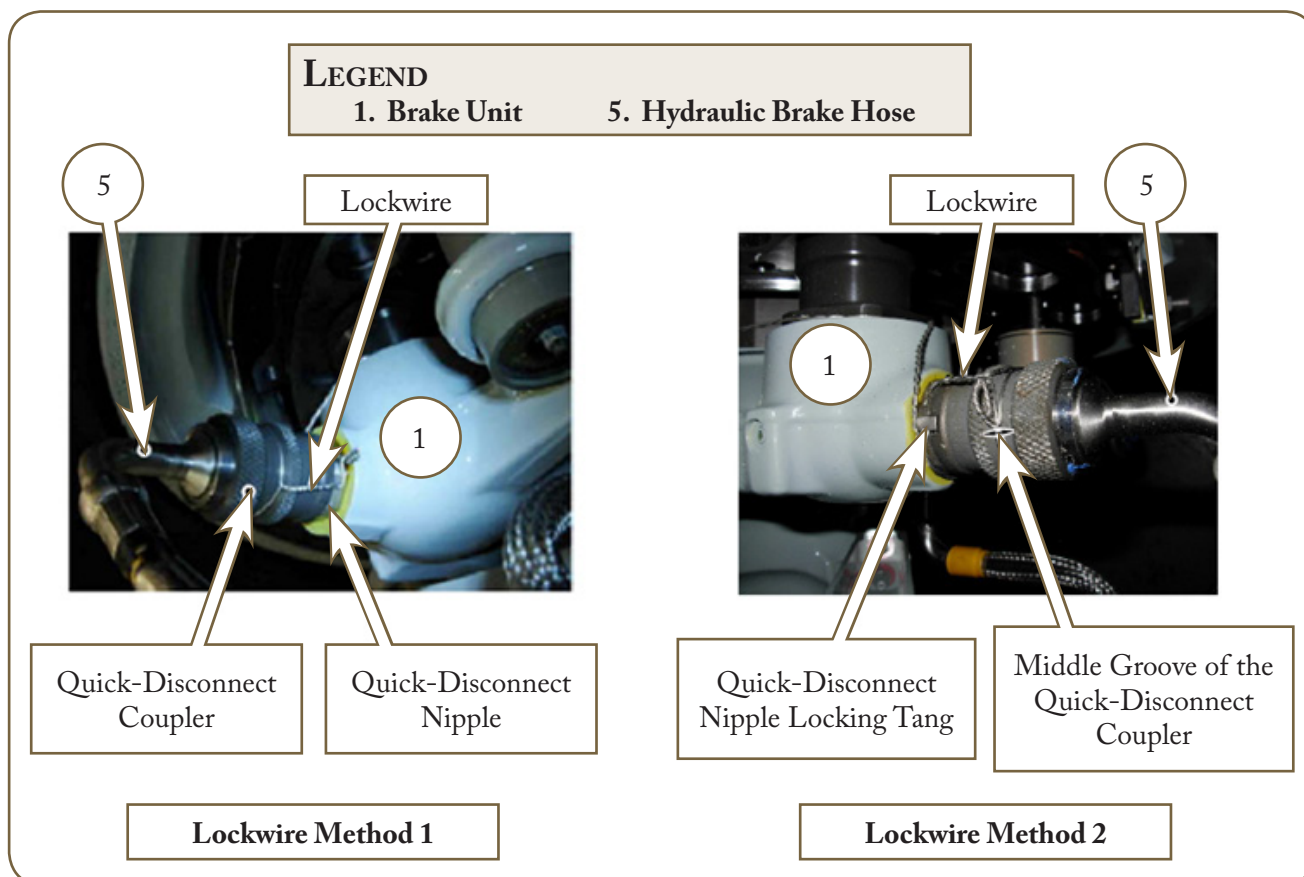
- 3 cases of brake quick disconnect (QD) fittings found loose which caused a landing with a locked / dragging brake. The loose QD allowed hydraulic pressure to be trapped within the brake causing it to remain locked on landing.
- 1 case where 2 QD fittings were found loose, causing the landing with no braking ability on the same gear.
- 3 potential cases where the QD fittings were found disconnected on the production line.

- Cleaning of the brakes could have lead to inadvertent disengagement of the QD locking tang subsequently leading to QD backing off (getting loose).
- QD was not connected properly (locking tang not engaged) after a brake carrier change.

In all cases, the inadvertent disengagement of QD's was considered to be due to human error.

When compared to the CRJ200/700 design, the CRJ705/900/1000 design is more susceptible to an incorrect installation through the inadvertent disengagement of the locking tangs. *(continued on next page...)*

The following Bombardier Aircraft Maintenance Manual (AMM) Temporary Revisions (TR) were released May 2011 which have introduced instructions to utilize 2 methods of lock wire on the brake QD for the CRJ705/900/1000. The addition of the lock wire is to prevent the inadvertent unlocking of the QD.

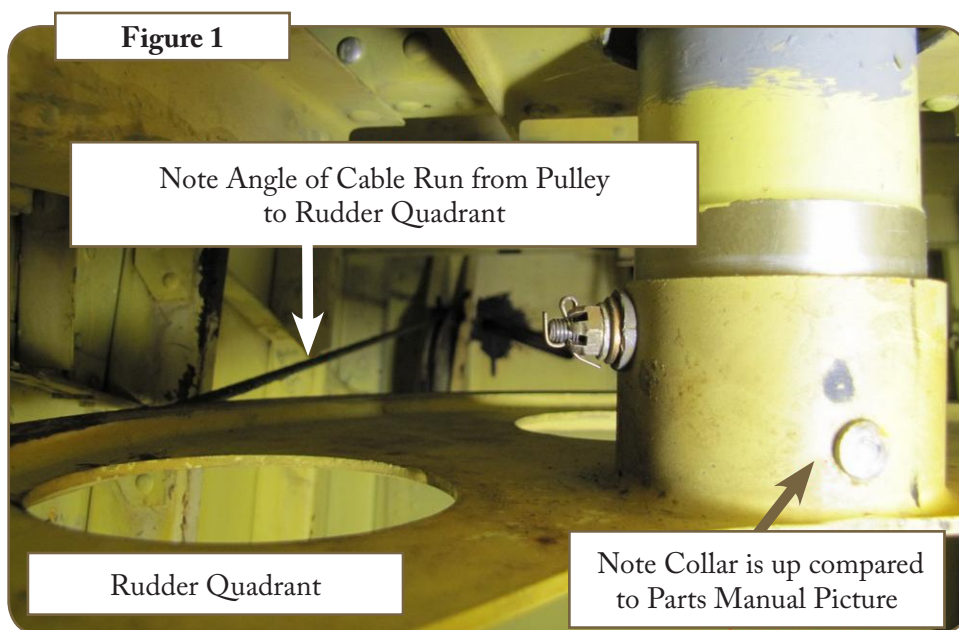
During a scheduled "B" check, maintenance discovered that the rudder quadrant located in the rear fuselage area was installed in an inverted or upside down position on its adjoining torque-tube tower-shaft. The aircraft maintenance engineer (AME) noticed that the flight control cables were not in line with the quadrant assembly as seen in figure 1.

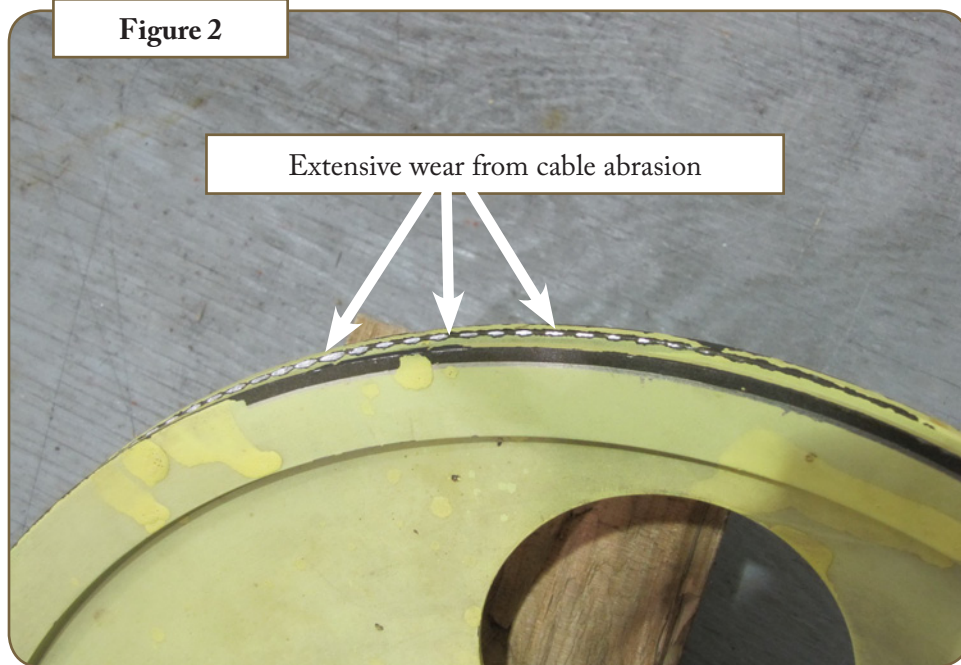
Figure 2

Through the extended operation of the improperly installed rear rudder quadrant, abnormal abrasion and wear of the cable guides occurred as seen in figure 2.

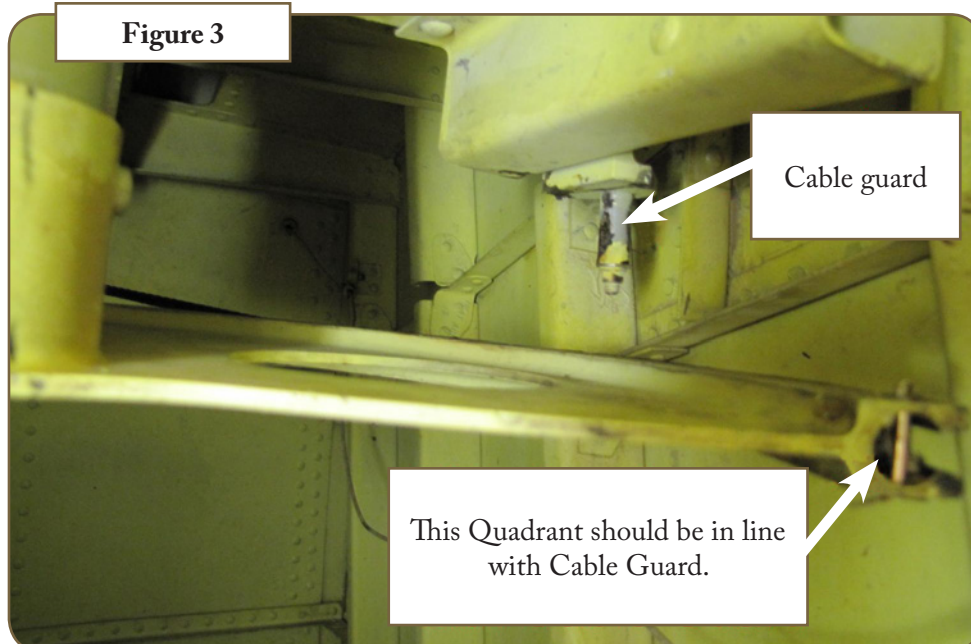
Figure 3

Also noted and seen in figure 3 was the quadrants misalignment of approximately 6.3 cm (2.5 in) away from the cable guard.

In this condition, the chances of the rudder cable in leaving or "jumping" out of its quadrant cable guides were significantly increased which would have lead to a complete operational loss of the rudder.

The required inspection item or "RII" of the system, be that a flight control as with this case or an engine control or propeller rigging must be inspected by a person other than the one who performed the work in compliance with CAR 571.10 Maintenance Release. ✖

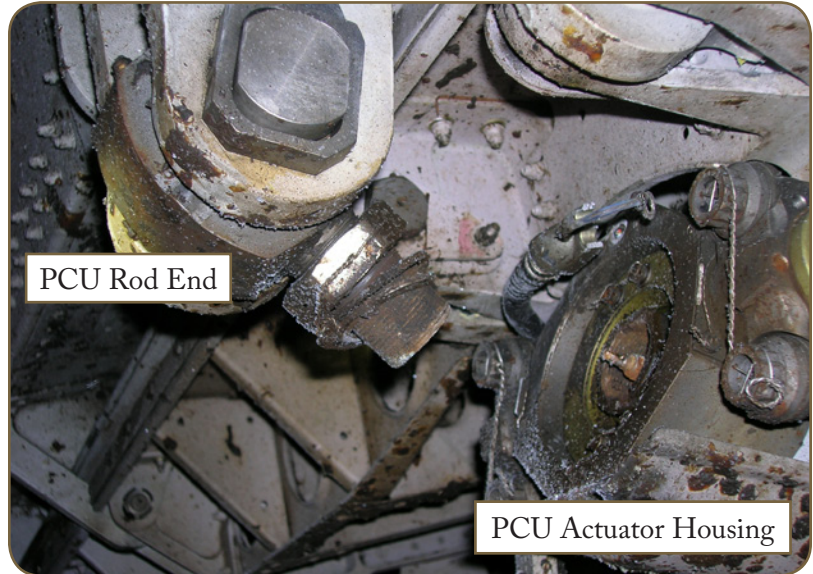
Flight Spoiler PCU Rod End Failure

During flight, a R/H spoiler panel began to float freely where maintenance discovered the #2 R/H Spoiler Actuator threaded rod end assembly had failed and separated from its adjoining PCU housing.

The flight spoiler PCU actuator was replaced, MEL removed and the aeroplane was made serviceable.

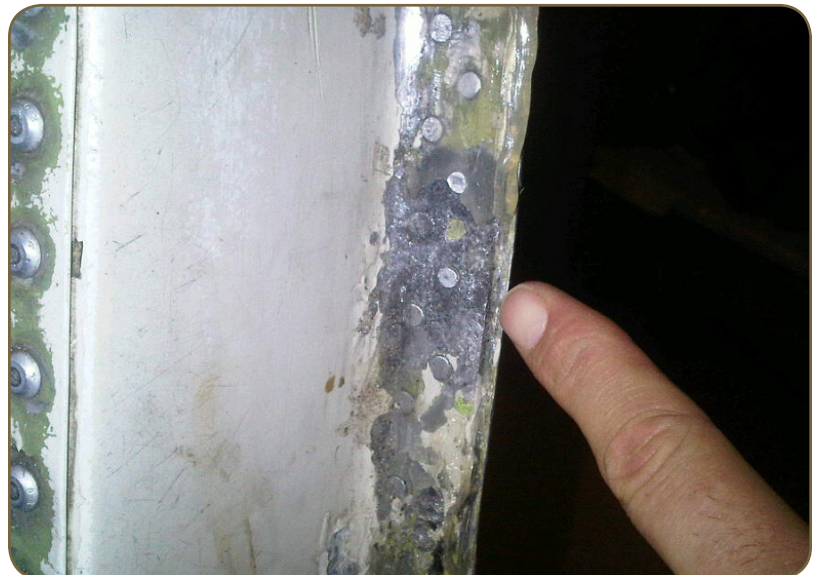
Passenger Door Seat Retainer Corrosion

The aeroplane passenger door seal had a small tear in it causing a pressurization leak. Upon maintenance inspection when the door seal was removed, corrosion was noted.

A further inspection found extensive corrosion through the skin with a width of 2.5 cm (1 in) by 1.27 cm (1/2 in) on the top of the door seal retainer under the seal.

A repair was carried out, the corrosion removed and the aircraft was made serviceable.

Transport Canada Civil Aviation (TCCA) would like to advise all owners and operators of this aeroplane model to be aware of this possible corrosion and BAEs corrective action to address this issue. ✖

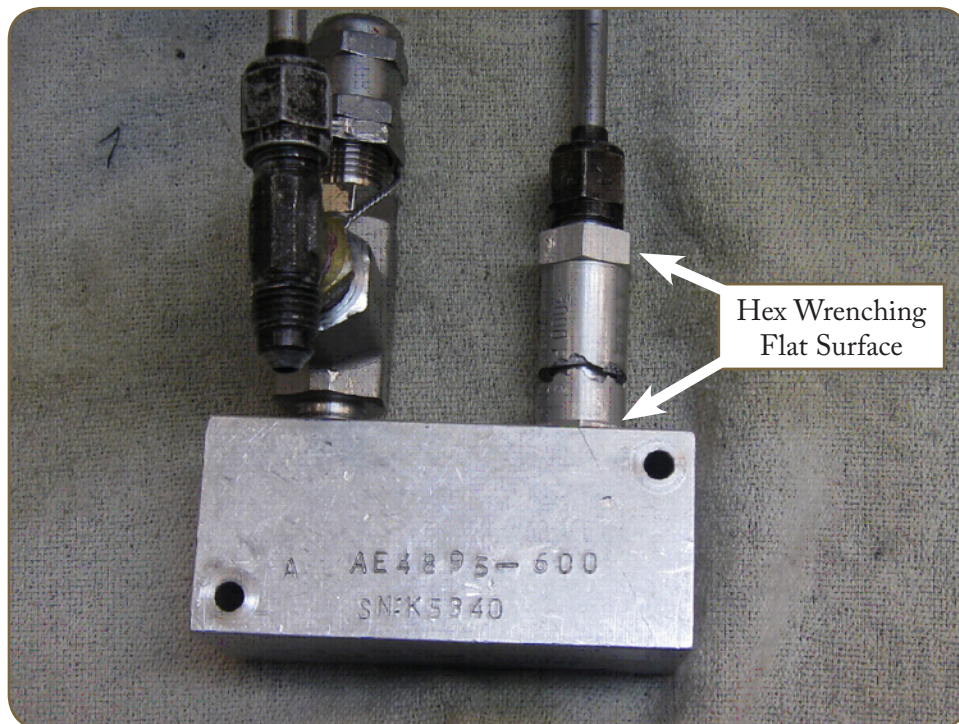
Cargo Door Hydraulic Leak

A hydraulic fluid leak was identified when closing the main cargo door. Maintenance investigation identified hydraulic fluid leaking from the cargo door manifold assembly at the check-valve body due to a circumferential and through crack.

It is suspected that the hydraulic line was torque during installation without the use and support of the check-valves Hex wrenching surface, stressing its cylindrical body and causing its failure.

The manifold assembly was replaced, a leak and function check carried out and the aircraft was made serviceable.

Transport Canada Civil Aviation (TCCA) would like to advise all maintainers the importance in understanding these design features and maintenance practices for the correct installation of hydraulic components. ✖

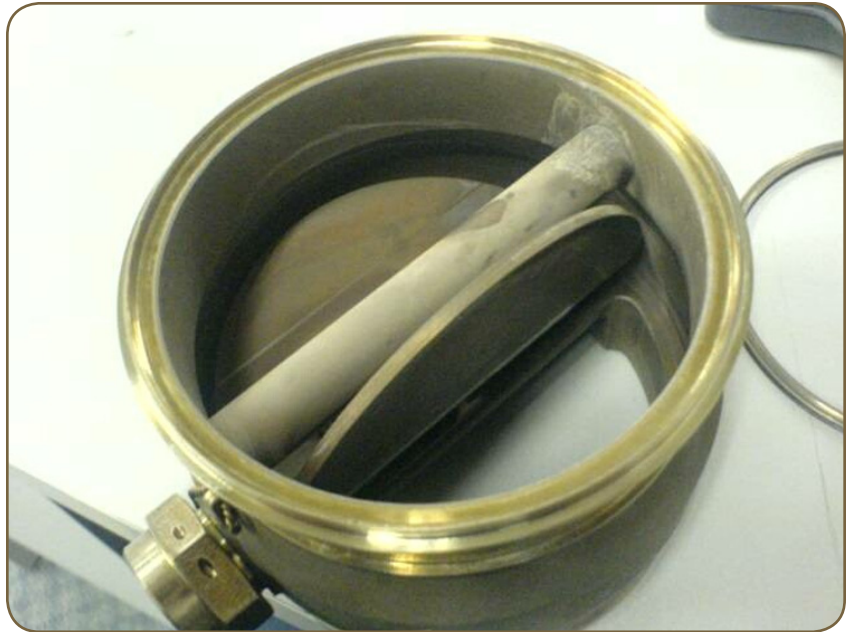
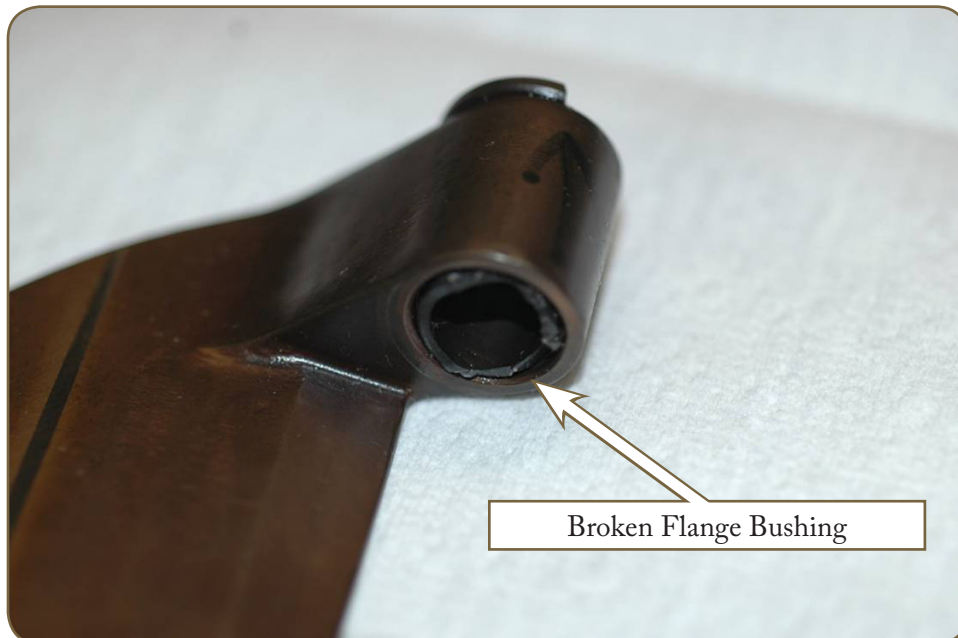
CFM56-7B Engine Check Valve Failure

During descent with the auto-throttle (a/t) engaged, the flight crew encountered a left engine surge and intermittent stalls. The crew disengaged the a/t and using manual throttle inputs, were able to sufficiently control the engines tendency to surge.

Maintenance personnel accomplished FIM 71-05 task 805 and subsequently found the 5th stage compressor check valve stuck open. The valve was replaced as the corrective action and the aeroplane was returned to service.

It is important for maintenance personnel to recognize the characteristics of a failed engine compressor check valve to prevent further engine surging. ✖

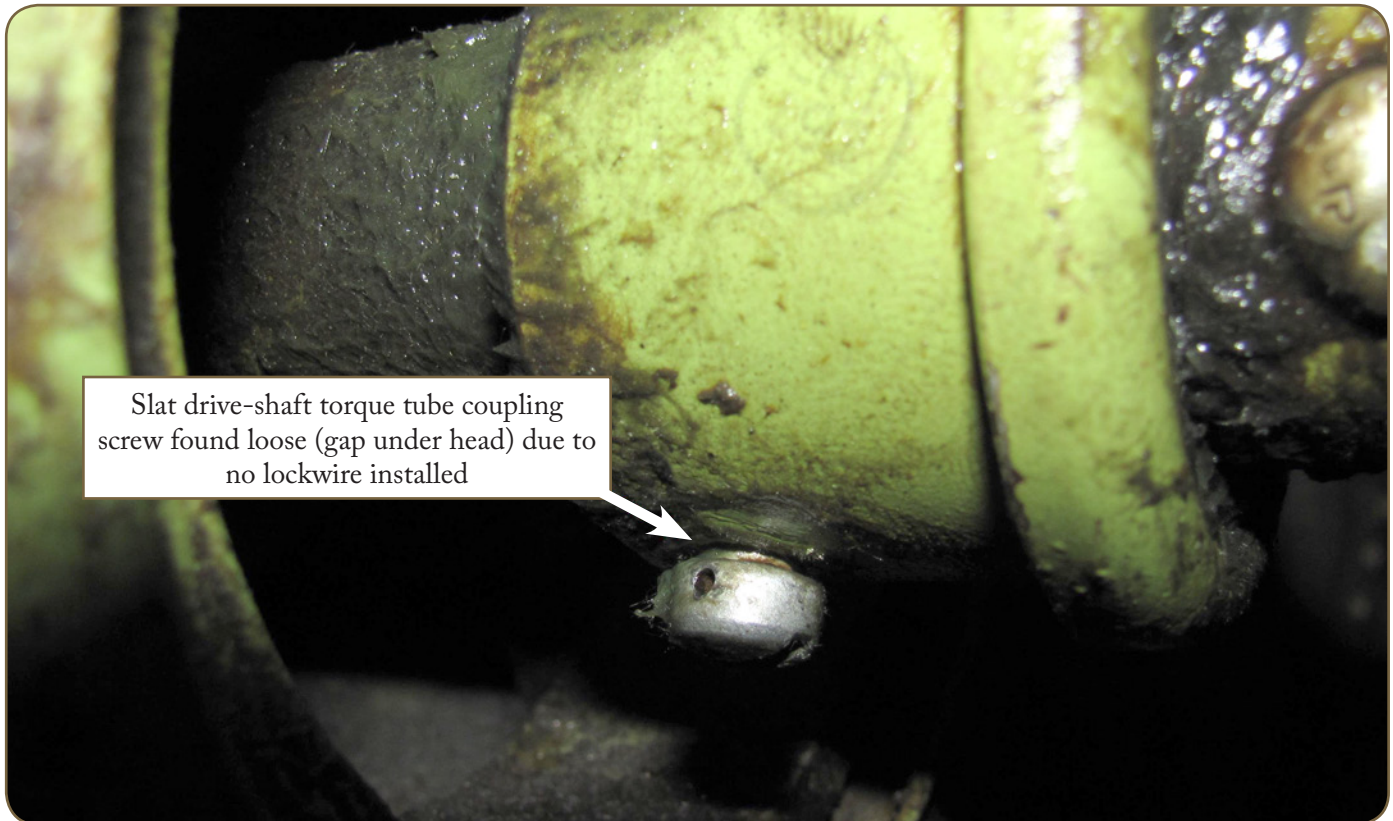
Slat Drive Shaft Loose Screws

While removing the right engine pylon during a scheduled event, maintenance found a left-hand wing leading edge flap drive shaft coupling sleeve, at wing station 468, with loose attaching screws due to missing lockwire.

All aeroplane attaching hardware incorporate a form of lock or safety to ensure that the applied torque is kept through the life of the fasteners installation.

Lockwire is one of several methods used to perform this important and essential function. ✖

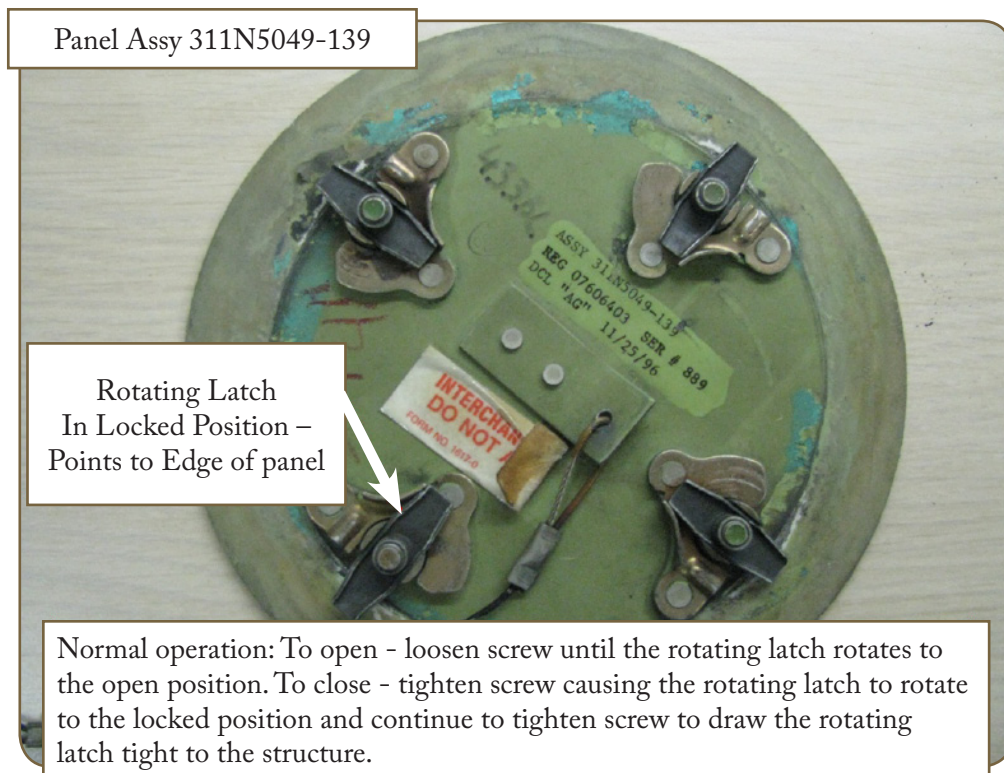
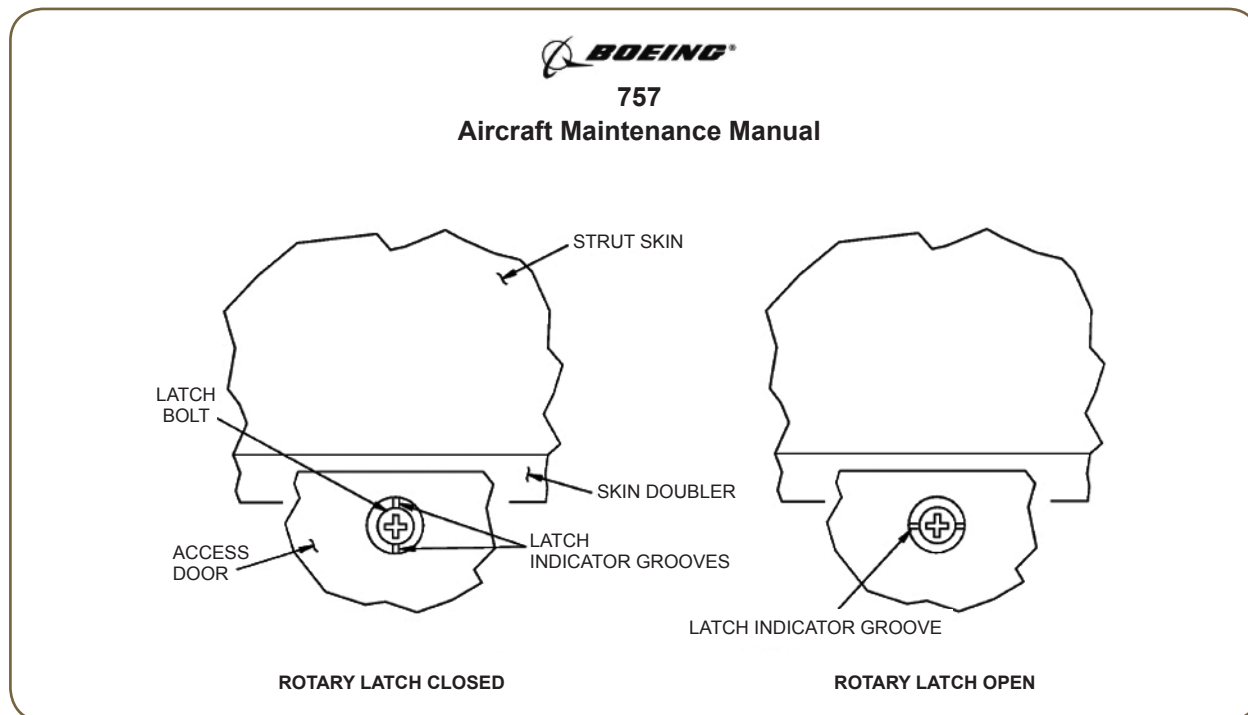
Pylon Panel Missing

On arrival after a flight, it was noticed that inspection panel 443BR on the outboard side of the right engine pylon was missing. Panel part number (P/N) 311n5049-139, IPC 54-53-01-05, item 175. The panel was replaced and the aeroplane was made serviceable.

The results defined the root cause of the events as being induced through the improper installation of the panel.

Boeing AMM 54-53-01 defines the correct panel "latch indicator groove" alignment as seen below for a "closed/locked" and "open/unlocked" position.

Also included is a picture of the backside of the panel as seen in the "closed/locked" position. Note that the "groove indicator" marks are a direct indication of the rotating latch position which retains the panel to the pylon structure. ✖

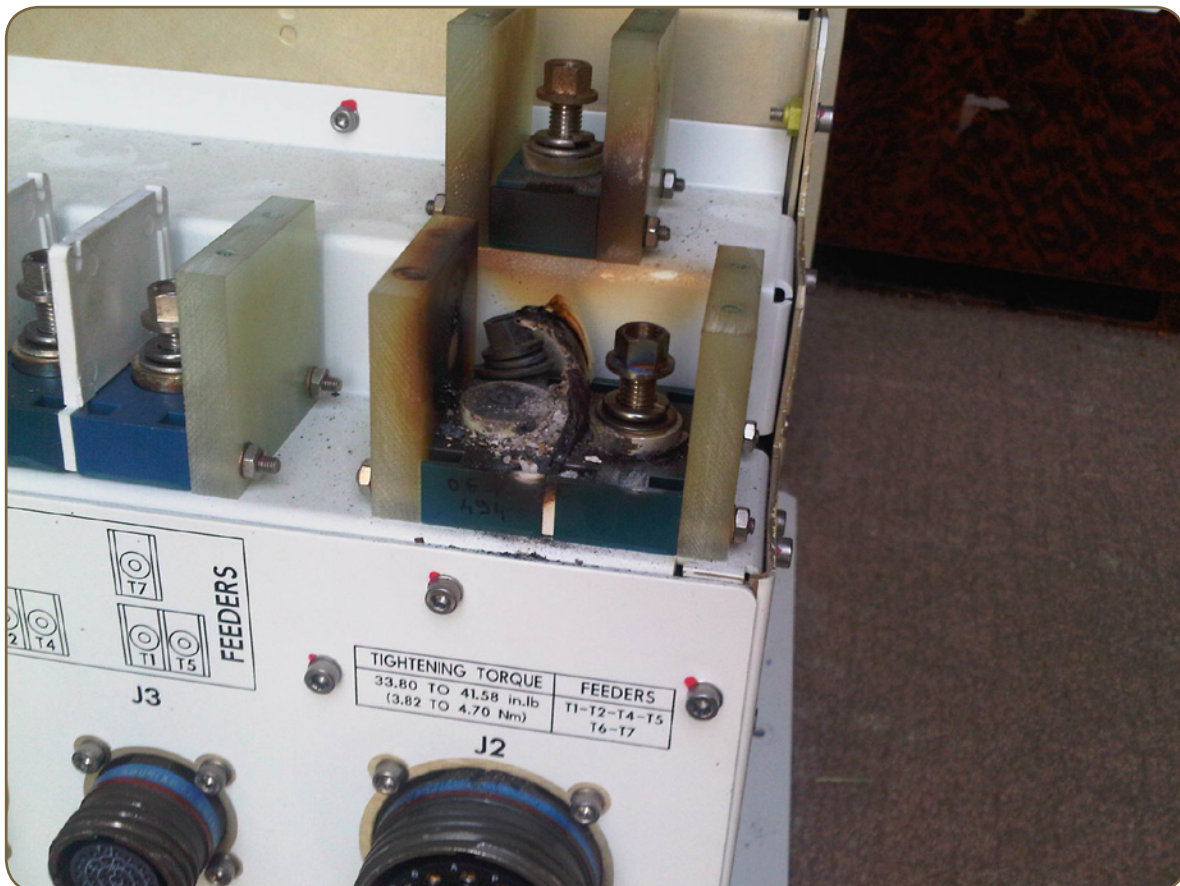
Global Express Secondary Power Center Stud Burn

Two bus bars (ESS bus) were confirmed with no power and the battery connections were verified all good. On visual inspection of the L/H Secondary Power Center (SPC), the T1 wire-lead and stud was confirmed as badly burnt and melted.

The SPC was replaced and the aeroplane was made serviceable.

Transport Canada Civil Aviation (TCCA) would like to emphasize to all operators and maintainers, the importance of correct wiring installation torque values of wire lead stud attachment points. ✖

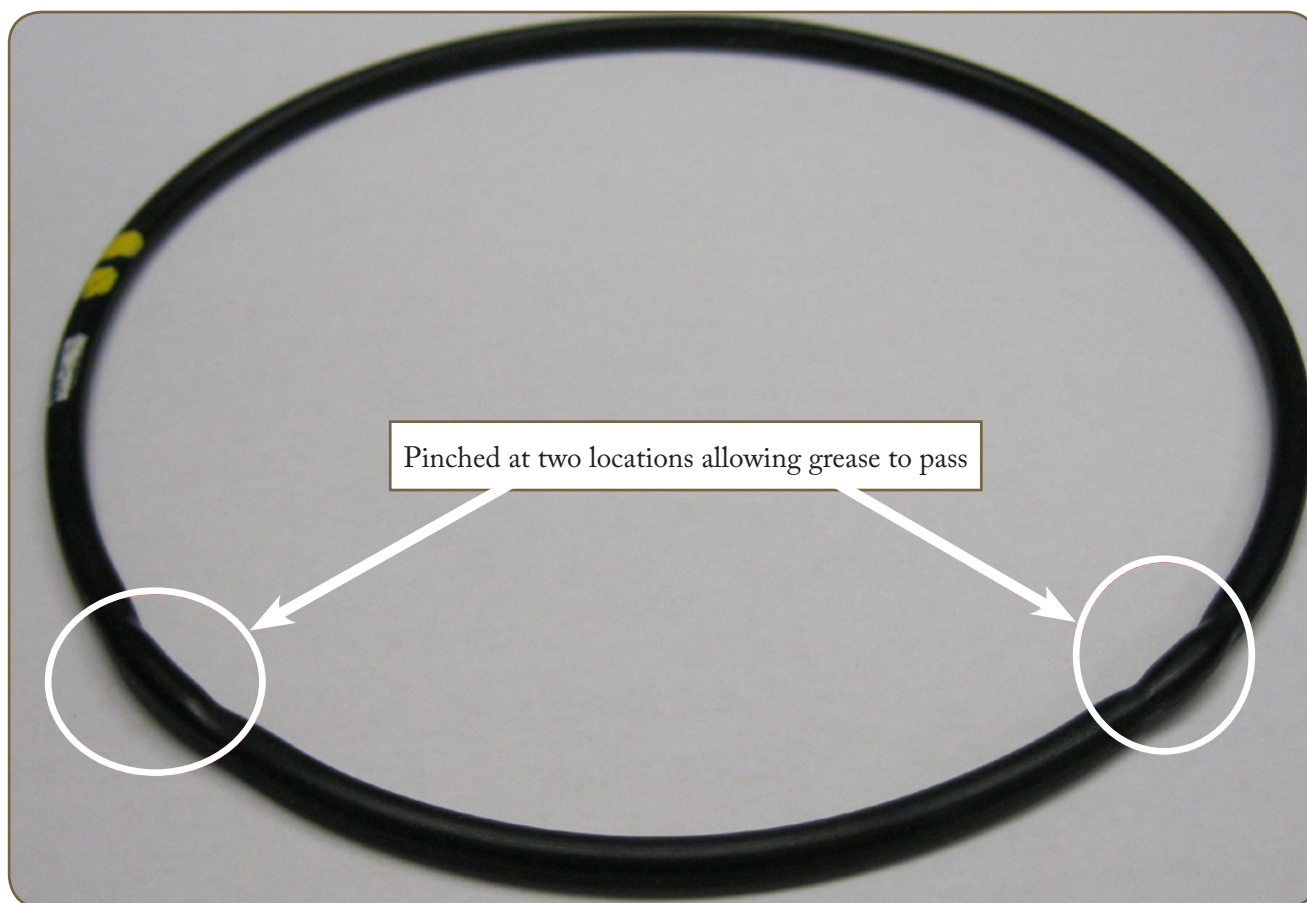
Global Express NLG Trunion End-Cap O-Ring Pinched

Maintenance investigation revealed that the bearing caps recessed O-ring was improperly installed and found pinched, allowing grease to ingress into the pressurized nose fuselage underfloor area.

Grease in that area is potentially dangerous because of the close proximity of four oxygen bottles therefore Bombardier Aerospace has issued advisory wire AW700-53-0328, defining this possible scenario and corrective action.

The O-ring was replaced and correctly installed; cap reinstalled per AMM and the aeroplane was made serviceable.

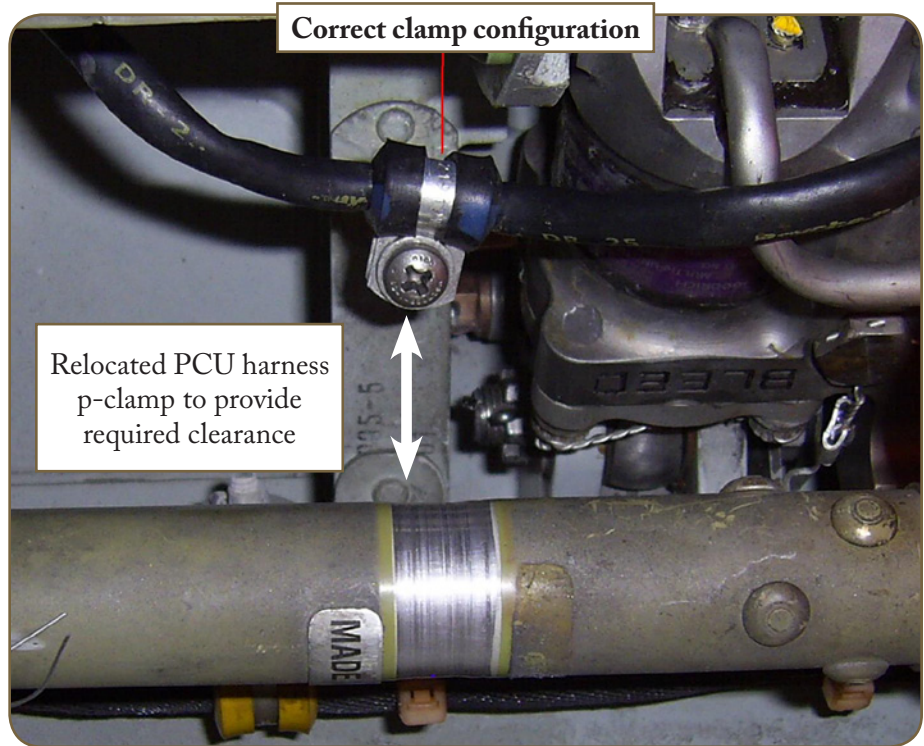
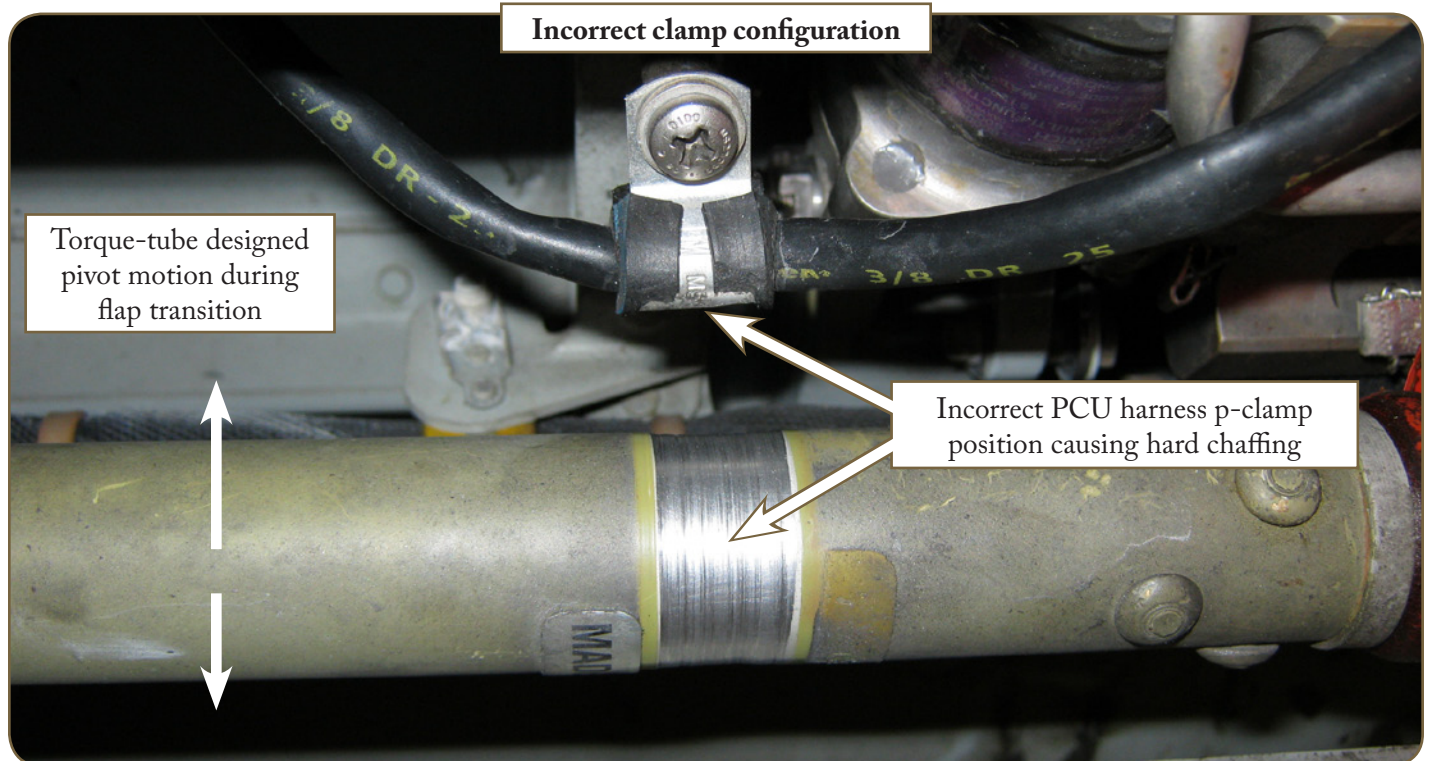
Spoiler Power Control Unit Harness Clamp Chaffing

TCCA advises all operators of this possible PCU harness configuration discrepancy. ✖

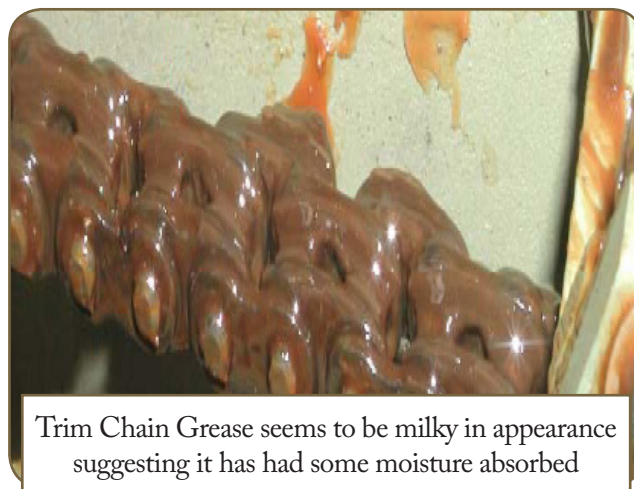
During cruise flight with autopilot engaged, the cockpit Advisory Message indicated “Mistrim Nose Dn”. The pilot disengaged the autopilot and then noted that additional forward control column force was required to maintain level flight. The pilot was unable to move the elevator trim forward because the trim wheel was jammed. The trim indicator also indicated a position forward of the take-off range. It was also determined that the elevator trim would move rearwards but not forward. Following an emergency declaration to ground control, the crew conducted a normal approach and uneventful landing.

Maintenance personnel carried out a functional check of the elevator trim system but were unable to duplicate the reported condition. Further examination revealed that the elevator trim screw jack assembly lubricant appeared to be milky in color with some water visibly present. Both the L/H and R/H screwjack assemblies were then purged of all contaminated grease/water and lubricated in accordance with the manufacturers’ instructions.

Prior to this flight, the aeroplane had been parked outside in heavy rain, which may have resulted in a buildup of water in the screw jack actuator cavity. By the time the aeroplane reached cruising altitude, ice had formed and restricted elevator trim movement. It appears that ice had clogged the trim actuator chain links preventing trim movement. Additionally, one of the tail plane access holes was not properly sealed thus permitting water to migrate into this area.

Operators are reminded to be cognizant of these hazards in inclement weather. ✖

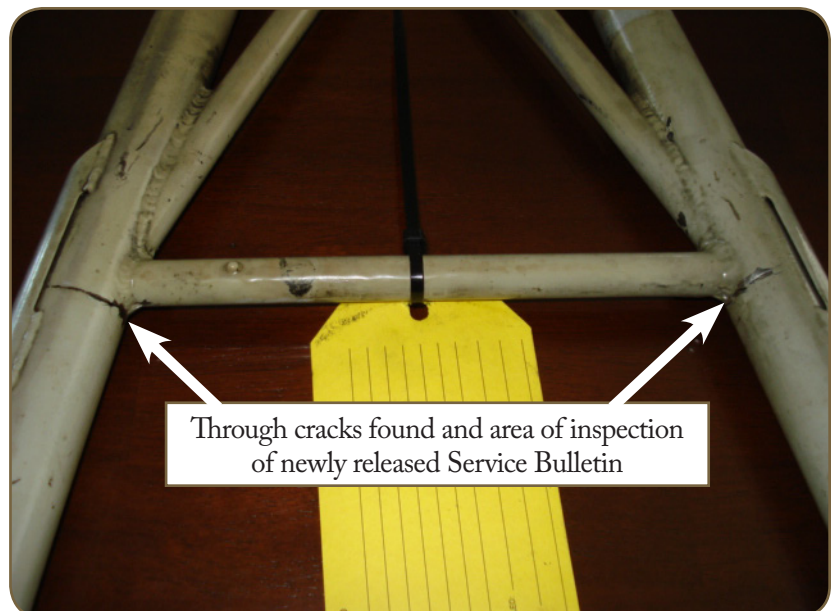
Engine Mount Cracks

Upon a routine servicing, maintenance found the L/H lower engine mount tubular frame to be cracked through on both of the inboard and outboard areas. The engine mount was removed and sent for repair.

TCCA would like to advise all operators that M7 Aerospace have recently issued Service Bulletin 226-71-018 for a detailed inspection of the concerned engine mount area. ✖

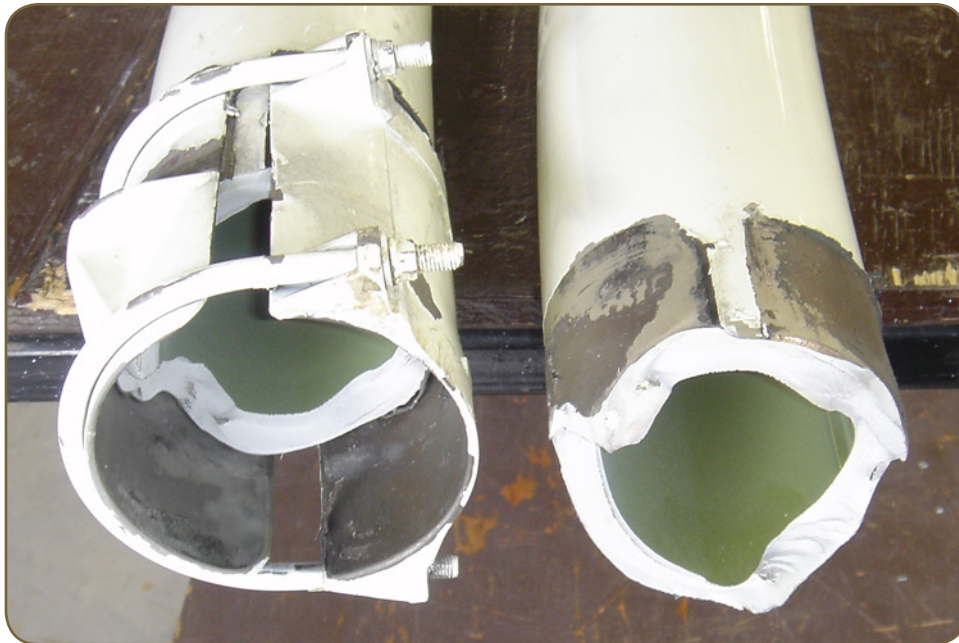
Cross Tube Cracked

While landing on a heli-ski run, a loud bang was heard and there was some slight settling on the right rear side of the helicopter. Inspection by heli-ski guide found no indications so operations continued. Post flight inspection by an AME found the aft landing gear crosstube cracked.

Upon removal, the crosstube was found broken through under the saddle. The crack is believed to have progressed from a small corrosion pit.
