AVIATION INVESTIGATION REPORT

A05Q0208

TREE IMPACT WITHOUT LOSS OF CONTROL

CESSNA 172M C-GPUL

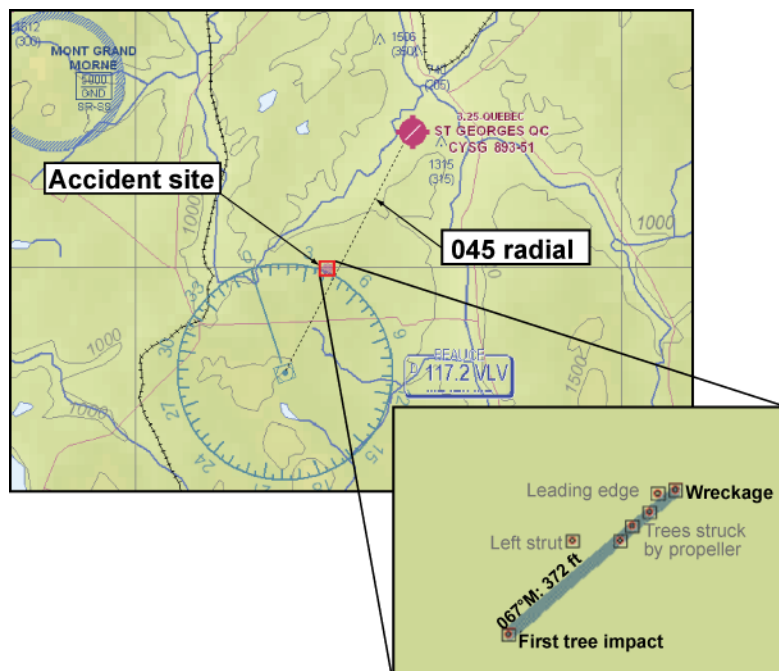
Figure 1. Accident site

The aircraft crashed in a forest clearing 30 miles east of the location where the wildlife protection officers in the aircraft were to rendezvous with those on the ground. The accident site is ½ mile northwest of the 045 radial for the VOR Runway 06 approach of the Saint-Georges aerodrome, about 6 nm southwest of the Saint-Georges aerodrome, and 5 nm northeast of the Beauce VOR (VLV) (see Figure 1). The accident site is at an elevation of 1350 feet asl, some 500 feet higher than the Saint-Georges aerodrome.

The aircraft flew over a field before striking the treetops at the edge of the wood. The aircraft's initial trajectory in the trees was 067°M. It entered the trees in cruise attitude. It started to break up on first contact with the trees and crashed in an inverted position in a clearing 372 feet from the point of first contact. The wreckage was partly destroyed by fire. It was not possible to determine precisely when the fuel-fed fire started. However, examination of the wreckage revealed that there was no in-flight fire.

Examination of the wreckage, systems and all components recovered revealed no faults that would have adversely affected control of the aircraft and no pre-impact failures or malfunctions. The engine was severely damaged by fire. The trees severed by the propeller and the impact marks on the leading edges of the blades indicate that the engine was functioning at the time of the crash. Examination of the flight controls could not establish the position of the flaps on impact. Examination of the seat-belts revealed that all occupants were buckled in. The buckles of the front seat shoulder harnesses were not attached to the seat-belt buckles.
