**AVIATION INVESTIGATION REPORT
A06P0123**

UNINTENTIONAL LIFT-OFF AND COLLISION WITH TERRAIN

**HIGHLAND HELICOPTERS LIMITED
EUROCOPTER AS 350 B2 (HELICOPTER) C-GBHH
GRANDE PRAIRIE AIRPORT, ALBERTA
05 JULY 2006**

Report Number A06P0123

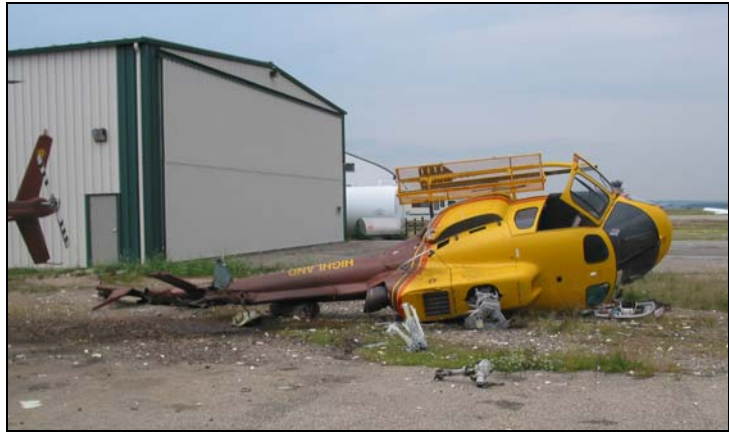
Photo 1. C-GBHH accident site

The helicopter quickly drifted backwards from the asphalt apron, turned about 90° to the left, and the tail guard on the lower vertical fin struck the ground and dug into the gravel surface now below. The helicopter slid back and rolled to the right, causing the landing skids and the main rotor blades to strike the ground. As a result of this heavy contact with the ground, the helicopter rolled over onto its right side. The rotor head and main rotor blades were destroyed; the blades shattered and were thrown over a large area. At the same time, the rear section of the tail boom broke off near the horizontal stabilizer forward attachment point and the tail rotor assembly tore out from the end of the tail boom.

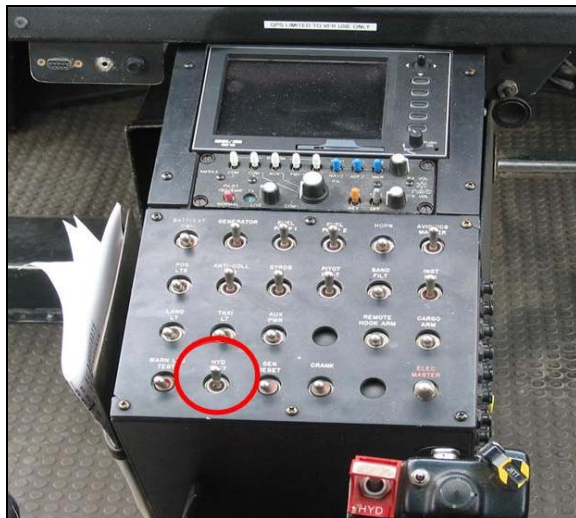
His practice was to select HYD TEST on the hydraulic accumulator test switch on the “VanIsle” centre console panel (see circle in Photo 2) and move the cyclic stick a number of times (normally 12 to 15 movements) in two specific directions – fore and aft, and laterally – so as to exhaust the servo accumulators. The pilot habitually performed these two functions in the same order each time: forward servo first, followed by the lateral servos.

Photo 2. Hydraulic accumulator test switch

In this particular helicopter, the hydraulic accumulator test switch is a two-position toggle switch mounted in the centre console switch panel (see Photo 2). Operating the switch on the ground verifies the correct function of the accumulators and it is normally set to the OFF position. Selecting the switch to HYD TEST depressurizes the hydraulic system (via the regulator unit) and simultaneously depressurizes the tail rotor yaw load compensator.

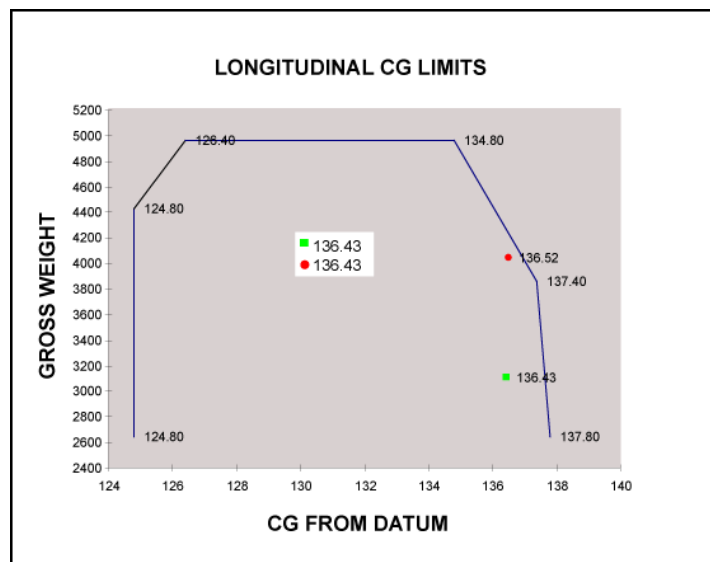
The CG, however, was near the aft limit (see Figure 1). An aft CG position in flight requires the pilot to maintain more forward cyclic stick input than normal, thus reducing the available forward cyclic stick travel. In cases of limited cyclic travel in flight, the amount of forward cyclic movement available may be insufficient for the pilot to control the helicopter.

Figure 1. Centre of gravity calculation for C-GBHH

The helicopter was well below maximum certificated gross weight and the longitudinal CG was near the aft limit. As a result of the relative light weight of the helicopter, a lesser amount of collective pitch application would have been necessary for the helicopter to become airborne. The aft CG condition would have required the pilot to maintain more forward cyclic input in flight than normal and thus reduced the available forward cyclic stick travel. Although not a significant factor until the helicopter became airborne, this reduction in forward cyclic stick travel made the helicopter vulnerable to nose-high attitudes; the onset speed and magnitude of this nose-up force may have lessened the pilot's ability to prevent the nose of the helicopter from rapidly rising.

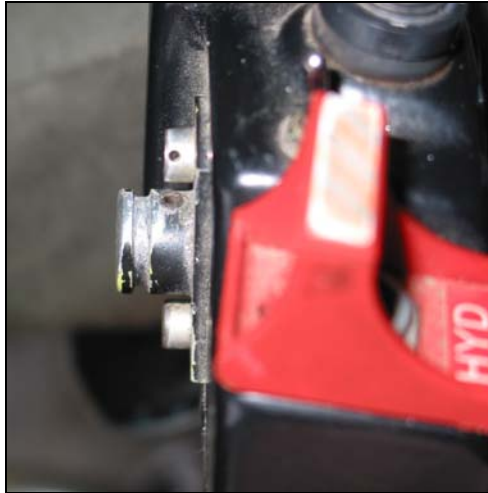
Preliminary examination of the locking plate in C-GBHH does show wear, but it also reveals clear signs of frequent improper engagement of the device (see Photo 3). By design, the locking plate engages the collective lock button in a machined groove intended to secure the spring steel locking plate. The plate is released by pushing down on the collective lever, allowing the plate to release from the groove and spring forward away from the lock button. In practical tests, this simple function occurred without fault when the plate was correctly engaged in the groove.

Photo 3. Collective locking button showing groove wear

1. The design of the lock button on the collective stick allowed improper engagement with the locking plate and led to premature release of the collective stick during the hydraulic test procedure.

The ASB is a one-time only instruction. It is clear that this part will continue to wear through normal service operation and now-serviceable locks will deteriorate without benefit of further examination. Eurocopter has since changed the instructions contained in the master servicing recommendations (MSR) chapter 05-20-01, as well as the associated work cards, to incorporate a periodic check of the button every 500 hours of service.

Eurocopter has designed a modified collective locking button to replace the original design as described in this report (new part number 350A27-3155-22). The shape of this new component evidently prevents improper engagement or premature release of the collective stick. Eurocopter has scheduled this improved part to be available to operators of the AS 350 helicopter in October 2007.

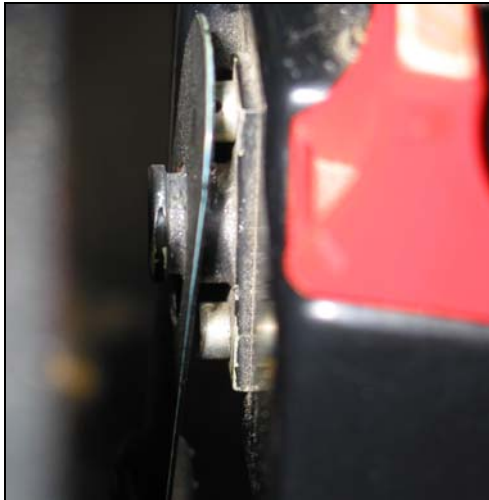
If the locking plate is engaged past the collective button, the plate catches on the machined shoulder on the button and locks the collective in that manner (see Photos 4 and 5). This position is outside the machined groove and it takes less force to release the locking plate than if it had been correctly engaged in the groove. Again, practical tests showed that the plate was positioned past the groove on most occasions, thus locking the collective improperly. The location of the device prevents this error being easily detected by the pilot and the only practical verification that the lock has engaged is the tactile sense that the collective cannot rise.

Photo 4. Collective locking plate improperly engaged on shoulder of button, not groove (accident helicopter)

The consequence is that the collective lock may be inadvertently released by the pilot bumping the collective, a force that normally would not cause it to release were the locking plate in the groove. The intent of the ASB is to prevent uncommanded release of the collective lock owing to wear on the anterior lip of the lock button; however, the safety action of the ASB does not address the circumstance of improper engagement of the lock.

On 06 June 2007, the TSB issued Safety Advisory A06P0123-D1-A1 (*Improper Engagement of Collective Lever Lock in AS 350 Helicopters*) suggesting that Transport Canada (TC) may wish to pursue the issue of improper engagement of the collective lever lock with the helicopter manufacturer, with the aim of improving the functionality and durability of the collective lever lock, thus reducing the risk of unintentional release.

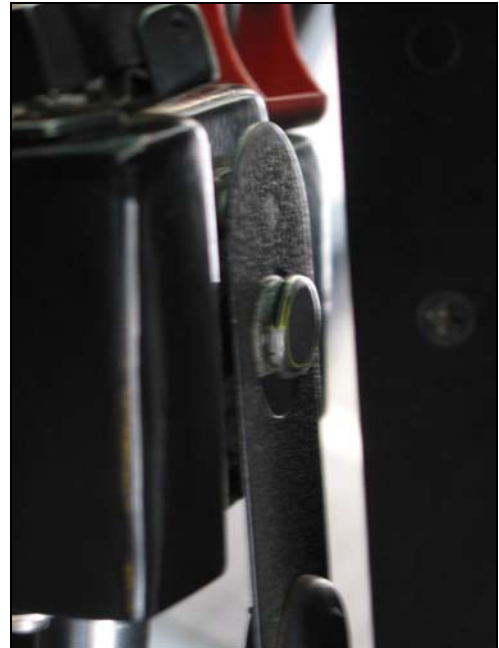
Photo 5. Collective locking plate engaged on shoulder of button, not groove (different helicopter)
