AVIATION INVESTIGATION REPORT A06P0224

LOSS OF VISUAL REFERENCE - COLLISION WITH TERRAIN

**VIH HELICOPTERS LTD.
BELL 206B (HELICOPTER) C-GWUF
KNIGHT INLET, BRITISH COLUMBIA
25 OCTOBER 2006**

Report Number A06P0224

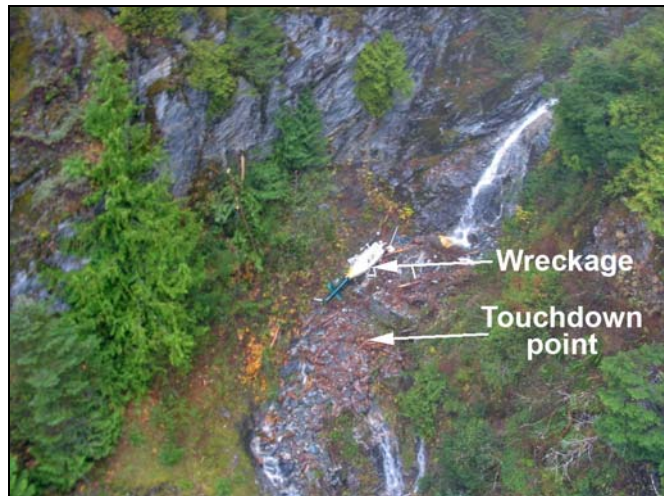
The landing site was a terraced ledge, about 40 feet wide, in a steep gorge on the west face of the mountain, and adjacent to a rapidly flowing waterfall. The site was surrounded by tall trees and almost-vertical rock faces, and the landing surface consisted mainly of loose rock and forest debris, constantly wet from the waterfall flow. The distance from the touchdown point to the waterfall rock face was about 50 feet, and the helicopter ended up about 20 feet away from the waterfall (see Photo 1).

Photo 1. View of touchdown area

1. The selected touchdown area was significantly sloped and the surface consisted of loose rock and debris, which allowed the skids to slip rearwards when the rear passenger climbed onto the left skid.
2. Saturated air, low temperature, rain, and mist from the waterfall caused significant water droplet accumulation on the outside surfaces of the helicopter windshields, impairing the ability of the pilot to maintain visual reference.
3. The air in the cockpit quickly became saturated when the first passenger entered the cockpit, causing the rapid formation of heavy condensation on the inside surfaces of the helicopter windshields and front door windows.

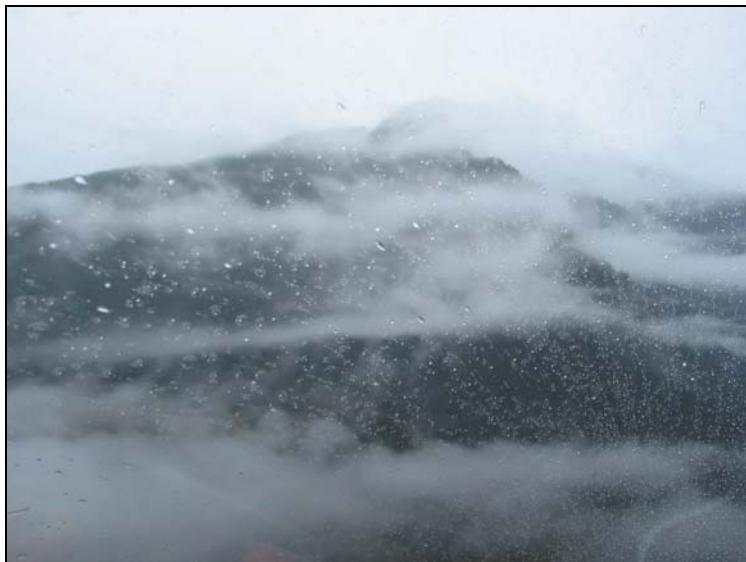
The weather at the time of the accident was reportedly not conducive to sustained visual flight because it was raining heavily and there was widespread, layered fog in the whole mountainside area. Nonetheless, the specific flight path chosen by the pilot was navigable with visual reference to the ground, and the landing site was discernable. The winds were shifting in strength and direction, at speeds estimated up to 15 knots. In general, the prevailing winds at the accident site would have been erratic at that time of the evening, and there was a possibility of downflowing air.

The weather conditions on the following day were reported by site personnel as quite similar to the day of the accident, and Photo 2 shows the weather conditions likely faced by the accident pilot.

Photo 2. View through windshield of likely weather conditions

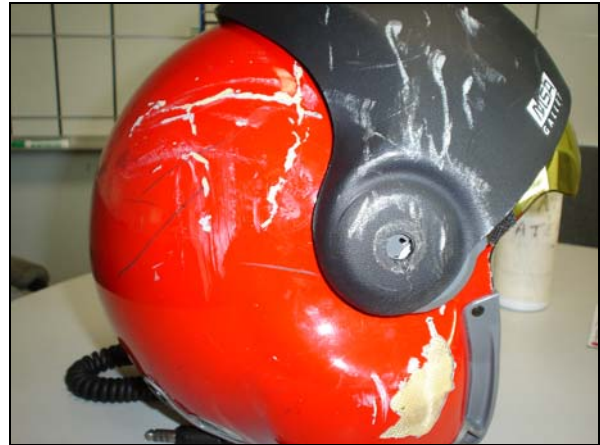
The injuries to the passenger in the left front seat and the pilot were caused by impact forces when the helicopter rolled over and struck the terrain. The passenger outside the helicopter received minor injuries when he dropped from the skid before the helicopter crashed. Medical information and injury patterns indicate that the pilot and passenger in the cockpit were wearing full seat restraints, and the pilot was wearing a flight helmet (see Photo 3). Both these factors contributed to their survival of the impact and the lessening of their injuries.

Photo 3. Damage to pilot's helmet

The full seat restraints, as well as the pilot's flight helmet, helped prevent more serious injuries. The formal review at the start of the operations at Knight Inlet regarding the hover exit procedures, emergency procedures, and local communication practices was thorough and effective. The quick reaction by the front seat passenger in securing the engine, fuel, and electrical services likely prevented a post-crash fire. This review also certainly benefited the notification and response of SAR forces, leading to the timely location and recovery of the survivors.

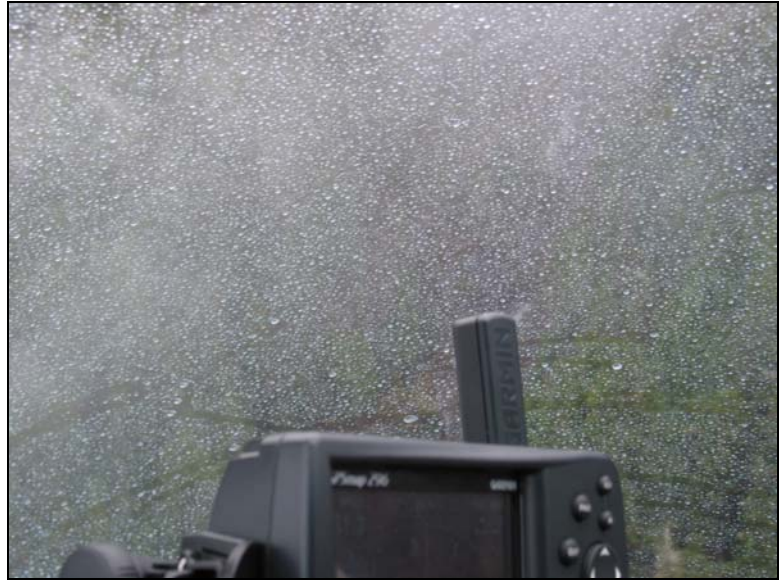
An additional restriction to vision for a Bell 206 pilot occurs in rain because the helicopter is not equipped with windshield wipers. When the helicopter is in forward flight, rain on the windshield runs off with a small amount of beading. However, at low forward speeds, and particularly in the hover, the airflow over the windshield is reduced and water can accumulate and cause significant restriction to visibility. Photo 4 shows the forward visibility from a Bell 206 cockpit at low forward speed in moderate rain.

Photo 4. Forward visibility in moderate rain

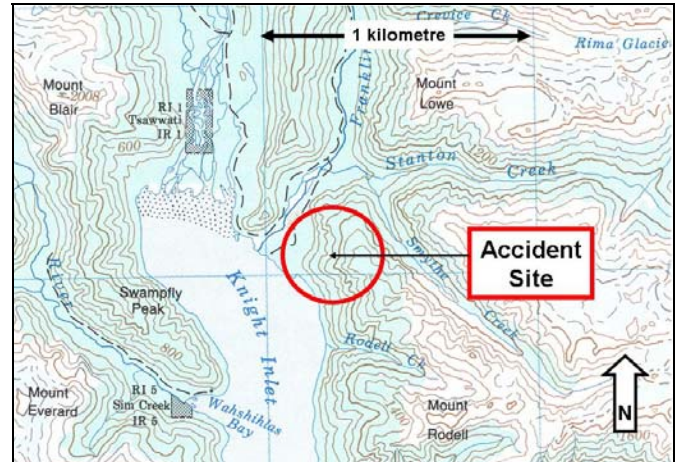
Figure 2. Close-up of accident site

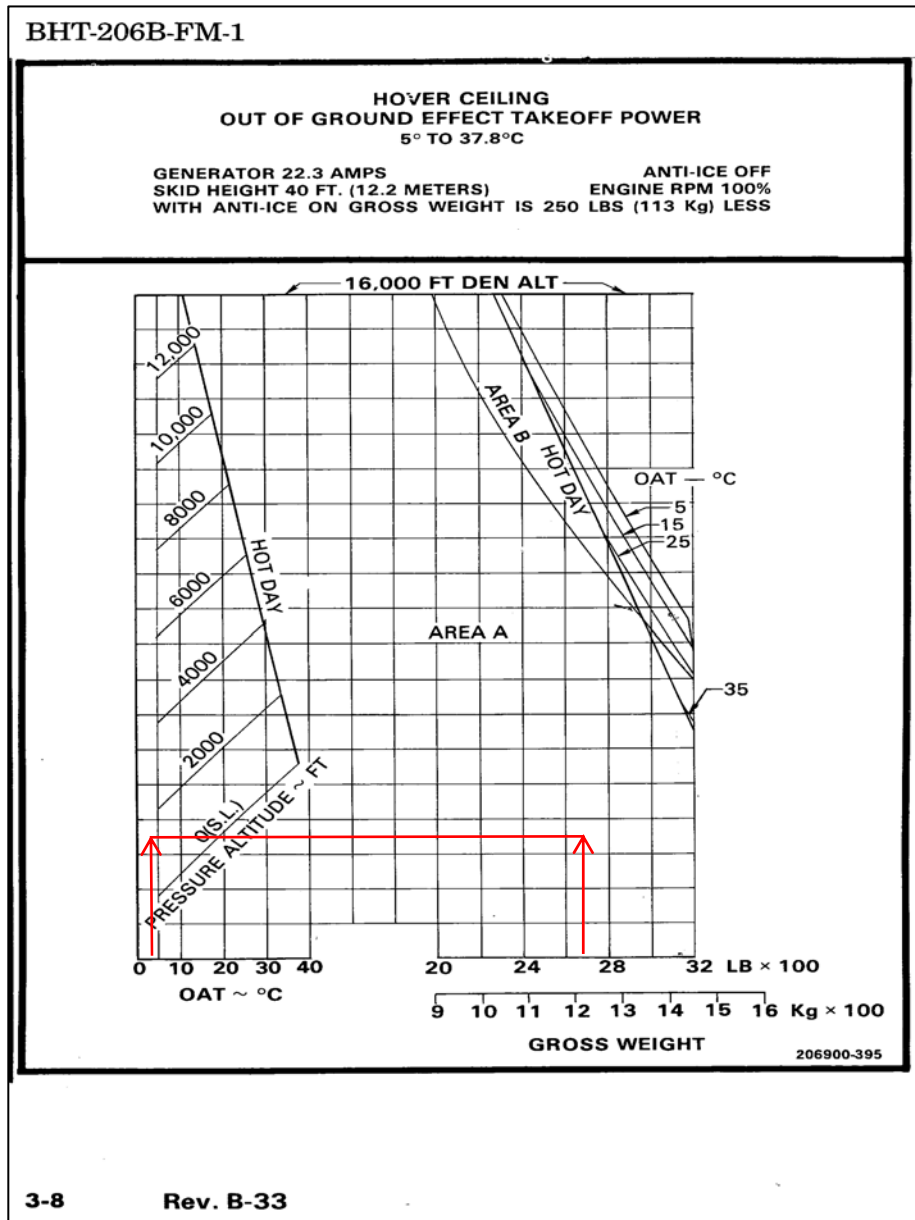
Appendix B – Hover Ceiling Out of Ground Effect (HOGE)

The hover-out-of-ground-effect (HOGE) hover ceiling chart in the Bell 206B RFM provides maximum allowable gross weight for varying conditions of pressure altitude and outside air temperature to ensure that the helicopter can hover without the performance benefit of ground effect. For the conditions at the time of the accident, the HOGE chart showed that the weight of the helicopter with the three occupants on board would have been well within the out-of-ground-effect performance capability of the helicopter (see Appendix B).

Ample engine (and transmission) power was available to hover out of ground effect. From a vertical performance perspective, this is the hardest condition to satisfy. Therefore, the helicopter aerodynamic performance did not contribute to the circumstances of this accident.
