AVIATION INVESTIGATION REPORT

A07W0072

LOSS OF SEPARATION

NAV CANADA EDMONTON AREA CONTROL CENTRE

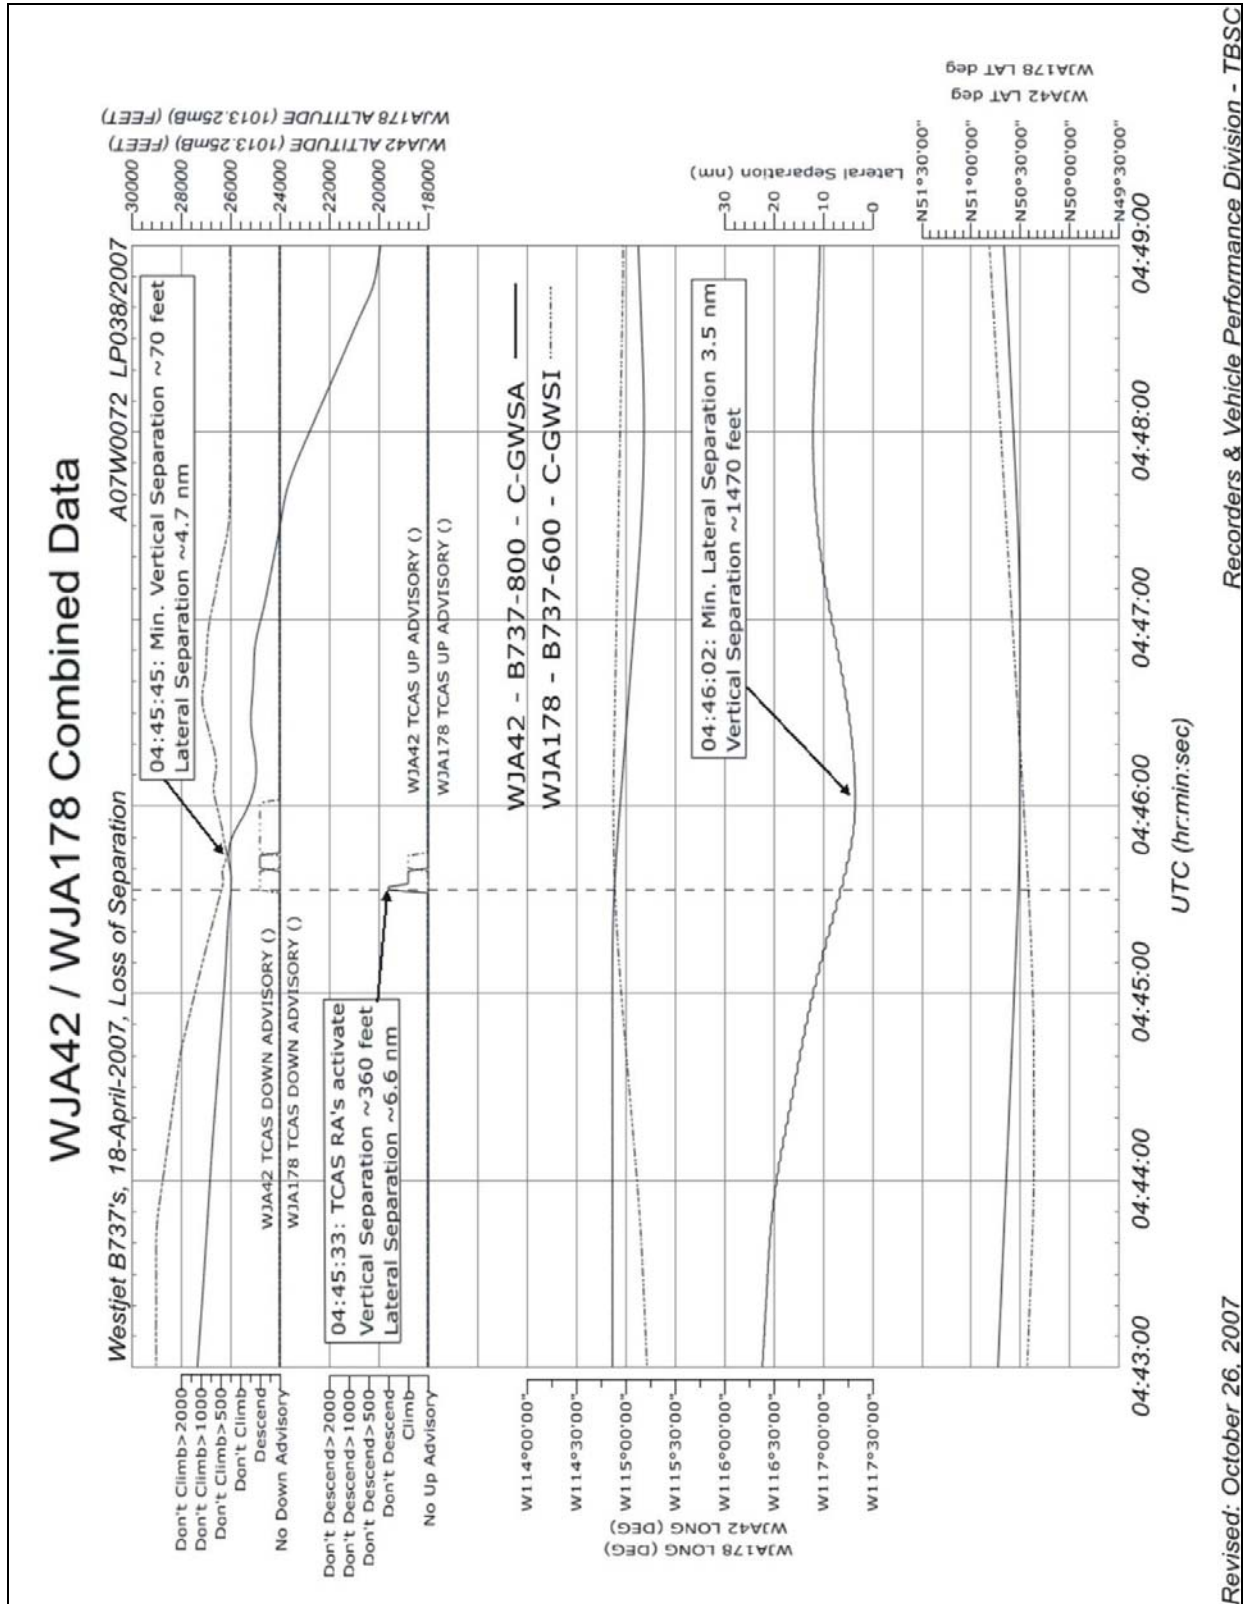
Appendix A – Combined Digital Flight Data Recorder Data, WJA 42 / WJA 178

At 2245:33, when the aircraft were separated by 6.6 nm laterally and 350 feet vertically, the traffic alert and collision avoidance system (TCAS) in both aircraft generated simultaneous resolution advisories (RAs). WJA 42's TCAS issued a "do not descend" RA that was followed

immediately by a “climb” RA (see Appendix A). The captain, who was the pilot flying, disconnected the autopilot and obeyed the RA. Eight seconds after the “climb” RA, the WJA 42 TCAS command changed to a “descend” RA. The captain obeyed that advisory while tightening the right turn in response to the position of WJA 178 appearing on his TCAS display.

At the same time that WJA 42 received the initial TCAS RA to climb, WJA 178 received an RA to descend. Within six seconds and coinciding with the WJA 42 “descend” RA, the WJA 178 RA changed to “climb.” Five seconds later, at 2245:45 the WJA 178 TCAS again commanded a descent. It is normal for TCAS to adjust commands as it recalculates changing position and altitude trends of conflicting aircraft. The controller was not informed of the TCAS RAs by the flight crews until after separation was regained.

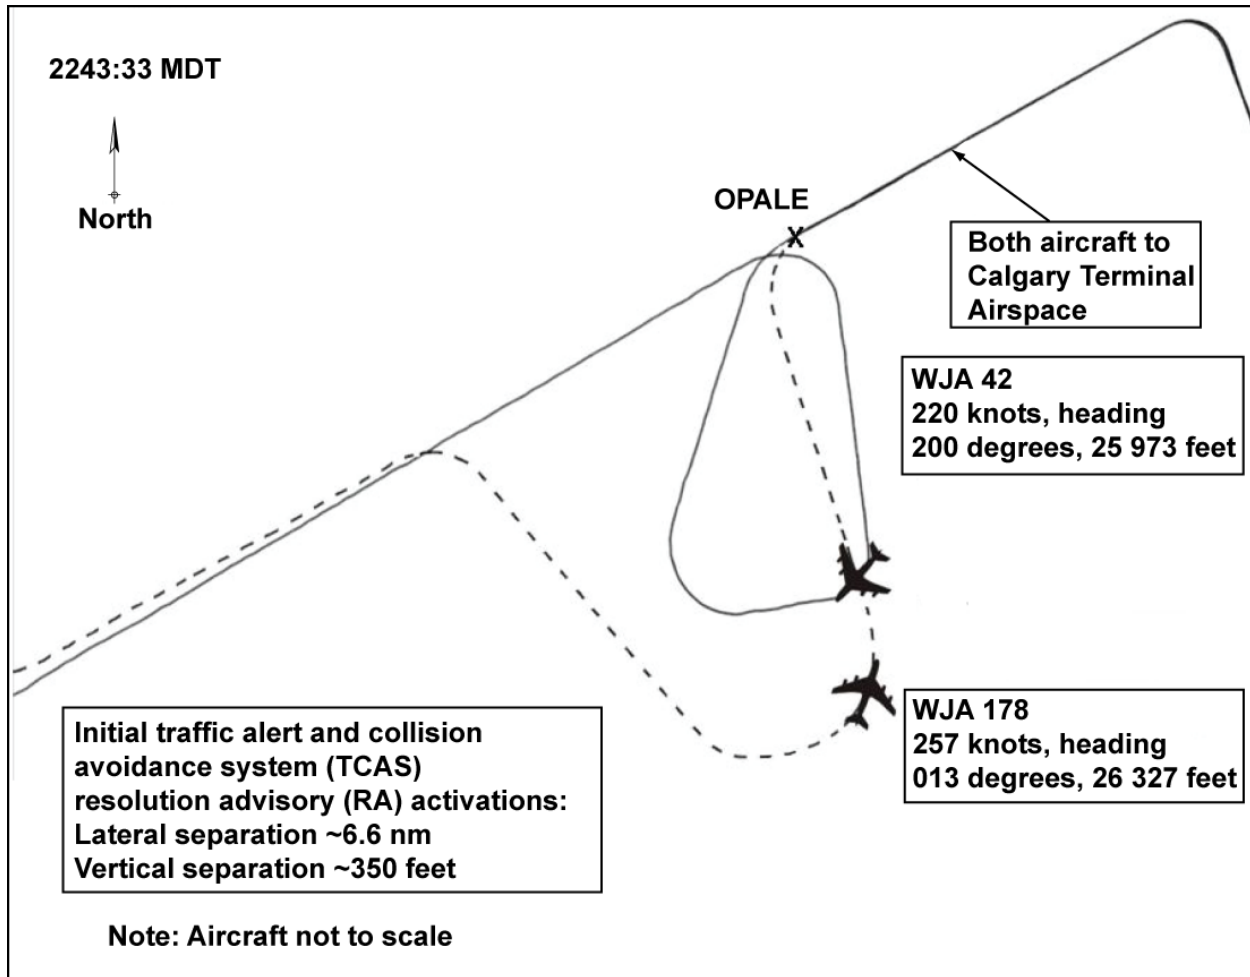
Appendix B – Plan View of Flight Paths, WJA 42 / WJA 178

The controller received a traffic alert at 2245:38, followed by a conflict alert at 2245:48. At that time, WJA 42 was on a heading of 201°M at FL 261, and WJA 178 was on a nearly reciprocal heading of 012°M at FL 261 (see Appendix B). The conflict ended at 2245:57 when separation increased to 3.5 nm laterally and 1200 feet vertically, with the aircraft on diverging tracks and altitudes.

1. While WJA 42 and WJA 178 were manoeuvring on converging vectors, the aircraft were inadvertently turned toward each other at the same altitude and a loss of separation resulted.
2. The Alsask and Banff sector controllers combined all the individual sectors prematurely, resulting in a high workload for the combined airspace radar controller. This adversely affected his monitoring of WJA 42 and WJA 178 while they were on delaying vectors and resulted in the loss of separation.
3. The handover briefing for the relieving controller did not clearly indicate what flow control provisions had been established for all aircraft inbound from the west. This affected his awareness of the traffic situation and increased his workload by requiring him to develop a traffic-metering plan for four inbound aircraft in a relatively short period of time.
