**AVIATION INVESTIGATION REPORT
A07P0123**

REDUCTION GEARBOX FAILURE/ENGINE POWER LOSS

**PACIFIC WESTERN HELICOPTERS
BELL 212 (HELICOPTER) C-GPWX
PRINCE GEORGE, BRITISH COLUMBIA
26 APRIL 2007**

Report Number A07P0123

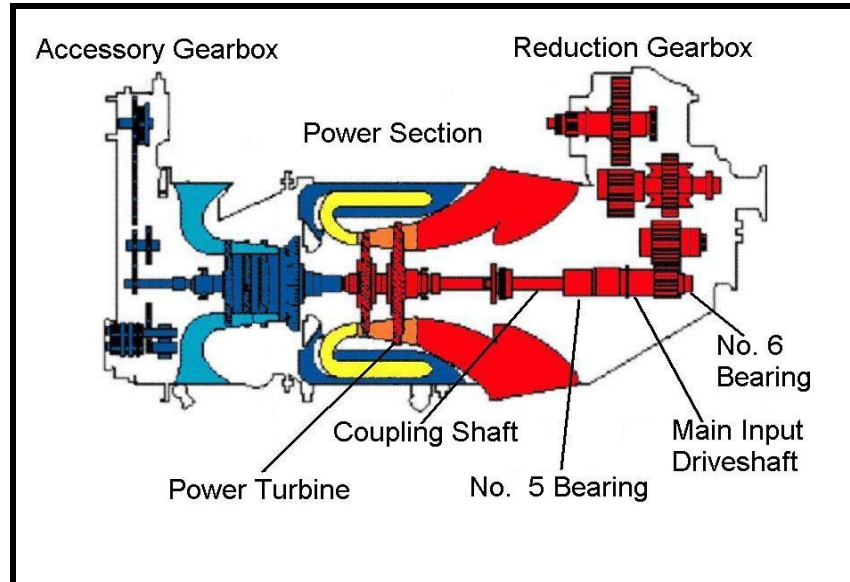
Figure 1. PT6T-3B engine, side view

Post-occurrence examination of the RGB revealed that the rolling elements (balls) and raceways of the number five bearing (part number 3021467, serial numbers F619A and F619B) installed on the number one main input driveshaft had deteriorated, allowing the main input driveshaft to move aft until the coupling shaft decoupled from the PT. The PT subsequently oversped, the PT bearing support failed, and the PT blades contacted the shroud. All of the PT blades suffered severe tip damage and several blades broke off near their platform.
