AVIATION INVESTIGATION REPORT

A07A0056

REDUCTION GEARBOX FAILURE

BELL 407 HELICOPTER C-GOFL

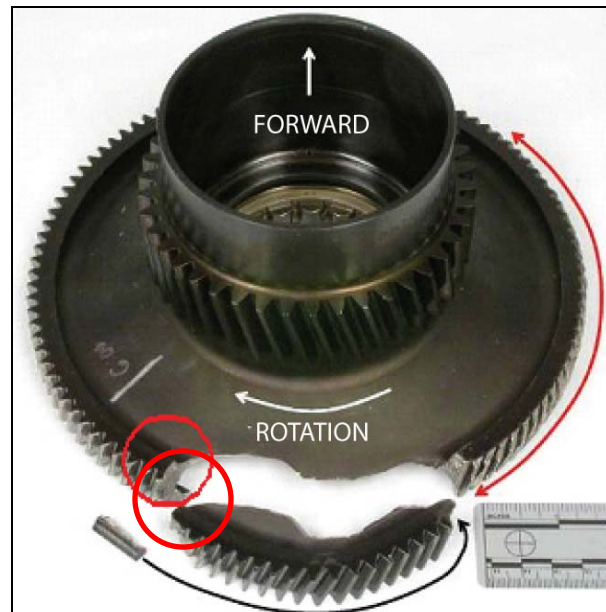
Photo 1. Broken torquemeter gear

The torquemeter gear (see Photo 1) exhibited significant gear tooth damage (the double-headed arrow marks a 90-degree arc). Microscopic examination of the fractured section of the torquemeter gear identified a fatigue crack originating on the driven surface of a tooth near the forward end (circle marks the location of a fatigue crack), at approximately the centre of the active profile. Damage to the fracture surface precluded detailed fractographic and metallurgical examination of the origin region. The tooth wear was measured and found to be 0.004 inch and, with the exception of damage done after the torquemeter gear failed, there was no spalling¹ or pitting noted. Material analysis determined that the torquemeter gear met the requirements of the engineering drawing.

The engine MM states that wear felt with the radius scribe is reason for rejecting and replacing the torque-meter gear, and Rolls-Royce indicated that the radius scribe will typically detect wear of 0.001 to 0.002 inch. Therefore, it could be concluded that the in-service wear limit would be 0.001 to 0.002 inch. Rolls-Royce has also indicated that, because the gearbox is maintained on-condition, the gears could far exceed the 3500-hour MPI requirement. The occurrence torque-meter gear had 0.004 inch wear, at least twice the in-service wear limit, and had failed at 4576 hours, 1076 hours beyond the MPI inspection requirement.

The torque-meter gear failed as a result of an undetected crack that progressed in fatigue. MPI is a method of non-destructive testing used to visually identify cracks originating at the surface in steel components. If an MPI had been carried out on the torque-meter gear before its failure then it is likely that the crack would have been detected. However, the requirement to perform the MPI is based specifically on the time-in-service of the torque-meter gear, and then only if the gearbox is already opened. There is no requirement to track the time-in-service for the torque-meter gear, or for any of the other gears in the gearbox. Therefore, if a serviceable gear is installed during gearbox maintenance, it is possible that the gear's time-in-service may not be determined.

1. The helical torque-meter gear failed as a result of an undetected crack that progressed in fatigue. The failure of the torque-meter gear resulted in the loss of engine power to the helicopter's transmission.

On 17 August 2007, Rolls-Royce issued *Commercial Engine Bulletin* (CEB) 72-6061, which advised customers of the 250-C30 and 250-C47 series engines that the power gears (pinion gear, torque-meter gear, and power take-off gear) had been redesigned to improve the reliability of the new gears. The CEB states that compliance is a customer option.

On 26 March 2008, Rolls-Royce advised that it is developing a visual inspection to be placed into the 2000-hour inspection section in the Operation and Maintenance Manual. Implementation is targeted for the third quarter of 2008.

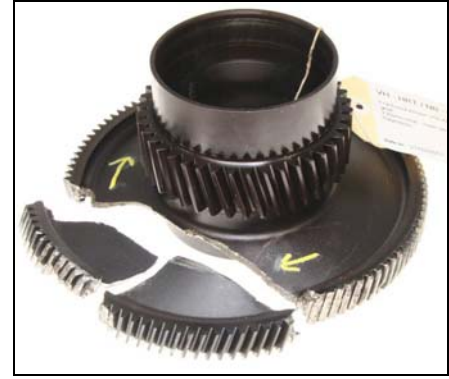
Photo 2. Broken Australian gear

On 02 February 2007, a Bell Helicopter Company model 407 medical helicopter departed Tamworth, New South Wales, Australia, en route to a car accident. The pilot reported that the engine chip detector advisory illuminated on the master caution panel. Approximately five seconds later, he heard a frequency vibration with a complete loss of engine power. Preliminary examination showed that the torque meter gear had fractured due to fatigue cracking from an origin at the root region of a rim gear tooth (see Photo 2). Magnetic particle inspection showed evidence of cracking at the roots of several other gear teeth adjacent to the location of the fracture. Localized gear tooth spalling and uneven surface contact patterns were also observed.
