## **AVIATION INVESTIGATION REPORT A07A0096**

### **ENGINE FAILURE / FORCED LANDING**

**FOREST PATROL LIMITED  
AYRES S-2R C-FBED  
BOSTON BROOK, NEW BRUNSWICK  
27 AUGUST 2007**

Report Number A07A0096

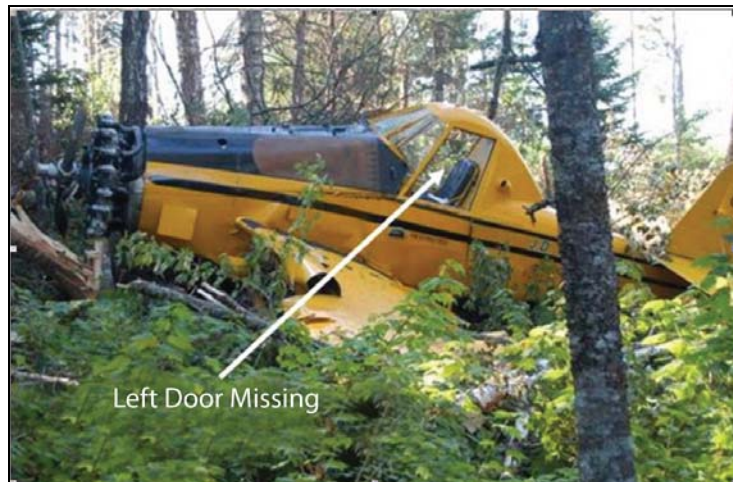
As the aircraft entered the trees in a right-wing-low attitude, it began to decelerate and yaw further to the right. Several large trees were broken off in the accident sequence, which caused damage to both wings, the tail section, fuselage, empennage, propeller, and engine. The pilot, who was wearing a four-point safety harness, was not injured. The cockpit integrity was not compromised.

**Photo 2.** Aircraft final position.

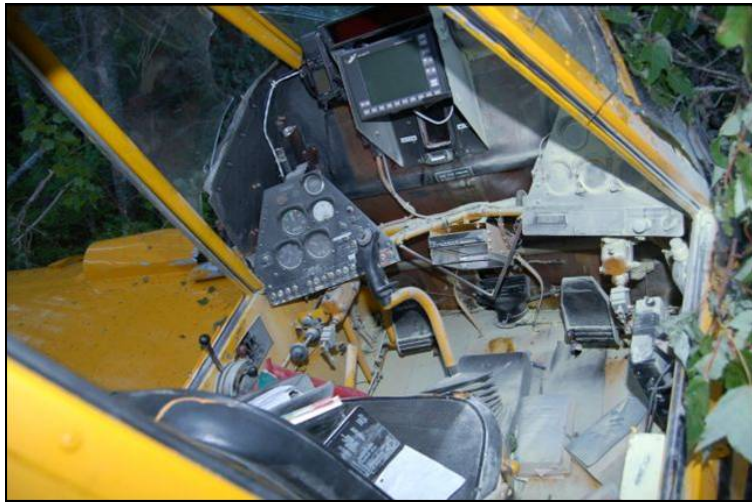
**Photo 3.** Cockpit integrity.
