AVIATION INVESTIGATION REPORT

A07P0345

LOSS OF CONTROL - COLLISION WITH TERRAIN

CESSNA 172M C-GGVK

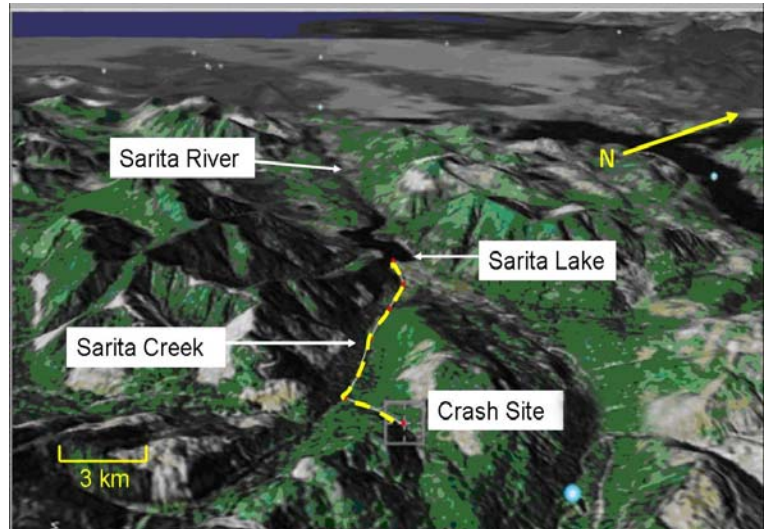
From that point on, the route is not known. However, based on the location of the crash site and the known destination, it is likely that the aircraft turned inland and followed the Sarita River towards Sarita Lake (see Figure 2). The lake is large enough to land a floatplane.

670 feet above Sarita Lake. This valley rises about 150 feet from the Sarita Creek valley to the accident site (0.5 nm) and a further 300 feet in 0.5 nm beyond the site. The peak elevation of this valley is about 0.75 nm past the accident site. Beyond this point the terrain drops into another valley. There is an elevation increase of 1100 feet in the 4 nm between Sarita Lake and the high point in the valley.

Figure 2. Likely track of aircraft from Sarita Lake.
