**AVIATION INVESTIGATION REPORT
A07O0095**

LANDING GEAR COLLAPSE AFTER TOUCHDOWN

**WABUSK AIR
PIPER PA31 C-GRVW
MOOSONEE, ONTARIO
09 APRIL 2007**

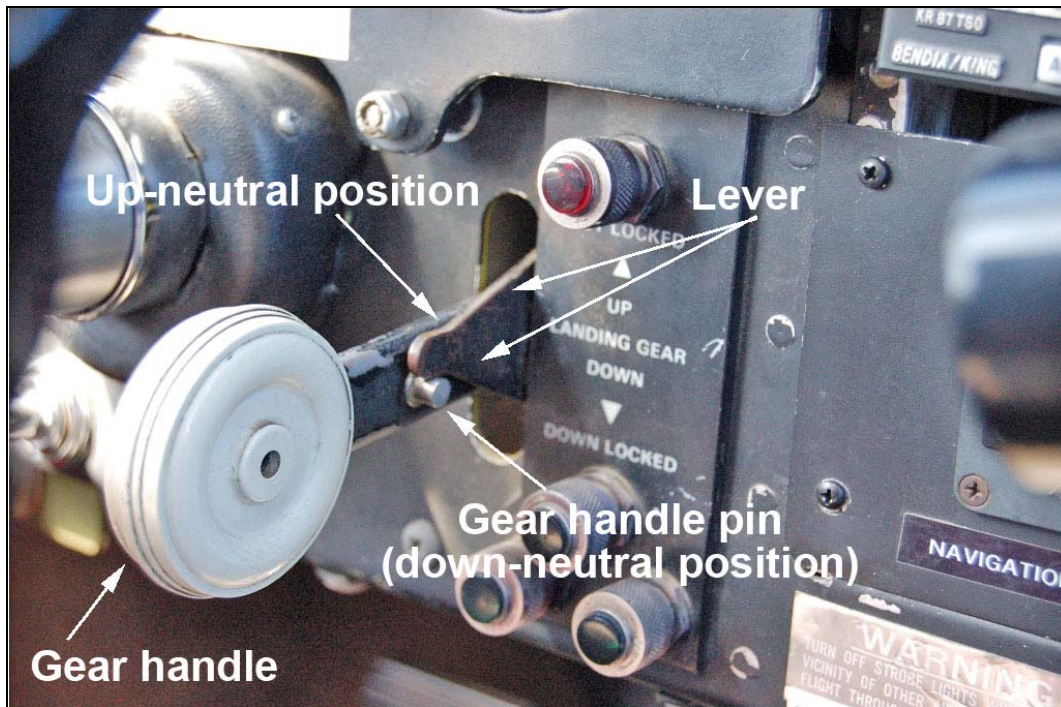
Photo 1. Landing gear handle

The landing gear handle was in the down neutral position (see Photo 1). The aircraft was lifted to enable extension of the landing gear. Once in the air, it was found that snow had packed into landing gear bays as the aircraft was dragged to the apron. The landing gear free-fell to the down position once the snow was cleared away. All three landing gear locked into the down position using the hand pump, and there were corresponding gear down indications. The landing gear was examined, and there was no mechanical failure to any of the landing gear components. Additionally, there were no discrepancies noted in the rigging of the landing gear, and the landing gear oleo extension appeared normal.

The landing gear handle is designed so the handle is spring-loaded to a forward position (towards the console). There is one pin on the inboard side of the handle that rests against a lever that acts as a neutral stop (see Photo 1). A spring ensures that the landing gear handle is positively seated in the forward position and cannot be moved unintentionally beyond the neutral stop. One end of the spring was found to be broken and the spring appeared to be weak. This caused the handle to be loose and prevented the landing gear handle from positively retracting to the forward position. During testing, the landing gear handle could be easily bumped over the down neutral position with the weight off the wheels and the master switch turned on. With the weight on wheels and the master switch on, the anti-retraction switch prevented any movement of the landing gear handle above the neutral stop. However, with weight off wheels, the landing gear selector could easily be bumped to a position where it was just above the centreline of the neutral stop, bypassing the solenoid-operated lock, but not triggering any of the warning horns. When weight on wheels was achieved, the landing gear handle could be selected to the up position. Additionally, movement of the landing gear handle to a position approximately 0.375 inches above "UP" neutral began the landing gear retraction sequence, allowing the landing gear to retract.

1. The spring in the landing gear handle was broken and allowed easy movement of the landing gear handle past the neutral stop.
2. During the approach, the landing gear handle was most likely placed in a position that bypassed the anti-retraction system.
3. The landing gear handle inadvertently moved to an "UP" selection during the landing roll, which activated the gear warning horn and retracted the landing gear.

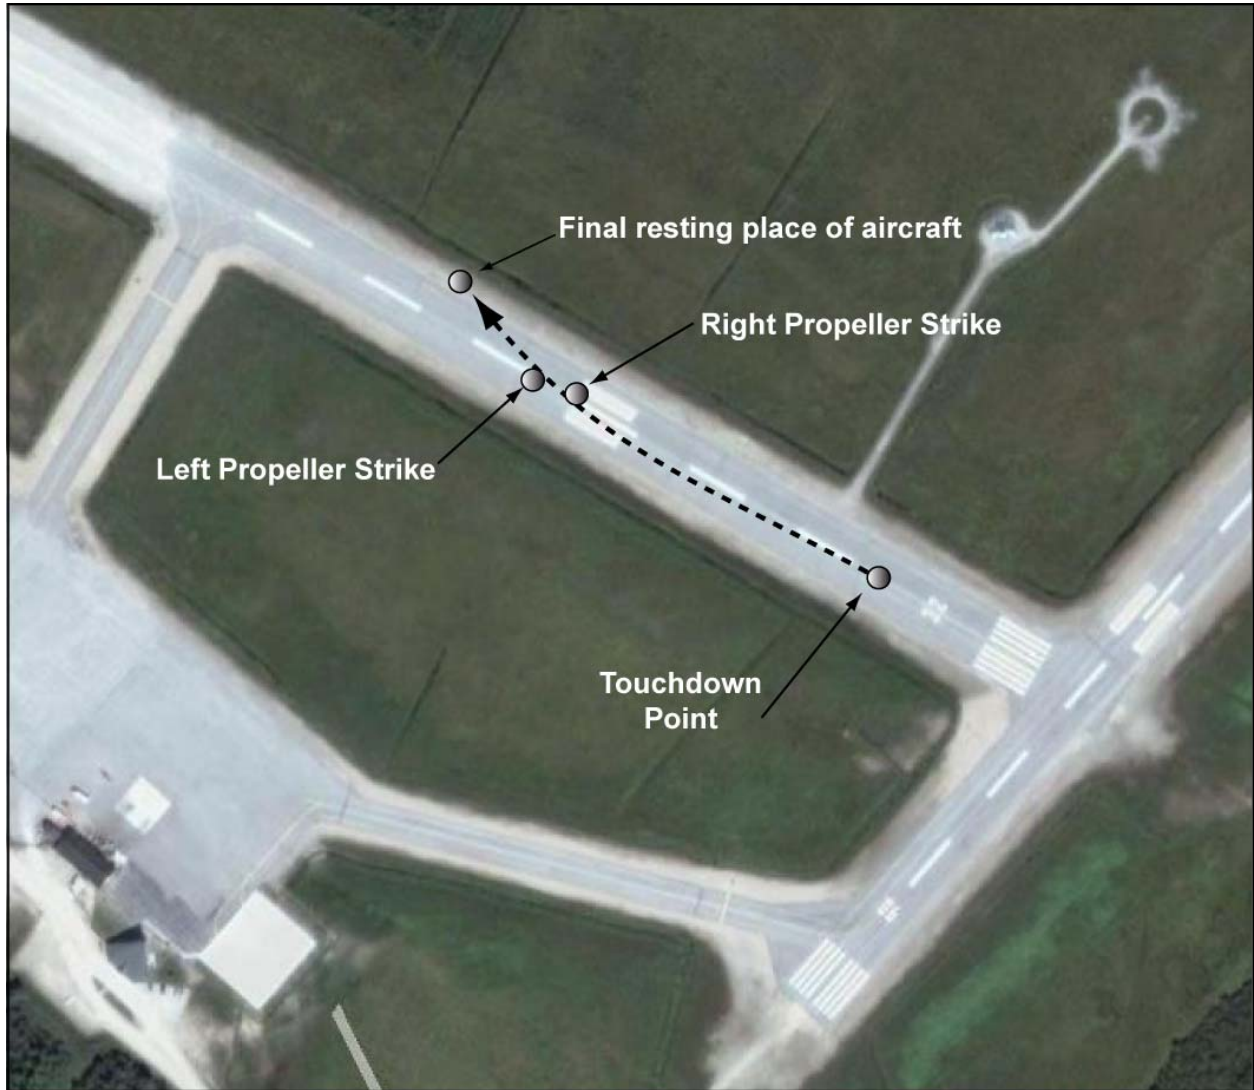
Appendix A – Site Diagram

When investigators arrived, the aircraft had been dragged from the runway to the apron area and was left secured for examination. The runway was examined and propeller strike marks were found for both propellers (see Appendix A). The marks confirmed that the right main gear collapsed first, followed by the remaining landing gear. The flaps and landing gear were in the retracted position. There was damage to the underside of the right wing tip, the underside of the aircraft fuselage, and the nose gear doors. The right engine propeller blades were bent back around the engine nacelle and were not feathered. The left engine propeller blades were bent back around the engine nacelle and were feathered.
