RAILWAY INVESTIGATION REPORT
R10D0088

MAIN-TRACK DERAILMENT

CANADIAN NATIONAL
FREIGHT TRAIN M36831-18
MILE 58.20, KINGSTON SUBDIVISION
LANCASTER, ONTARIO
18 OCTOBER 2010

Report Number R10D0088

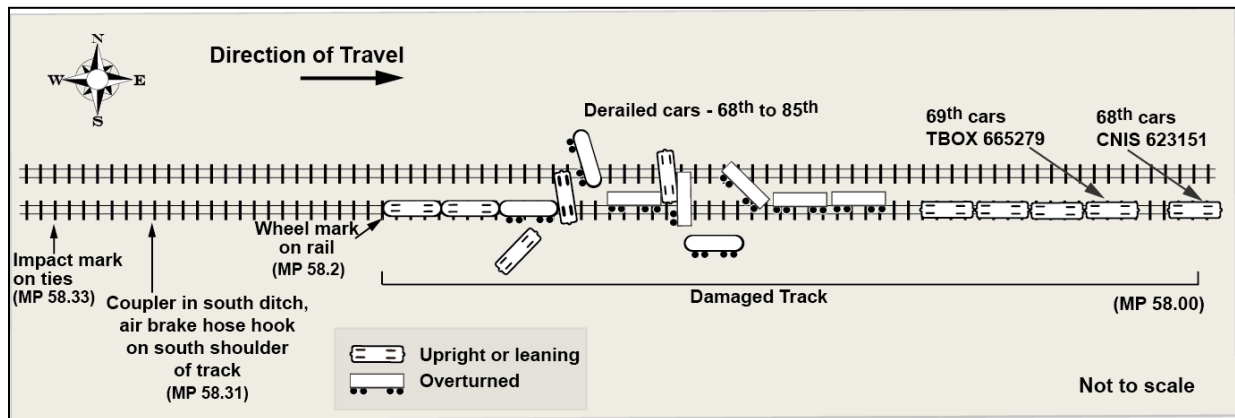
Figure 2. Site Diagram

At Mile 58.33, two ties displayed fresh impact marks between the rails. Wheel marks were observed on the web of the north rail at Mile 58.20, about 700 feet east of the damaged ties. The rail had lifted out of the tie plates and was resting on the spikes. The rail was broken and the track was destroyed for approximately 500 feet. Further east, the north rail was rolled over all the way to the first derailed car, CNIS 623151, the 68th car from the head end. The 69th car, TBOX 665279, and the following 3 cars stayed coupled together and were derailed upright on the track. Sixty feet to the west, cars CNA 404920 and CNA 407068 were overturned off their trucks and were resting on their sides. The remaining derailed cars had piled up and were fouling both the north and south main tracks (see Figure 2).

Car CNIS 623151, an empty centre beam flat car, came to rest at Mile 57.98 with the north wheels of its trailing truck derailed and resting on the gauge side base of the rail. The leading end of the following car, TBOX 665279, an empty box car, was 55 feet to the west of CNIS 623151. The car came to rest with all wheels derailed. The north rail was rolled to the field side and the wheels were resting on the gauge side web. The south side wheels were resting on the gauge side of the rail.

The moderate damage to the trailing end of the 68th car and the leading end of the 69th car is indicative of a low impact collision between the 2 cars when the trailing portion ran into the head-end portion. The damage to the north side of the 68th car and the resting angle of the coupler of the 69th car, skewed to the north, suggest that the impact force was applied at an angle. As a result, the lateral force generated was sufficient to cause the rail to roll over and the train to derail.

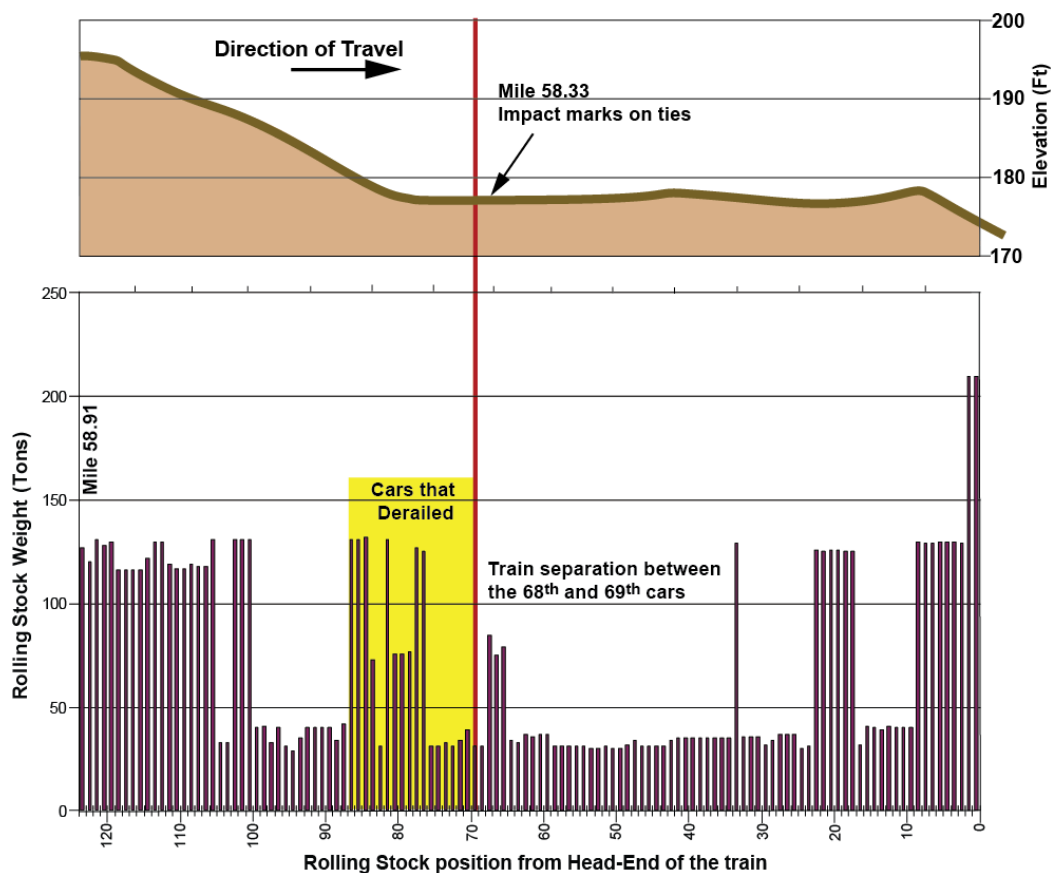
Figure 3. Location of rolling stock at the time of train separation

Before departing MacMillan Yard in Toronto, the train received a certified car inspection. The train consisted of 6 blocks of loaded and empty cars (see Figure 3). The 1st, 5th and 6th blocks from the head end were to be set out in Taschereau Yard in Montréal while the other blocks were destined for Garneau Yard near Shawinigan, Quebec. The tail-end block was composed of 19 loaded cars. The portion of the train trailing the first derailed car, car CNIS 623151, accounted for 44% of the number of cars and 55% of the train weight. The trailing 25% of the train length (32 cars) accounted for 37% of the train weight.

Train M36831-18 was marshalled with a block of loaded cars on the tail end trailing mainly empty cars. This marshalling configuration is susceptible to a derailment through the generation of high in-train forces. When the train experienced an emergency application of the brakes after the separation between the 68th and 69th cars, both portions of the train began to slow. Because the trailing portion of the train was composed of mainly loaded cars and was situated on a steeper descending grade, the brakes were not as effective as on the leading portion composed of mainly empty cars. Consequently, the trailing portion of the train decelerated at a slower rate and collided with the leading portion of the train.

Although CN had started developing marshalling rules aimed at reducing in-train forces, the rules were not fully implemented at the time of the derailment. A rule controlling weight distribution was put in place 2 months after the derailment. Had this rule been in effect at the time of the derailment, the weight of the tail end of the train would have been reduced; thus, decreasing the risk of run-in and the magnitude of the collision impact force.

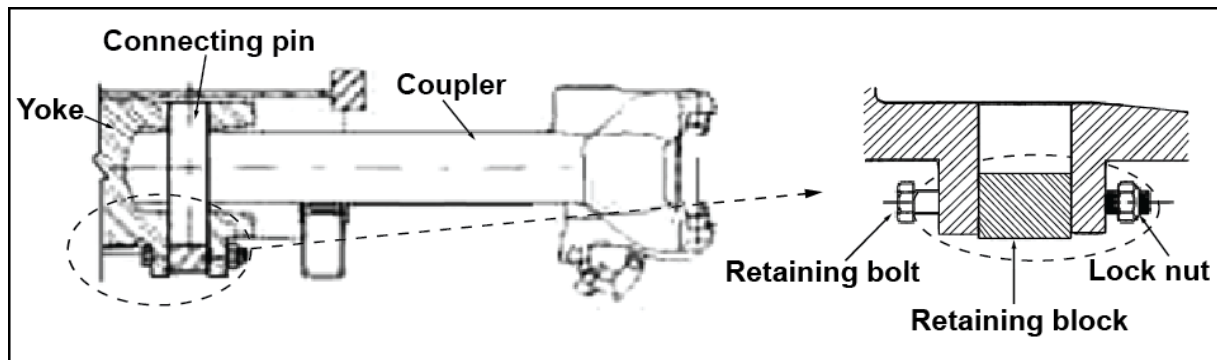
Figure 4. Coupler assembly CNIS 623151

The leading end of car CNIS 623151 was equipped with an E type coupler (code SBE68BE), connected to the yoke with an assembly that consisted of a vertical connecting pin, a retaining block, a 7/8" x 9" retaining bolt and a lock nut (see Figure 4). The trailing end coupler was found laying in the south-side ditch at Mile 58.31, but its connecting assembly was not found. Neither the coupler nor the yoke displayed any fractured surfaces.

The coupler and the yoke of the trailing end of car CNIS 623151 did not exhibit any fracture surfaces; therefore, the train separation was caused by the failure of the connection joining the two components together. The retaining bolt of the connection has been identified by the AAR as being prone to fatigue failure. In this occurrence, the retaining bolt was not found; however, it is likely that the bolt fractured causing the retaining block to fall to the ground. With no redundancy built into the coupler design, the connecting pin had worked its way out of the assembly, no longer securing the coupler to the yoke. As the coupler was pulled away from the yoke, the train separated between the 68th and 69th cars.

3. The train separated when the coupler pin retaining bolt in the yoke/coupler connection of the trailing end coupler of car CNIS 623151 likely failed and the coupler was pulled away from the yoke.

The AAR amended Rule 17, requiring the replacement of the retainer bolt, which secures the coupler to the yoke, with a more robust pin assembly once the car is placed on a repair track. Since the rule came into effect, car CNIS 623151 was repaired on a repair track at least twice by certified car mechanics who were trained and cognisant of the rules. Nevertheless, the car was repaired and returned to service without having the retaining bolt changed.
