**MARINE INVESTIGATION REPORT
M10M0014**

CAPSIZING AND SINKING

**SMALL FISHING VESSEL
CRAIG AND JUSTIN
OFF MARGAREE HARBOUR, NOVA SCOTIA
01 MAY 2010**

Report Number M10M0014

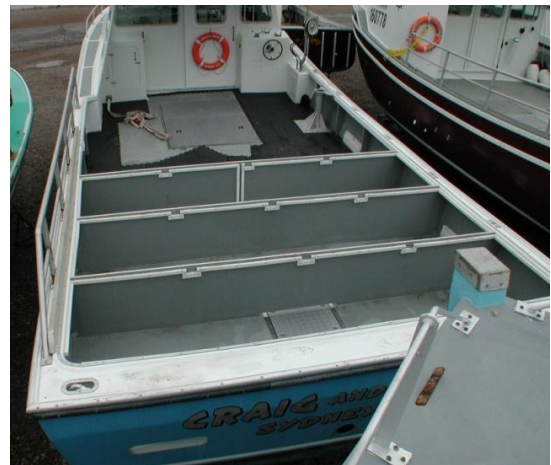
The working deck was fitted with 3 transverse pound boards to create storage areas (see Photo 2). Small holes were cut into the transverse pound boards, which allowed water to flow between the areas. The pound boards were fitted with portable covers, extending to the transom, on which the traps and gear could be stowed.

Photo 2. Working deck with transverse pound boards (Courtesy of Briand Marine Surveys)

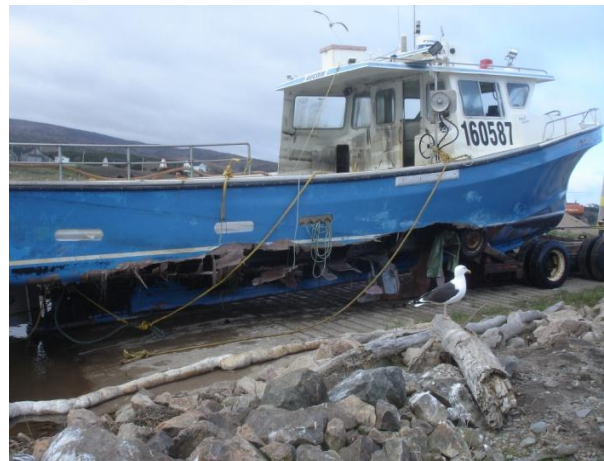
The vessel was subsequently salvaged, but the hull had been extensively damaged on the starboard side and was declared a total loss (see Photo 3).

Photo 3. *Craig and Justin* following salvage

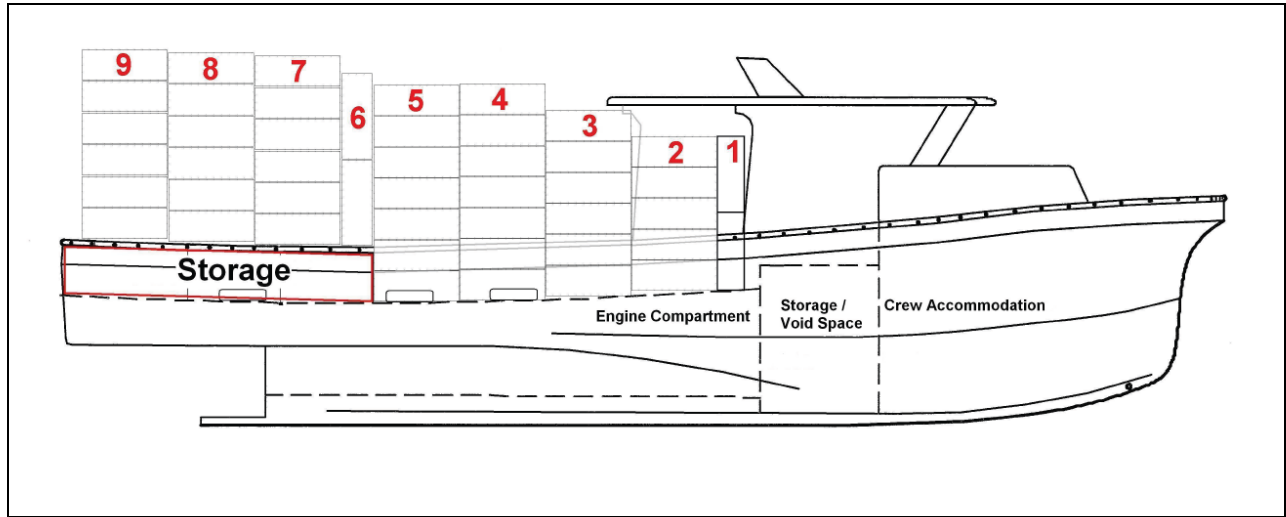
Appendix A – Vessel Profile and Loading of Lobster Traps

When the vessel departed port, the 275 lobster traps were stacked in 9 tiers of varying heights. The foremost 5 tiers were placed directly on deck, and the last 4 tiers were on top of the pound board covers (see Appendix A).

Tier	Column x Row	Traps
1	-	5
2	6 x 5	30
3	6 x 6	36
4	6 x 7	42
5	6 x 7	42
6	6 x 2	12
7	6 x 6	36
8	6 x 6	36
9	6 x 6	36
Total		275

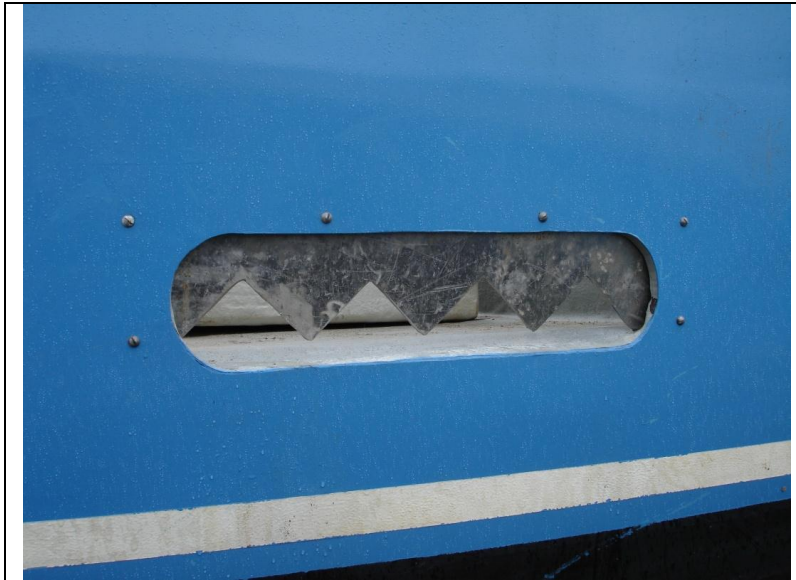
In this occurrence, the 2 forward-most freeing ports of the *Craig and Justin* were modified after its initial delivery without conducting an evaluation of the possible safety implications. While this did not play a significant role in the occurrence, owners may not be fully aware of the safety implications of their modifications unless they are adequately assessed.

Photo 5. Saw tooth style freeing port viewed from outside vessel

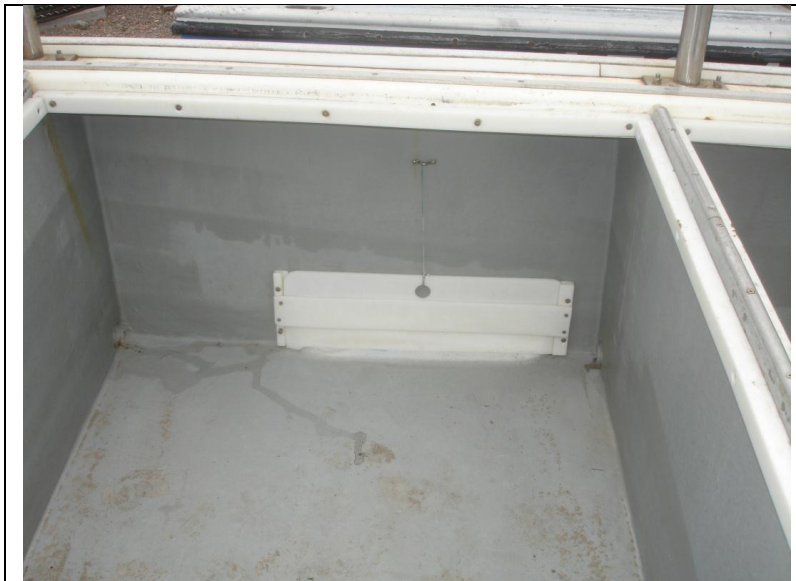
Although the weather and sea conditions were forecasted to be favourable, the small freeboard would have been ineffective at preventing the entry of water on deck via the freeing ports as a result of encounters with natural waves or the motions of the vessel. As such, the 2 forward-most freeing ports, which had not been fully blocked off, would have allowed water to enter the deck well as the vessel manoeuvred along. This water would then have been able to drain aft, through the drain holes in the transverse pound boards, and would have been trapped in the well because the other freeing ports had been effectively blocked by the slider plates.

Photo 6. Slider style freeing port viewed from inside vessel
