Transportation Safety Board  
of Canada

## **MARINE OCCURRENCE REPORT**

**DISAPPEARANCE AND PRESUMED SINKING  
OF THE F.V. "LE BOUT DE LIGNE"  
WITH THE LOSS OF THE THREE CREW MEMBERS  
GULF OF ST. LAWRENCE  
13 DECEMBER 1990  
REPORT NUMBER M90L3033**

Report Number M90L3033

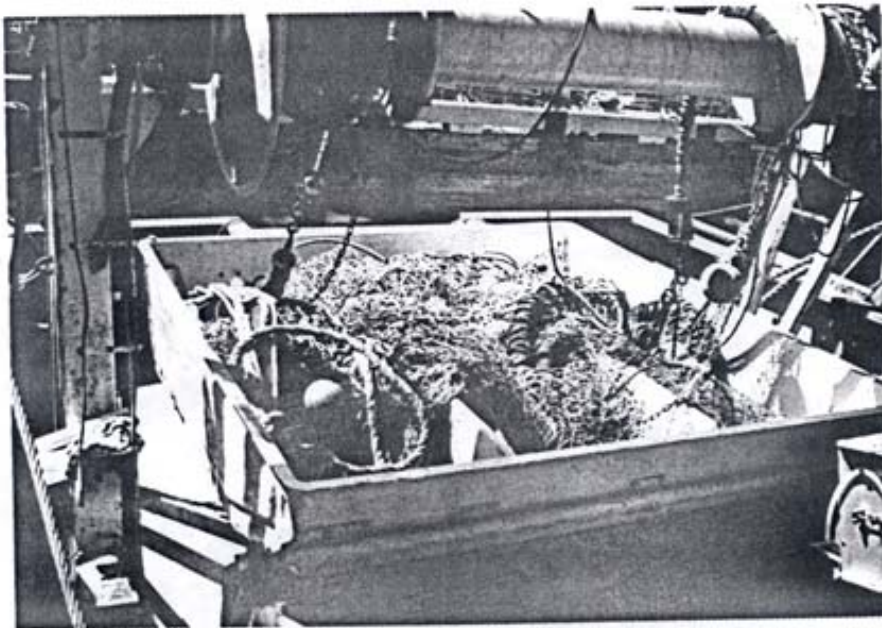
At the time of the occurrence, the "LE BOUT DE LIGNE" had a relatively low freeboard aft of 0.53 m. In adverse weather conditions with following seas, large waves are often shipped over the stern. These waves could then fill the fish box and some water could be retained on deck. The effectiveness of the holes in draining sea water, as reduced by ice and the net, is suspect, particularly under the icing conditions which prevailed at the time of the disappearance of the "LE BOUT DE LIGNE". The fish box, when completely filled with water, would weigh over five tonnes (allowing for permeability). This, in conjunction with the weight and free surface effect of the water retained within the shelter on deck, could substantially raise the vessel's (virtual) centre of gravity, thereby reducing her stability.

**VIEW OF ALUMINIUM FISH BOX ON AFTER DECK.**

In February 1991, a TSB Marine Safety Advisory was forwarded to the Canadian Coast Guard (CCG) concerning the potential hazard associated with fish boxes carried on the decks of fishing vessels. Subsequently, the CCG Laurentian Region instructed its surveyors to pay special attention to these boxes and to restrict their numbers and dimensions on the decks of fishing vessels. Further, at an annual meeting of fishermen, the CCG explained the need for the evaluation of the fish box installations by ship surveyors given the danger that these boxes presented with respect to ship stability, as a result of freezing, inadequate drainage holes and their location.
