Transportation Safety Board
of Canada

MARINE OCCURRENCE REPORT

**OF THE FISHING VESSEL "NADINE"
GULF OF ST. LAWRENCE
16 DECEMBER 1990**

REPORT NUMBER M90L3034

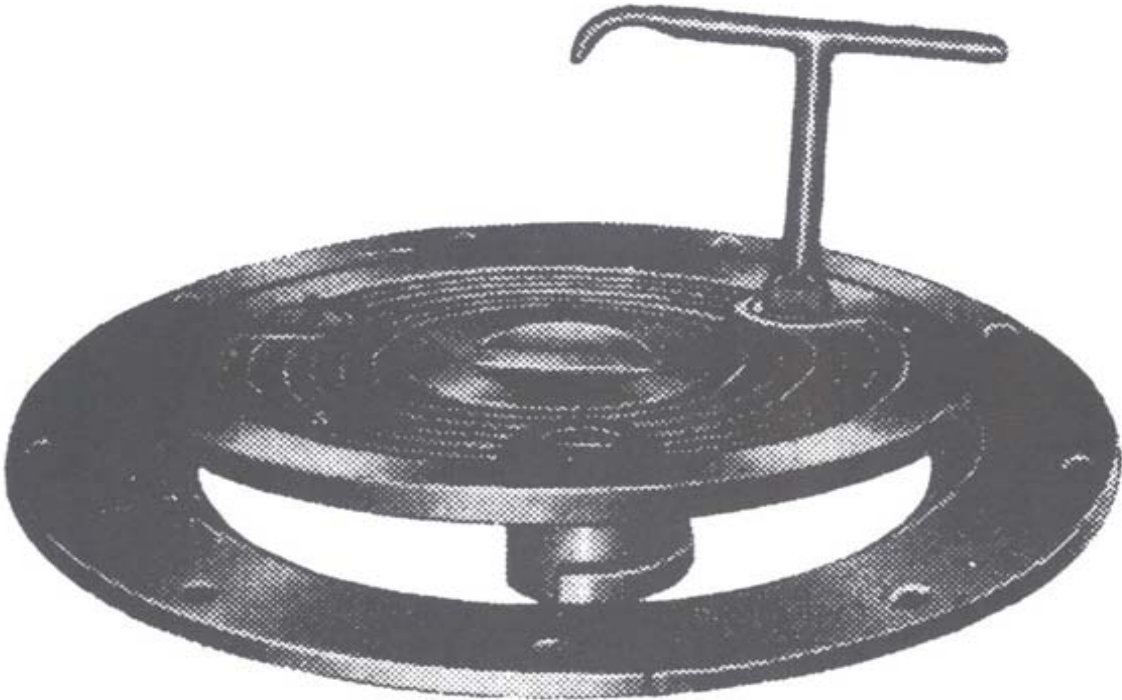
Appendix L - Photograph of a Manhole Cover and its Dogging Clip

In the interest of safety, the Large Fishing Vessel Inspection Regulations state that the covers should be secured or attached by a permanent chain. The TSB found only one piece of chain on the underside of a single cover.

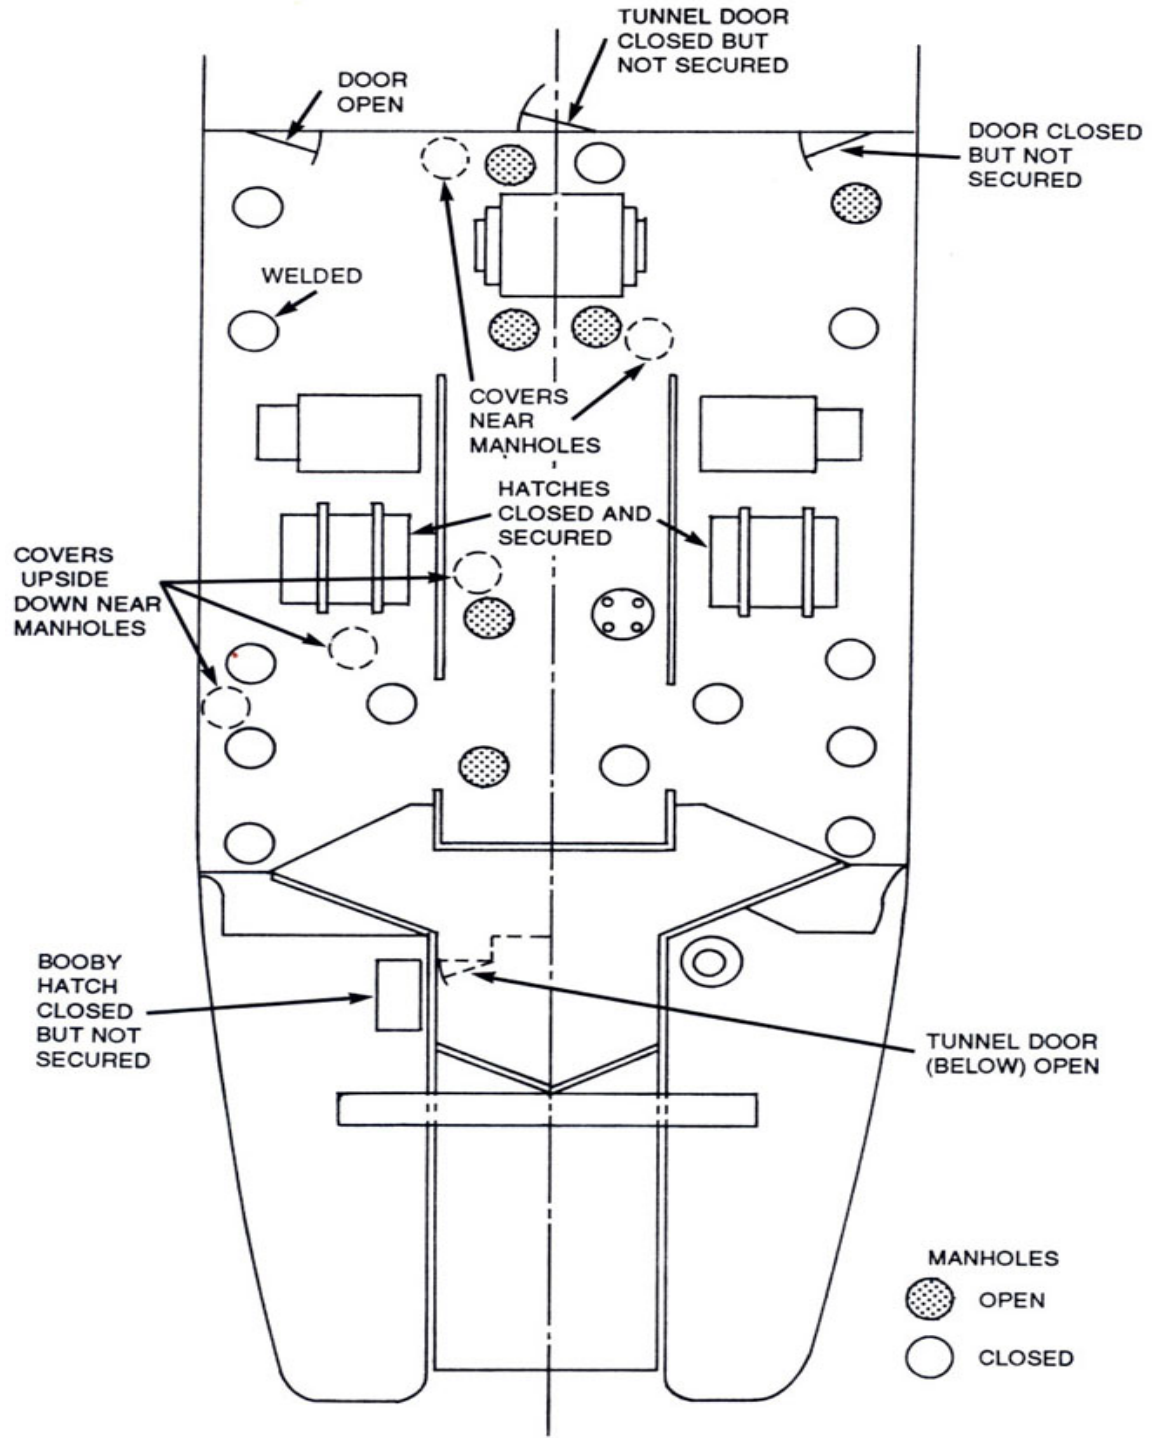
Appendix M - Diagram of Manholes, Hatches and Doorways as Found After the Sinking

- approximately 10 m of netting was unrolled from the trawl drum;
- fourteen manholes were secured (see Appendix M);
- there was no sign of damage to the manhole covers that were in place;

- there was no sign of damage to the dislodged covers;
- no damage was evident to the rims of either the open or the closed manholes;
- the lazaret scuttle cover was closed but not secured, the after hinge was broken,

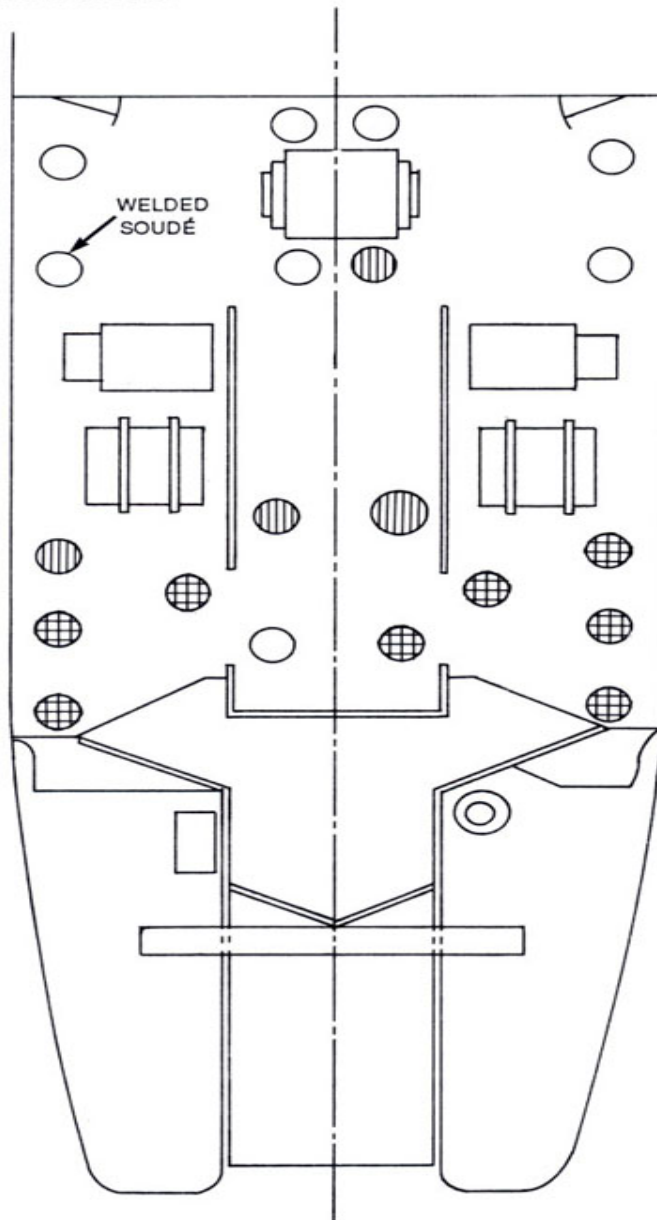
Appendix N - Condition of Manholes and Covers After the Refloating

- SILICONE APPLIED
SILICONE APPLIQUÉ
- ▨ TRACES OF SILICONE FOUND
TRACES DE SILICONE RETROUVÉES
- NO SILICONE FOUND
AUCUNE TRACE DE SILICONE

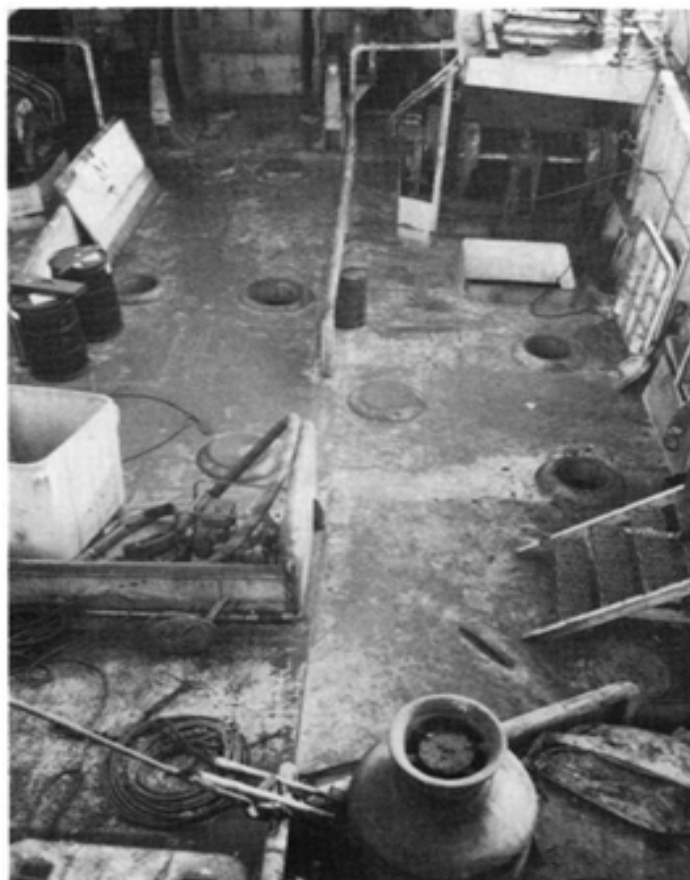
on the afterdeck, induced by the vessel's pitching, rolling and listing, would have started the trawl moving also and caused the unsecured manhole covers to the fish holds to become dislodged from their rims.

Main deck looking forward towards port bow. Note open manholes and door to port of winch drum.

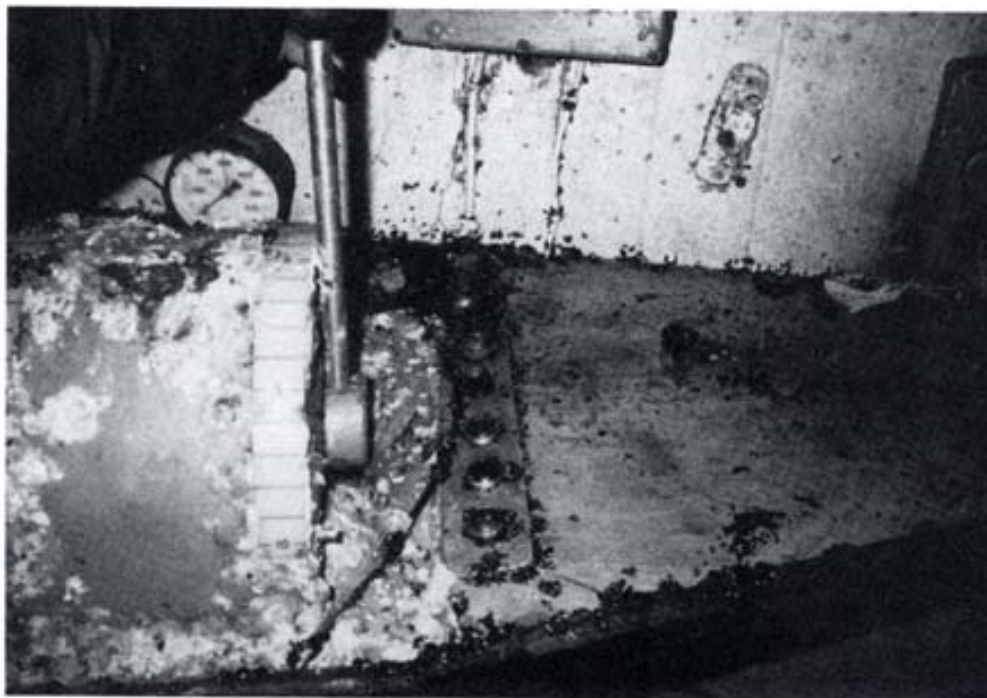
Push-buttons to the right of bridge control. Note absence of labels.

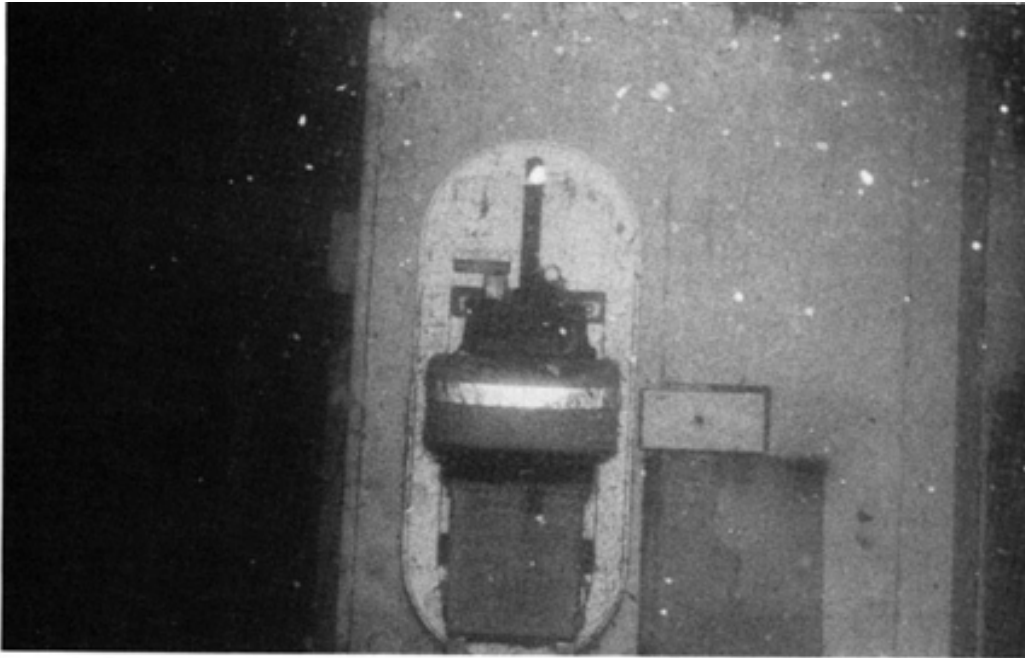
In January 1991, the Quality Assurance Directorate of the Department of National Defence tested the Class I EPIRB and found it to be fully operational. In October 1991, the two Class II EPIRBs were inspected. One was not watertight and was not in working order. The other had operational electrical circuits but failed the short-term frequency stability test.

Class II EPIRB, located in the wheel-house, photographed underwater.

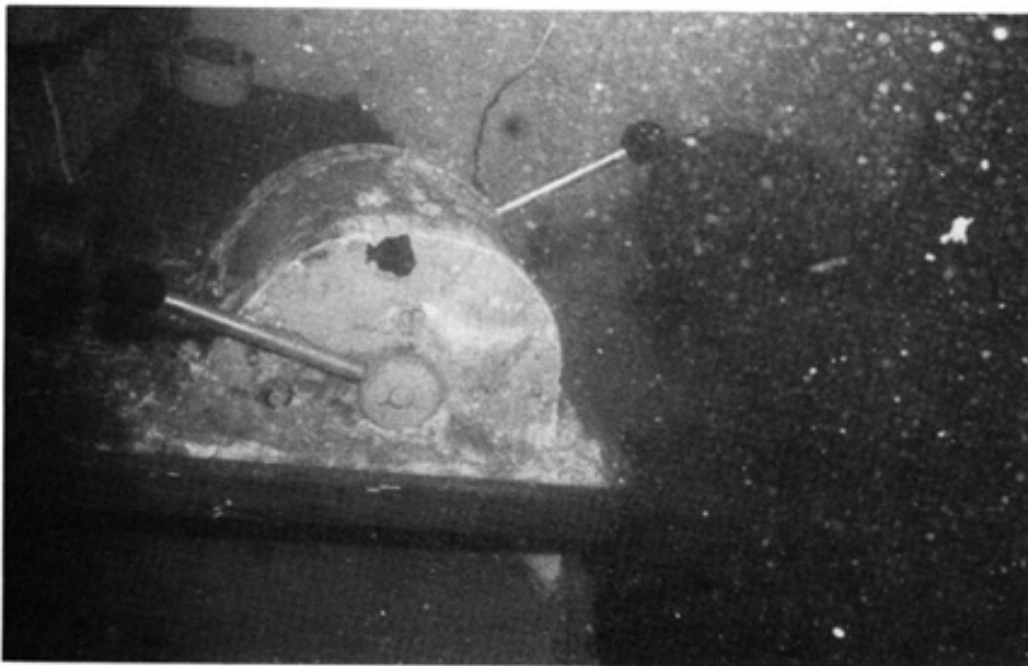
On 10 November 1991, divers from the Quebec Police Force (SQ) inspected the hull and found that there was no major damage except for a crack in the shell plating in way of the after port ballast tank. They found that the propeller pitch control was set to astern.

Starboard wheel-house engine and propeller pitch controls photographed underwater before refloating.

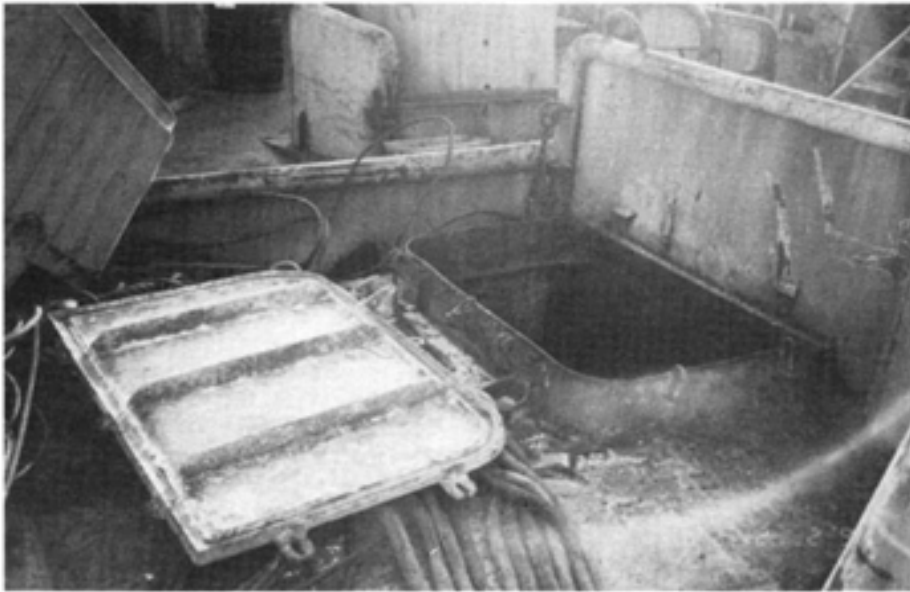
The reported increase in stern trim must have resulted from flooding of the vessel's after compartments. A leak in the stuffing box may have contributed to the flooding, but the lazaret compartment would have flooded through the scuttle in any event since underwater inspections revealed that the lazaret scuttle cover wedges were not in place, and that the cover was therefore not secure. One of the hinges of the cover was damaged, probably as a result of battering by the waves which were constantly washing over the deck while the cover was not secure. The motion of the water

Lazaret scuttle cover.

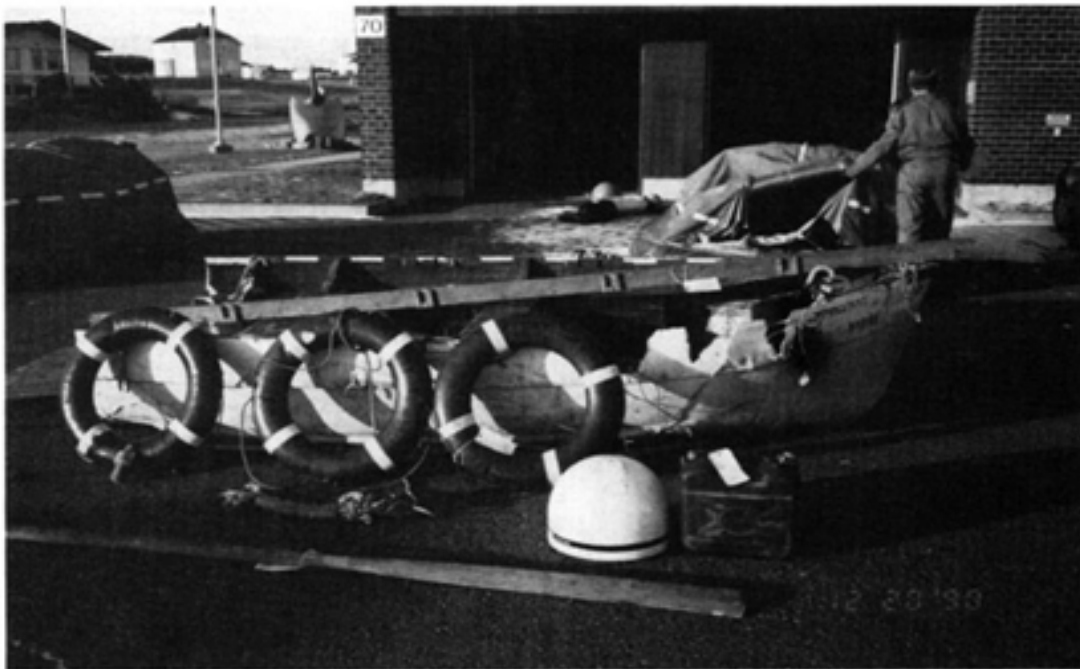
At 0610, the first search objective, the lifeboat, was located by the Aurora aircraft with the assistance of the "SUZANNE P". This was the forward portion of the boat, which had broken in two, and no survivors were found with it.

Recovered lifesaving equipment includes 2 liferafts, 3 lifebuoys and forward section of lifeboat.

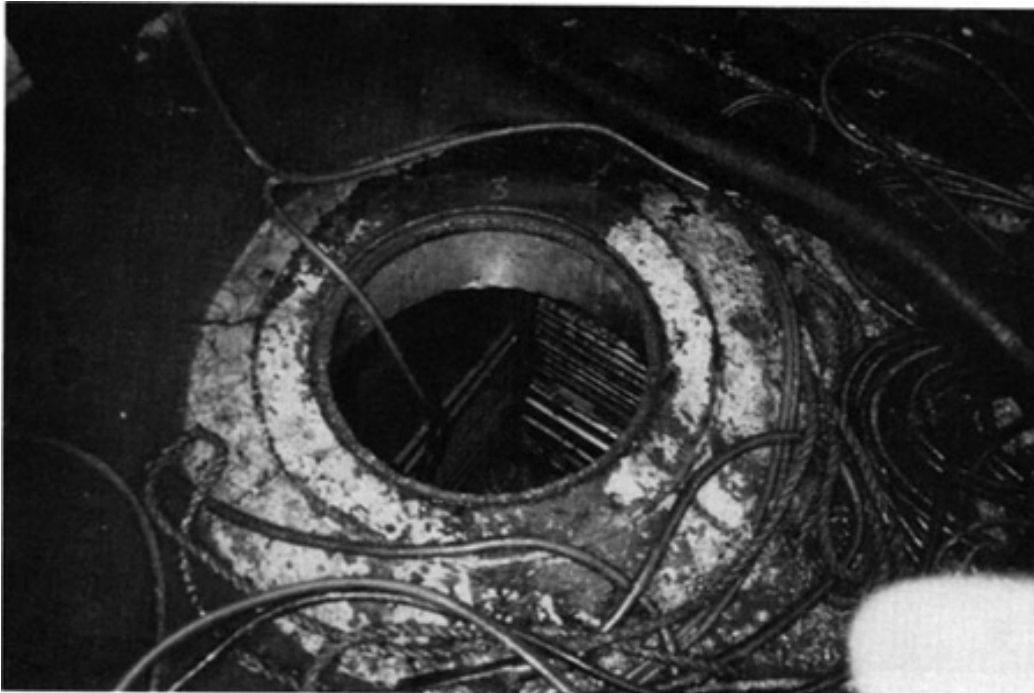
Typical manholes with raised rims.
