MARINE OCCURRENCE REPORT

**CAPSIZE AND SINKING OF THE
F.V. "STRAITS PRIDE II"
IN POSITION 47°58'N 51°54.8'W
WITH FATALITIES TO THREE
OF THE SIX-PERSON CREW
17 DECEMBER 1990**

REPORT NUMBER M90N5017

16 December 1992

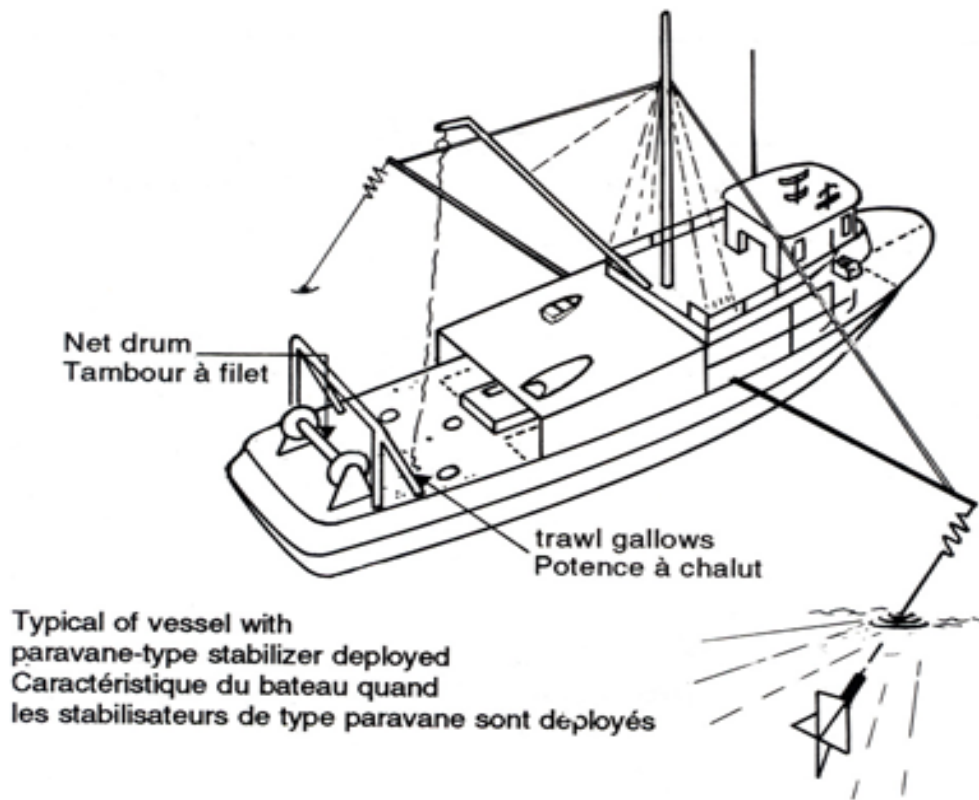
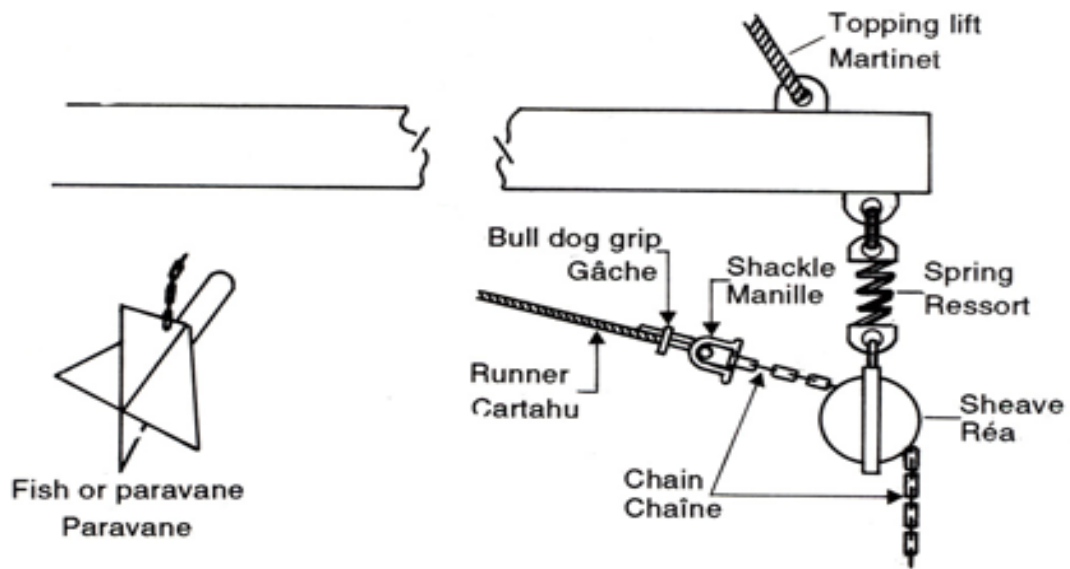
Appendix B - Typical Paravane-type Stabilizer Layout

The "STRAITS PRIDE II" had been equipped in 1984 with outrigger stabilizer booms which were owner-designed and fitted. Normally, as in this instance, the design is copied from those fitted on other vessels which are known to perform satisfactorily. However, aboard the "STRAITS PRIDE II", the booms were hinged at the bulwark rail instead of the mast to give a better damping effect to the vessel. Each boom was constructed of 1.27-cm-thick welded steel plate 10.06 m in length and 10.16 cm square in total length. The inboard end was hinged to the bulwark rail about mid-length of the vessel. The outboard end was fitted with a spring absorber to which a sheave block was attached. A 1.58-cm topping lift wire was secured to the outboard end of the boom and rove through a sheave at the mast head, down the mast to a "Pullmaster" winch that permitted raising and lowering of the stabilizer boom. Another 1.58-cm wire extended from another winch on deck and was shackled to an 18-m length of 1.58-cm chain which ran through the sheave at the end of the spring absorber. Shackled to the end of the chain was a paravane constructed of two 1.27-cm-thick steel plates welded one to the other; one in the vertical plane (rudder) and one in the horizontal plane. Each plate was triangular in shape 0.9 m on a side with their vertical and horizontal apex to a point. A 0.30-m length of

7.62-cm-diameter steel pipe filled with lead was welded to the apex to form a nose piece.

The total weight of the paravane was approximately 70 kg. The paravane was suspended from the end of the stabilizer booms to a depth of approximately 10 m. (See Appendix B.)

The port paravane of the "STRAITS PRIDE II" was lost when the chain from which the paravane was suspended parted under stress for unknown reasons; the chain is of a common type fitted in a number of applications. This caused the vessel to heel to starboard and, as no quick-release mechanism was fitted and the weather was very adverse, the starboard paravane could not be jettisoned to offset the list and eliminate the danger from the downward force now acting on only one side.

At present, there are no regulatory requirements governing either the construction or fitting of such devices nor their inspection. Indeed, very little is known about their operation, efficiency, design, etc. because their design is very much a word-of-mouth affair passed from one fisherman to another. A diagram of a vessel so equipped is attached in Appendix B.

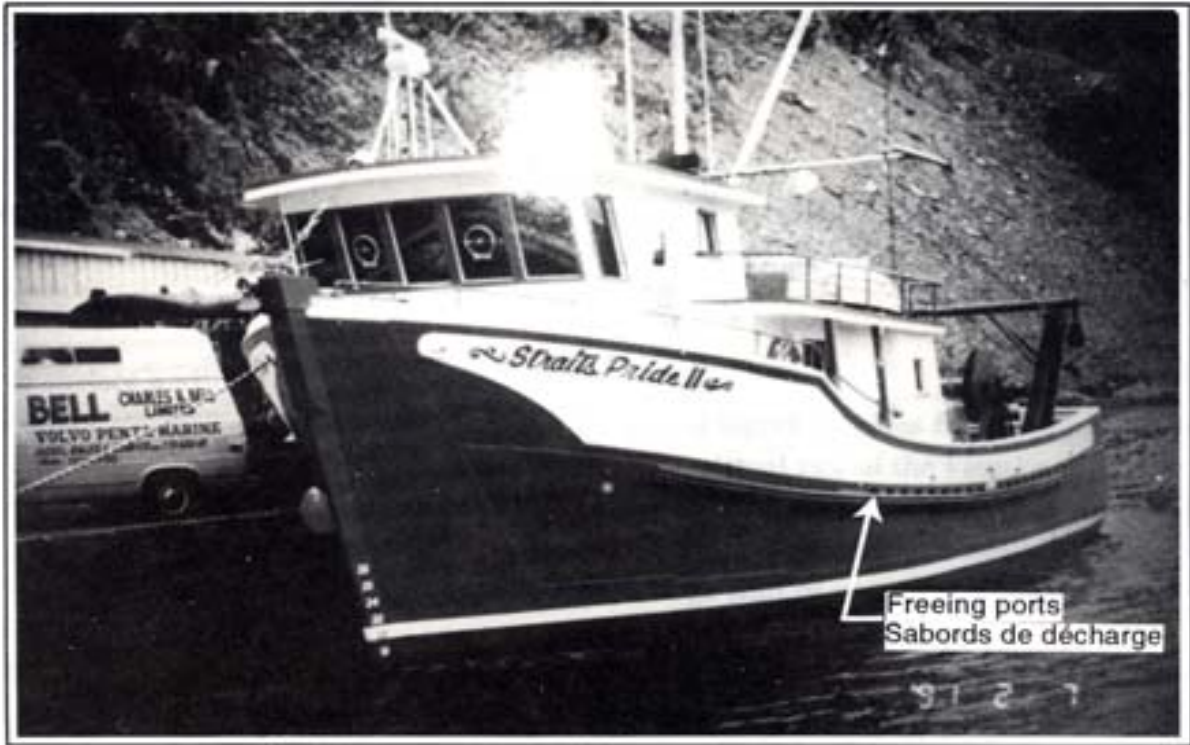
*Appendix D - Photograph - "STRAITS PRIDE II"
- Typical Deck and Penboard Arrangement in
Way of the Fish Hold*

Although not required by regulations, but consistent with good seamanship practice, the fish hold aboard the "STRAITS PRIDE II" was divided into 12 pens with portable longitudinal and transverse divisions to prevent movement of fish carried in bulk.

penboards, and the resultant transverse shift of weight in heavy seas would have had a detrimental effect on the vessel's transverse stability. This situation would have been further complicated when water found its way in with the (fish) cargo.

The Department of Transport, in collaboration with the fishing industry, implement a safety program to educate fishermen and fishing vessel operators about the potential dangers of shifting cargo due to improper penning.
