National Défense
Defence nationale

1016-22-1 (DFS 3-4)
4 July 2008

Annual Report on Flight Safety

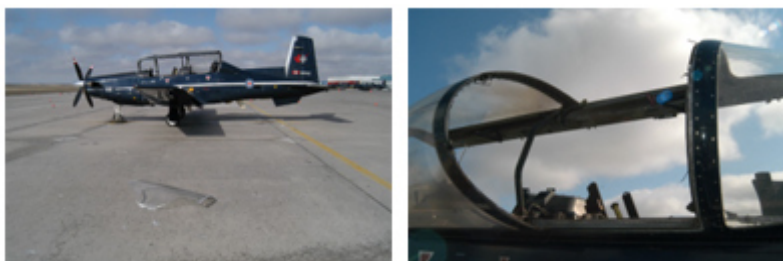
1.2.2.1 4 Apr 07, CT156112 Harvard II, Incident, Cat 'D', Moose Jaw, SK, Case ID # 130570

The incident involved a CT-156 Harvard II training aircraft, crewed by an instructor pilot in the rear seat and a student pilot in the front seat. After the engine was started, as the crew was completing the pre-taxi checks and was about to request taxi clearance, the student pilot inadvertently ejected from the parked aircraft. The student pilot landed at the edge of the parking ramp, under a fully deployed parachute. He sustained minor injuries from the detonation of the canopy fracturing system and the subsequent parachute landing on the concrete ramp. The instructor pilot, who remained in the aircraft, sustained minor injuries from the detonation of the front canopy and the fireball produced by the front underseat rocket motor.

The investigation has not found any pertinent technical deficiencies with the ejection system and has focussed on what actions the student pilot may have taken, which accidentally initiated the ejection sequence. Immediate preventive measures taken as a result of this incident include briefing all pilots on the requirement to meticulously adhere to the proper strap-in procedure. The investigation into the incident is on-going, however there are indications that a communications cord may have been routed through the student pilot's ejection seat handle during the strap-in process.

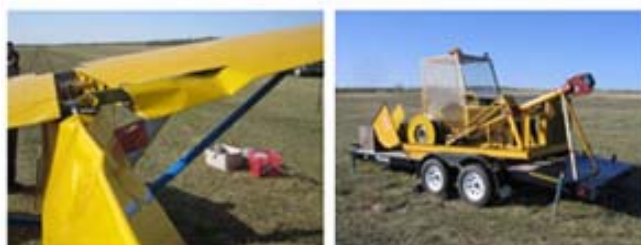
1.2.2.2 5 May 07, C-GCLJ Schweizer, Accident, Cat 'B', North Battleford, SK, Case ID # 130843

The glider was participating in the Spring Season familiarisation flying at the North Battleford Gliding Centre in North Battleford, SK. The glider was launched, but at approximately 150 feet above ground level (AGL) the winch operator observed a partially failed splice in the cable and cut power to the winch. The pilot hesitated prior to initiating the recovery procedure causing the glider to stall. The glider contacted the ground in a severe, nose-down, attitude 452 feet from the launch point.

The investigation is focusing on human factors, training issues and regulatory discrepancies. The accident is under investigation.

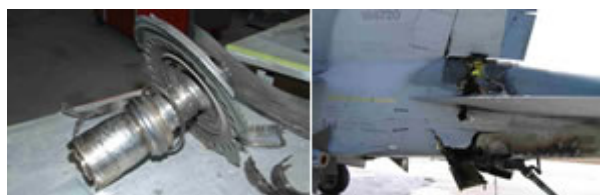
1.2.2.4 16 May 07, CF188720 Hornet, Accident, Cat 'B', Bagotville, QC,
Case ID # 130948

A formation of two CF-18s was carrying out some pre-briefed air-to-ground training in the Bagotville training area during a return flight from 14 Wing, Greenwood, after participating in a monthly armament training session for technicians. After 20 minutes of air-to-ground training the wingman advised the lead that he was experiencing an "engine left" warning. An engine fire, confirmed by the lead, followed this indication. The wingman secured the left engine in accordance with the checklist. Damage sustained by the aircraft caused flight control problems and led to operation in MECH mode.

The focus of the ongoing investigation is to conduct detailed laboratory analysis of the engine and its components to determine the cause of the catastrophic failure. Also, ground searches are underway to locate the missing fragments of the low-pressure turbine disk. The accident is under investigation.

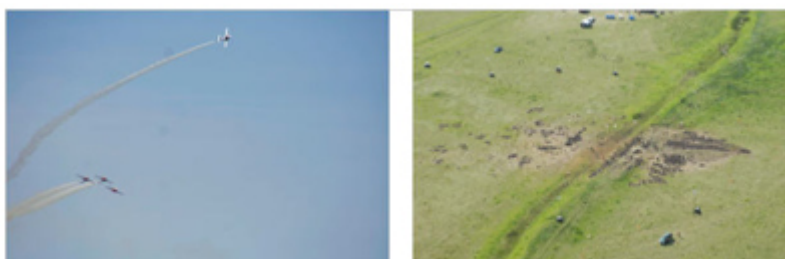
1.2.2.5 18 May 07, CT114159 Tutor, Accident, Cat 'A', Malmstrom AFB, Montana,
Case ID # 130974

On Friday, 18 May 2007, the Snowbirds had completed a transit from Moose Jaw, Saskatchewan to Great Falls, Montana. At approximately 22 minutes into the show, as Snowbird 2 was rolling inverted for the Inverted Photo Pass, the aircraft was seen to dip low, waver, and then depart the formation. Still inverted, the aircraft climbed, then subsequently rolled upright. Upon reaching a nearly wings level attitude, at approximately 750 feet above ground level, the aircraft nosed over. The aircraft impacted the ground approximately 45 degrees nose down. The pilot did not eject and was killed on impact.

Initial analysis has determined that the pilot's lapbelt became unfastened when Snowbird 2 rolled inverted, causing the pilot to fall out of his seat and lose control of the aircraft. The investigation is focussing on how the lap belt became unfastened. Preventive measures taken to date include modifications to the pilot restraint system, as well as enhanced training for aircrew and passengers. New procedures as well as changes to the Aircraft Operating Instructions have been implemented to reduce the likelihood of a recurrence. The accident is under investigation.

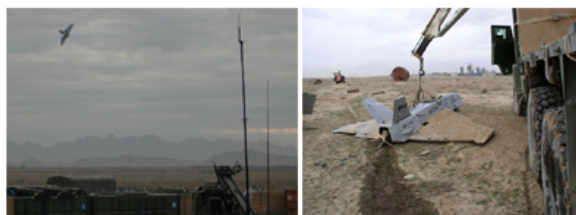
1.2.2.7 24 Jan 07, CU161014 Sperwer, Accident, Cat 'A', Kandahar, Afghanistan,
Case ID # 129933

Immediately following launch, the AV entered an un-commanded steep left turn, descended and crashed approximately 250 metres from the launcher. There were no injuries and the AV was destroyed.

A series of human factors contributed to this occurrence. The crew was using a modified and unapproved checklist, condoned by supervisory personnel, in order to cope with perceived time pressures. Additionally, at the precise moment when the Hybrid Navigation System (HNS) was to be selected to alignment, the MC was distracted by a radio call. The MC was not directly referencing the checklist; rather, the checklist was being actioned by memory and the step was consequently missed. Additionally, a red thematic page warning that showed the HNS was still in standby mode, was available to the crew; however, neither the AVO nor MC checked it prior to launch as this check was not an explicit checklist requirement.

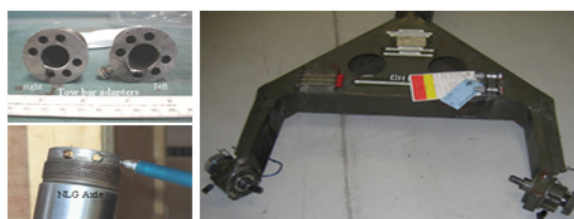
1.2.2.11 7 May 07, CH149910 Cormorant, Accident, Cat 'C', Gander, NL,
Case ID # 130855

On 07 May 2007, the CH-149 was being towed onto the ramp when, after a turn was initiated, the tow crew heard a loud bang followed by a hissing sound. The towing evolution was stopped and the tow crew found the tow bar entirely disconnected from the aircraft.

The investigation revealed that the safety feature of the tow bar did not preclude damage to the landing gear. A review of the technical publications revealed that there are no torque specifications for the tow bar safety bolt and shear bolts. The analysis of the occurrence suggests that the torque of the safety bolt, in all probability, delayed the shearing of the shear bolts.

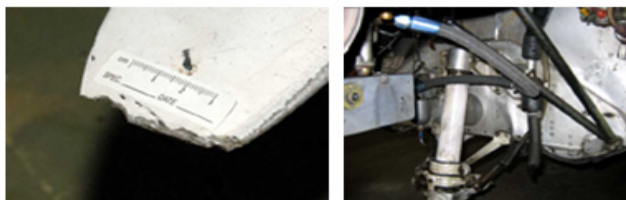
1.2.2.14 13 Jul 07, C-GFVE Cessna 172M, Accident, Cat 'C', Waterville, NS,
Case ID # 131463

A solo student on an Air Cadet Power Flying Scholarship had a hard landing while flying a non-CF aircraft, Cessna 172 C-GFVE. The aircraft had bounced hard on the runway several times and on one of the bounces the prop contacted the runway. Overshoot was ordered and the solo pilot landed the aircraft without further incident.

With no other evidence available to explain the student performance, the occurrence is attributed to poor technique, compounded by inexperience – a recognized risk inherent in ab-initio pilot training.

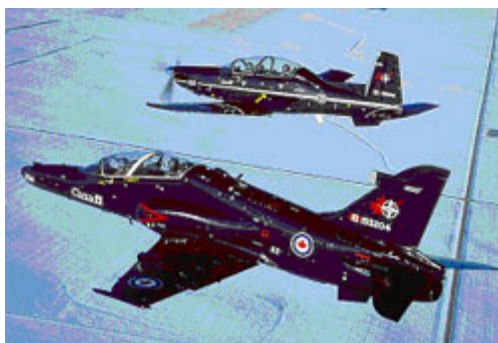
1.2.2.18 19 Oct 07, CT156115 Hawk/Harvard II, Incident, Cat 'E', Moose Jaw, SK,
Case ID # 132518

A Harvard II and a Hawk narrowly avoided a collision while flying in the Moose Jaw Flying Area (MFA). The weather was clear with blue sky against dark ground. The Harvard dual aircraft was in straight and level flight when the instructor pilot (IP) saw a “sudden dark flash” at his 8:30 position. The Hawk solo pilot had just engaged in a rapid descent via a “barrel down” manoeuvre and was in a 20-degree nose down attitude at 320 KIAS. As he rolled back in the upright position he saw the Harvard aircraft going from left to right for a split second. Separation was estimated to be 100-200 feet.

Despite efforts on education and awareness briefs, near miss occurrences have been increasing in Moose Jaw. Shortly after this incident, 2 CFFTS published an Aircrew Information File (AIF) to help manage congested areas, limiting the maximum number of aircraft in a specific area. The investigation recommended using common frequencies as part of the airspace management AIF, and providing clear guidance regarding airspace safety prior to executing rapid descents. The investigation recommended that TCAS/ACAS I be implemented in both Harvard and Hawk fleets to increase traffic awareness. This measure has proven itself in similar flying training operations in other countries. It was also recommended that the current paint scheme be changed to a two tone (dark and reflective) to optimize aircraft conspicuity.

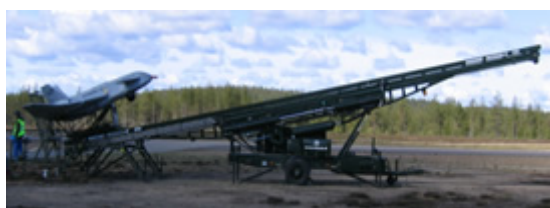
1.2.2.24 6 Dec 07, CU161000 Sperwer Launcher, Accident, Cat 'B', Kandahar, Afghanistan,
Case ID # 133003

At 08:45 local time during post launch activities with a cylinder pressure of 152 bar, both launch cylinder rods came out of their tubes when the trolley was approximately 12 inches from the launch lock. Extensive damage to the launcher and to all major components resulted. Two ground personnel were rushed to the hospital and two others made their way to the MIR.

The design of the launcher is such that hydraulic and pneumatic forces oppose each other in a manner that requires the precise alignment of two pairs of large piston rods. At the time of the occurrence, the alignment was compromised which resulted in an explosive release of pneumatic pressure and the expulsion of numerous components. The investigation concluded that the
