National  
Defence

1016-22-1 (DFS 3)  
24 August 2009

# Annual Report on Flight Safety

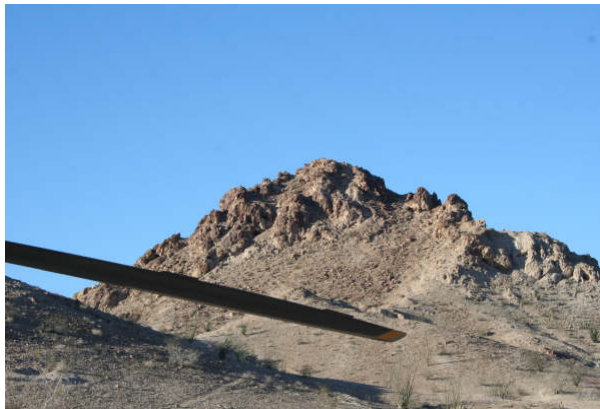
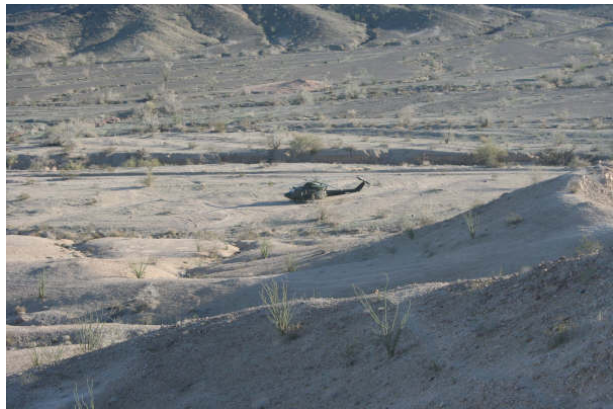
### 1.6.2.1 19 Jan 08, CH146488, Accident, cat 'C', Yuma, Arizona, Case ID # 133269

Griffon CH146488 was tasked to transport five passengers from Marine Corps Air Station Yuma to the Yuma Range. It was decided to land on a narrow ledge with only the right skid resting on the ledge and conduct a right skid only insert. At five feet above the touch down, the helicopter suddenly lost lift and abruptly settled with the right skid on the ledge. The belly of the aircraft was punctured as it rolled left. During the manoeuvre, the Flight Engineer and Mission Specialist were partially thrown out their respective doors, but were prevented from being completely thrown out of the aircraft by their 'monkey tail' harness. The helicopter once again became airborne, but it was necessary to conduct some aggressive manoeuvres in order to avoid terrain that was in front of the helicopter which resulted in over torque. The investigation is focussing on site selection, environmental conditions, and helicopter aerodynamics.

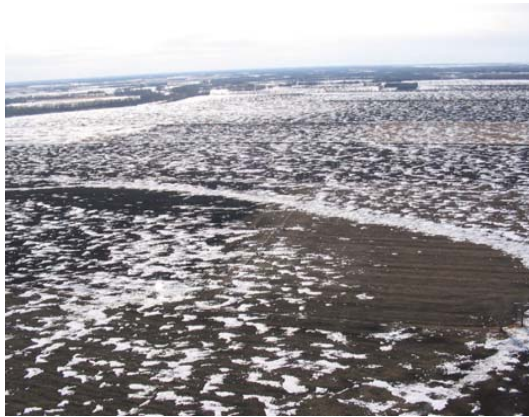
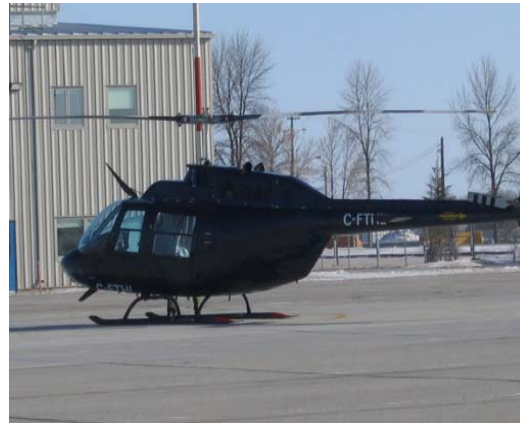
1.6.2.6 19 Mar 08, CH139305/6, Accident, cat 'E', Southport, Manitoba, Case ID # 133821

On 19 Mar 2008, the first Jet Ranger departed Southport airport to conduct student training in 'Area North' of the Southport Flying Area. The helicopter entered the training area and the instructor demonstrated a surprise practice forced landing (PFL) to the student. During the demonstration, the helicopter over-flew a second helicopter that was conducting circuit training in Area North. The second helicopter had just lifted off and was climbing through 300 feet AGL when the first helicopter was observed descending to the right, and within a distance of 30 feet of the second helicopter. As the helicopter doing the practice forced landing commenced an overshoot at 150 feet AGL, they were informed by the second helicopter that a near-miss had occurred.

The investigation determined that due to local radio procedures, helicopters entering Area North are unaware of other helicopters operating in the same area and traffic avoidance relies on the 'see and be seen' principle. At the time of the occurrence the local ground conditions of patchy, melting snow produced a dark and light checkerboard pattern that made the visual identification of helicopters below the horizon very difficult. Radio procedures have been developed to de-conflict aircraft operating in the area.

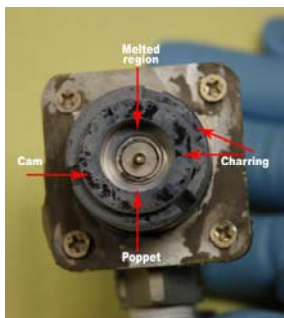
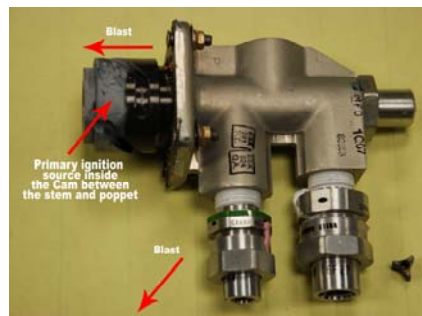
#### 1.6.2.8 02 Apr 08, CC177703, Accident, cat 'C', Long Beach, California, Case ID # 134008

While disconnecting the liquid oxygen servicing hose filler nozzle from the combination valve, an explosion occurred. The technician handling the servicing hose filler nozzle was seriously injured. The aircraft also sustained serious damage.

The investigation revealed that isopropyl alcohol was used during troubleshooting to remove frost from the outside of the liquid oxygen service hose filler nozzle. The evidence shows that a

small quantity of isopropyl alcohol made it to the crew fill and vent combination valve. Isopropyl alcohol is a highly flammable liquid and will ignite or explode when in contact with liquid oxygen if subjected to a mechanical impact or an electrostatic spark. During the multiple attempts to connect, internal parts of the combination valve made contact creating the ignition source for the liquid oxygen and isopropyl alcohol. The explosion instantly destroyed the oxygen service panel and service hose filler nozzle.

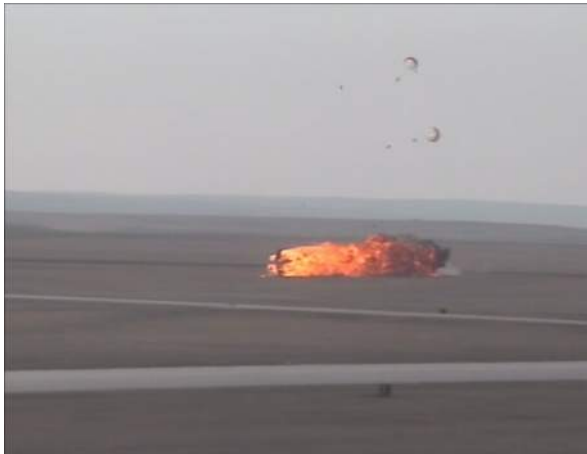
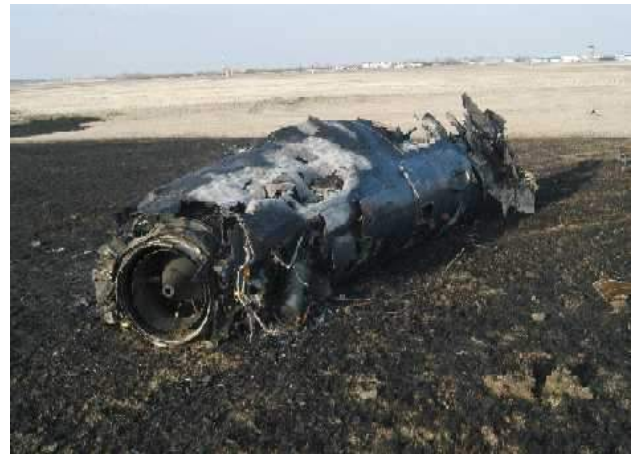
1.6.2.10 18 Apr 08, CT155215, Accident, CAT 'A', Moose Jaw, Saskatchewan, Case ID # 134108

The Hawk training aircraft was climbing through 10,000' above sea level at maximum continuous power when the pilots noticed a change in engine noise, followed shortly afterwards by a T6/NL caution in the rear cockpit, indicative of an engine malfunction.

The qualified instructor took control, zoomed, turned towards the airfield, reduced power to idle and declared a "Mayday". The vibration increased dramatically, followed by a loud bang and the illumination of the oil pressure and generator lights and the loss of the Head-Up display. The instructor realized they were not going to make the runway and commanded ejection. Both pilots successfully ejected at an estimated height of 200 to 300 ft above ground while the aircraft was in a steep descent. Both pilots sustained serious injuries during ejection. The aircraft struck the ground 1.5 seconds after the ejections in a wings level 30 degree nose down attitude and exploded. The investigation is focussing on the engine failure Hawk forced landing procedures and training, and ejection systems issues.

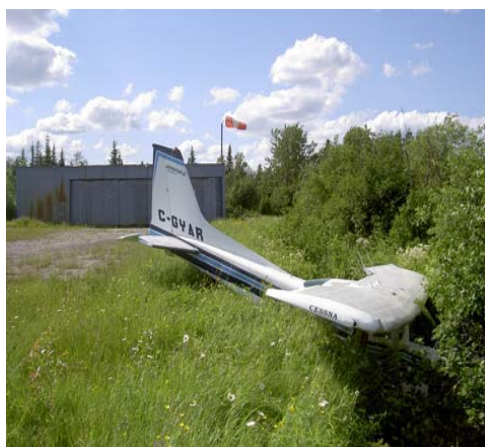
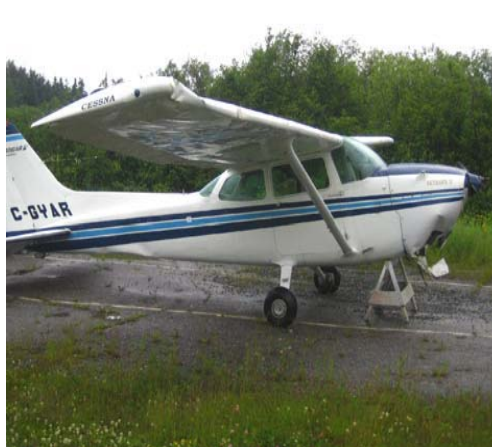
1.6.2.14 02 Jul 08, Cessna C-172, Accident, cat 'B' Lac Etchemin, Québec,  
Case ID # 134911

The accident involved a Cessna C-172 that departed St-Frédéric airport, QC for the purpose of conducting training as part of the Air Cadet Powered Flight Program. This was the Class 4 instructor pilot's first time landing at Lac Etchemin, a 2400-foot gravel runway with a slight upslope on the first half of runway 06. Due to a combination of tailwind, excessive groundspeed and ineffective braking technique, the pilot was unable to stop the aircraft on the runway. The aircraft continued off the end of the runway at approximately 25 knots and came to rest in an 8-foot ditch. The aircraft was extensively damaged and the cadet student pilot received minor injuries.

The investigation revealed three main contributing factors as follows:

- A generalized communication breakdown at the organizational and supervisory levels in that key information was not conveyed clearly to all pilots involved.
- A hasty pre-mission planning and briefing during which risk was not properly assessed, leading to unrealistic expectations on the part of the CFI and expectancy on the part of the IP.
- The decision to accept a tailwind and to continue with the landing even though the touchdown point negated the deceleration benefits of the upslope. As a preventive measure, the Flying School has now issued a written policy that restricts instructor pilots from landing on non-paved runways less than 3000 ft.

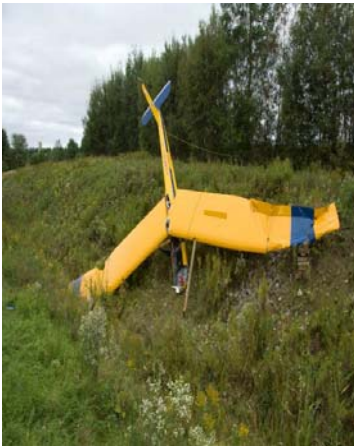
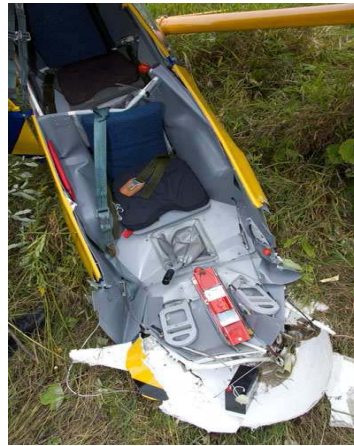
1.6.2.23 6 Sep 08, Glider Schweizer 2-33A, Accident. cat 'A', Lachute, Québec, Case ID # 135687

The accident flight was the second of two flights that formed the 60-day check for the cadet. Between 80 and 130 feet AGL, the cadet heard a metallic "clunk" sound and, thinking that it was the instructor simulating a rope break, initiated the rope break procedure. After the instructor confirmed that the cadet had released the rope, the instructor took control and initiated a low level steep turn in an attempt to return to the departure runway. The right wingtip contacted the ground during the turn and the glider impacted the ground heavily. It came to rest in an almost vertical nose-low position in a drainage ditch that ran parallel to the runway. The cadet sustained serious injuries and the instructor sustained very serious injuries. The glider was damaged beyond economical repair.

The preliminary investigation has indicated that neither the Tow Plane nor the Glider had suffered mechanical problems prior to the rope release and that the rope was in good condition. The investigation is focussing on training practices and human factors.

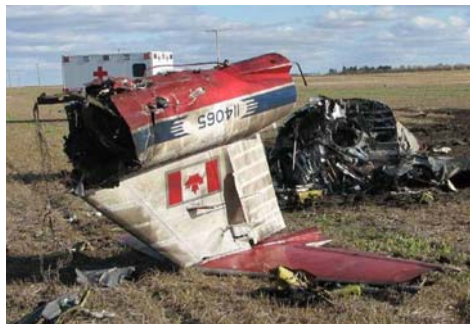
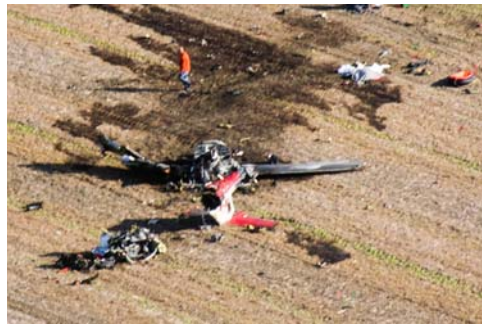
1.6.2.24 9 Oct 08, CT114065, Accident, cat 'A', Moose Jaw, Saskatchewan,  
Case ID # 136094

The accident aircraft was crewed by a pilot in the right seat and a military photographer in the left seat and was part of an authorized four-aircraft dissimilar formation tasked with taking pictures for publicity purposes. The main formation crossed over the Base in "Vic" formation at about 300 feet AGL, then rolled into a 25 degree right bank turn. At this time, the chase aircraft was flying just behind the 3 o'clock line and high above the formation to take a picture of the formation as they passed the tower. The chase aircraft was observed to descend, roll with the formation and fly a slightly convergent path with the formation. It continued in this steady descending turn until it impacted the ground on a heading of 297 degrees magnetic in the approximate 4 o'clock position below the plane of the main formation. Both occupants were killed immediately and the aircraft was destroyed.

The focus of the investigation is on the requisite training and knowledge required for pilots tasked for photo-chase missions. In addition, the investigation is examining the available guidance and direction available with respect to photo-chase missions, and in particular, low altitude photo-chase missions. To date, the investigation has not found any indication of a pre-
