Transport
Canada

Issue 4/2011

Feedback

Canadian Aviation Service Difficulty Reports

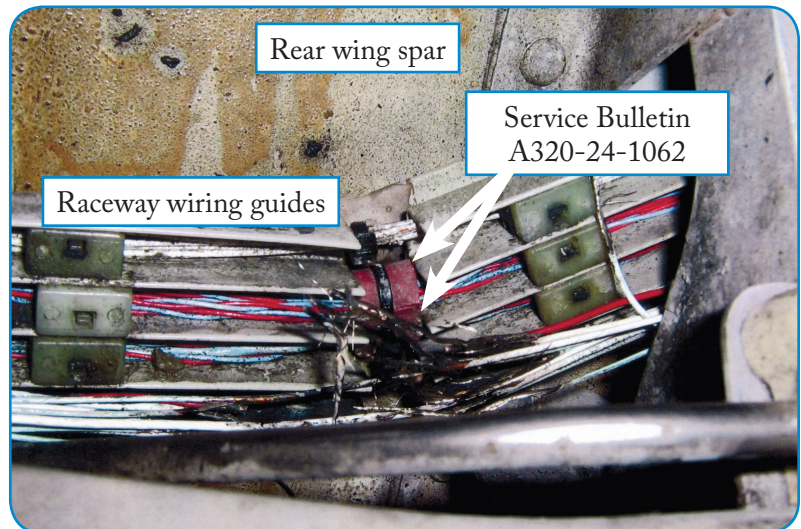
The aeroplane arrived with a no-go snag for a left wing tip brake solenoid fault. While maintenance was troubleshooting this defect, it was discovered that several wires were chaffed and burnt on the left wing aft spar raceway just outboard of the #1 engine pylon area.

Other systems affected due to the wiring fault included the #1 engine low pressure fuel valve and the left-hand nav/strobe light.

The wiring was repaired and the aeroplane was made serviceable.

European Aviation Safety Agency (EASA) Airworthiness Directive (AD) 2008-0051R1 mandated the incorporation of Airbus Service Bulletin (SB) A320-24-1062 which installed insulation for the "S" or inner harness runs.

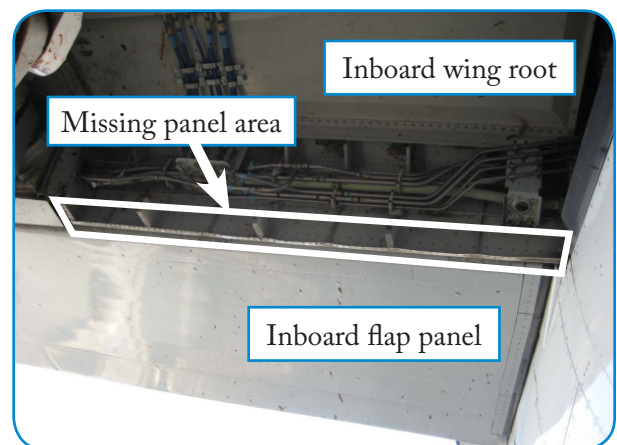
Wing Panel Missing

During a maintenance walk-around, it was discovered that a riveted panel, forward of inboard flap on right wing, was missing.

The aeroplane was repaired as per the Structural Repair Manual (SRM). A new wing panel was installed and the aeroplane was made serviceable.

European Aviation Safety Agency Airworthiness Directive 2006-0107 was issued which mandated the one-time inspection of the supporting fasteners and surrounding structure of this discrepant wing panel. Following this and due to the occurrence of more events of this nature, European Aviation Safety Agency Airworthiness Directive 2008-0002 was issued mandating the incorporation of Service Bulletin A330-57-3100, which replaces the existing blind rivets with bolted fasteners.

Transport Canada Civil Aviation (TCCA) would like to advise all A330-200/300 and also applicable 340-300 operators of this possible scenario and available documentation. The accomplishment of the latest Service Bulletin is recommended to be done at the soonest possible opportunity. ✖

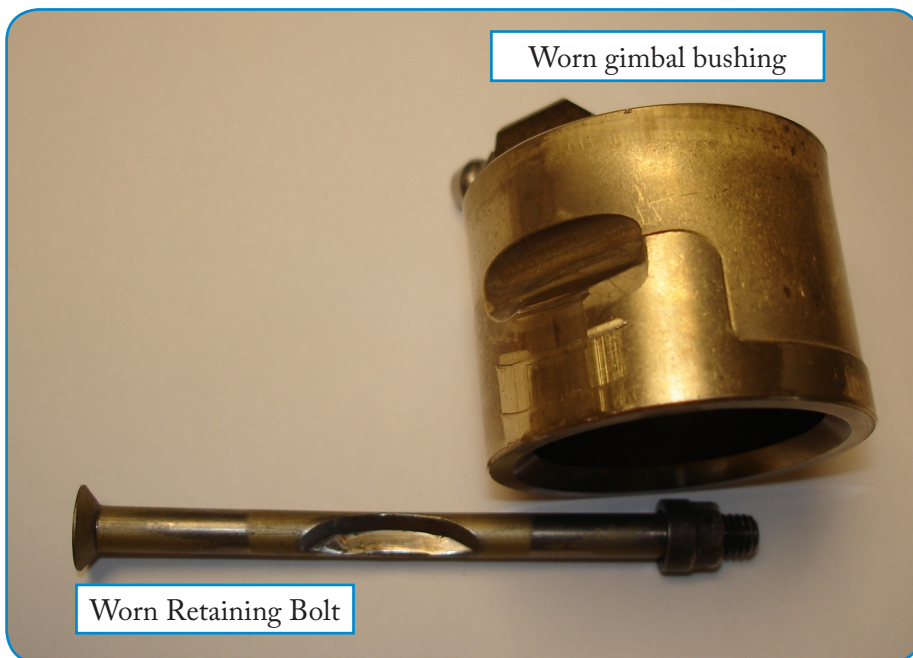
Flap Gimbal Bushing Excessive Wear

During a scheduled performance of Boeing task cards 27-144-00-01/02 to lubricate the left and right inboard flap outboard ballscrew and gimbals, it was found that the lower gimbal bushing assembly on both the left and the right inboard flaps had migrated out from their respective gimbal seats.

The results of these migrated bushings were excessively worn attachment bolts, which are used to retain the bushings within the gimbal.

The photo to the right shows the abnormal wear of a retaining bolt and gimbal bushing. Both gimbal bushing assemblies and retaining bolts were replaced and the aeroplane was released back to service.

Boeing Fleet Team Digest (FTD) 737NG-FTD-27-03006 defines in detail this possible scenario which is rooted to the application of excessive high grease-gun pressures that can apply undue pressure on the gimbal bushing, forcing it to migrate out and wear into its retaining bolt.

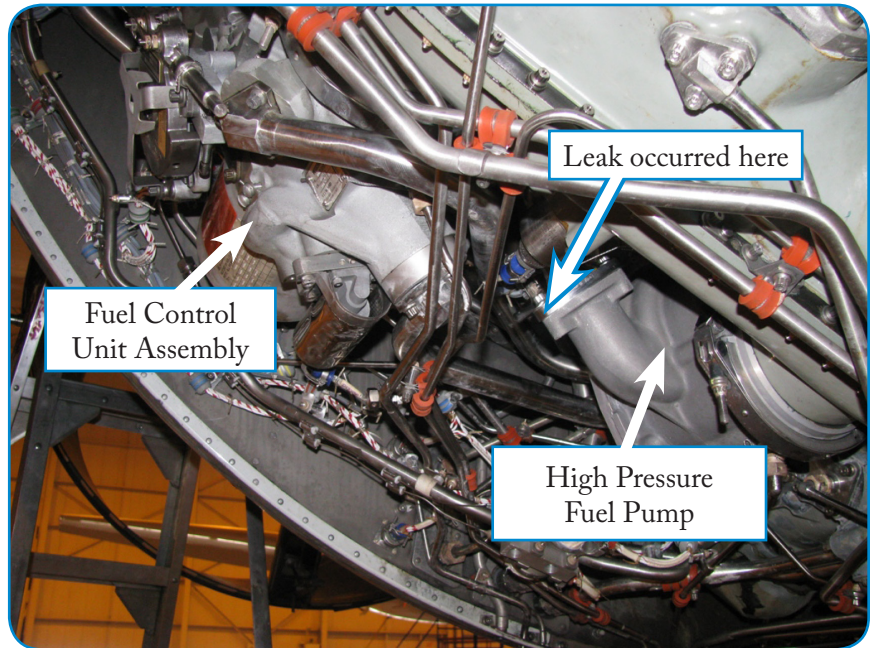
Engine Fuel Leak and Imbalance

During cruise, the aeroplane experienced a large fuel imbalance due to a fuel leak at the right hand engine. The aeroplane declared an emergency and diverted where upon arrival the right hand tank fuel quantity was 1500 kilogram (kg) less than the left hand tank.

Maintenance personnel found an o-ring that was leaking at the right engine high-pressure fuel pump feed line. The o-ring was replaced and the aeroplane was returned to service.

Six flight legs previous to this event, the right engine high-pressure fuel pump had been replaced where new o-rings were used and leak checks carried out.

The reason behind the failure of the o-ring has not been determined but is suspected that possible damage or improper installation of the new o-ring was incurred during the pumps replacement.

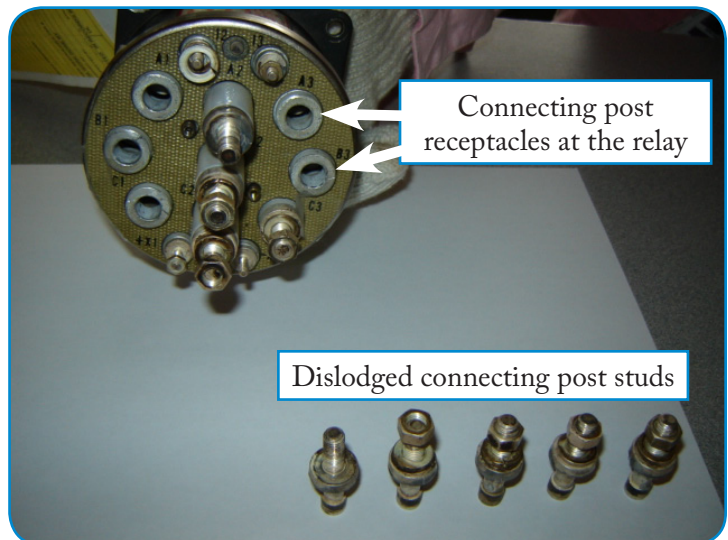
Relay Failure

During flight, several system failure messages were posted where maintenance troubleshooted the fault to a failing relay.

It was noted that several of the connecting post studs were loose within the relay body receptacles, breaking the posts electrical continuity capability.

The relay was replaced and the aeroplane was made serviceable.

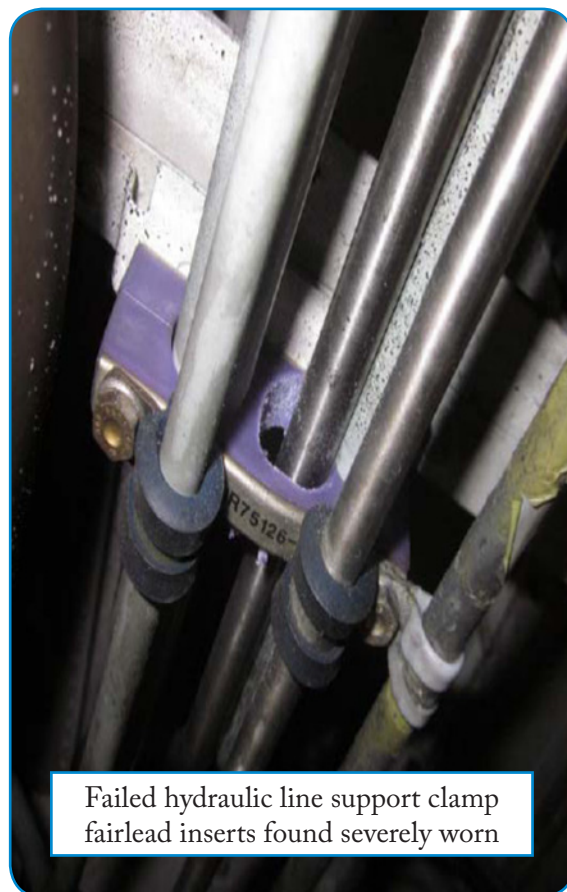
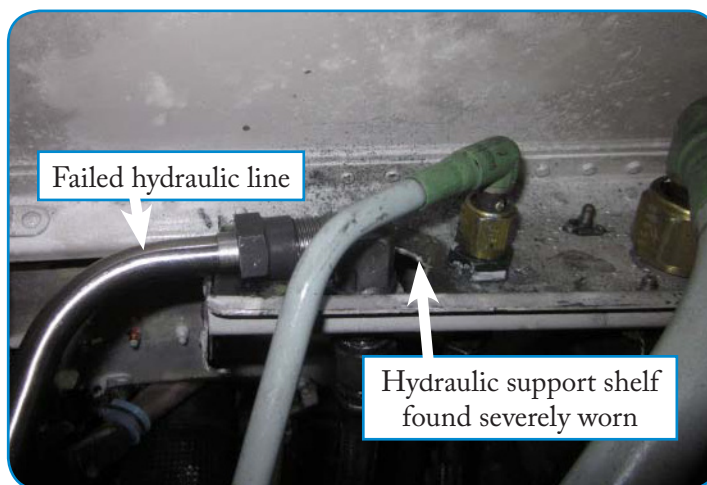
Insufficient Hydraulic Line Support

Upon maintenance investigation, it was found that the #1 hydraulic pressure line in the aft equipment bay was chaffed through, causing the complete loss of the fluid. The chaffing was a result of the hydraulic line jam-nuts at the top of the hydraulic support shelf coming loose, allowing significant movement and vibration.

The hydraulic support shelf was severely worn along with several support bracket fairleads downstream the line.

This scenario demonstrates that the worn fairlead inserts were an indicator of a more significant failure else-where in the system.

The hydraulic support shelf was repaired, the hydraulic line and fairlead inserts for the support brackets were replaced and the aircraft was made serviceable.

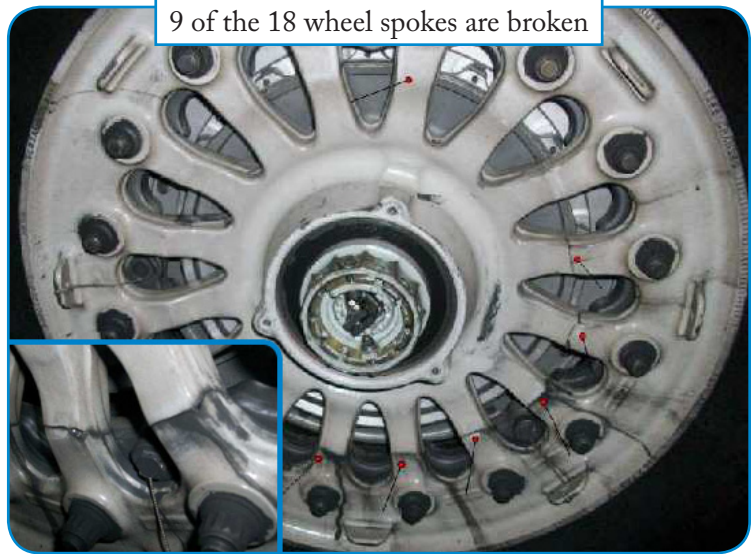
Main Landing Gear Wheel Rim Cracks

During a standard service check it was found that several rim spokes of the main landing gear wheel number 2 (left-hand inboard) were found cracked.

The wheel assembly was replaced as per the aircraft maintenance manual and the aeroplane was made serviceable.

The close visual inspection of all wheel assembly landing gear items is an essential task to accomplish for all pre-departure walk-around and service checks. ✖

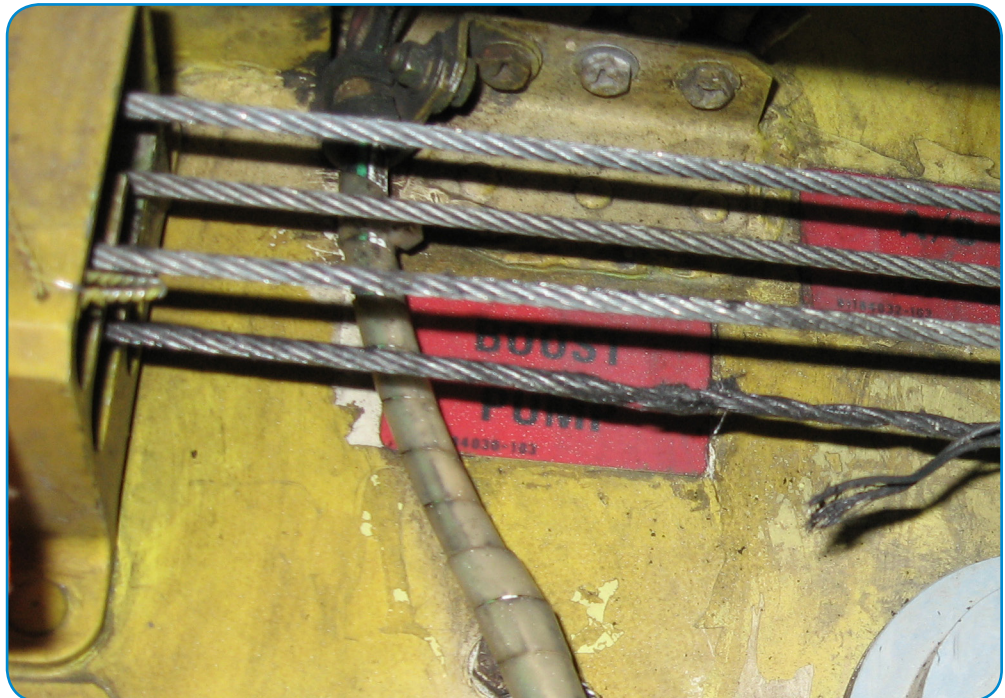
Frayed Aileron Cable

During inspection, the right-hand aileron cable was found to be significantly frayed and beginning to unravel. The area of the failing cable (Wing Station (WS) 181) is located in a cable block on the aft spar where aluminum guide rollers part number FL4C6-2. This particular area of the cable is almost impossible to see when the gust lock is engaged and/or the aileron is in a neutral position because of the cable block.

The SDR database reveals several previous reports of this nature in this general area.

A reminder for personnel that during flight control cable inspection that the entire cable run must be inspected to detect these types of failures. ✖

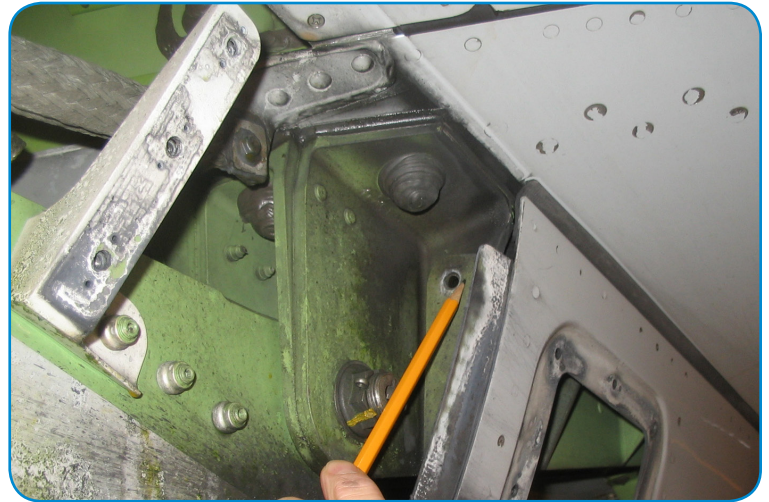
Pylon Fairing Missing Attaching Hardware

During a heavy maintenance “N1” check visit on the aeroplane, a left-hand pylon inspection found that the aft lower fixed fairing assembly was missing several items of attaching hardware. Within the pylon fixed fairing, both forward quick release pins had fallen out, as had one of four mid-point attach bolts. The missing hardware was found in the bottom of the fairing. The right-hand pylon was found to have the two forward quick release pins and three of four mid-point bolts also missing. The pins and two of the three missing bolts were found inside the fairing. In both cases, the four aft mounting bolts were found installed and properly torqued.

This operator obtained the required engineering Original Equipment Manufacturer (OEM) and company approval to install a single dash length longer attaching bolt and reinstalled new quick release “pip” pins.

Transport Canada Civil Aviation (TCCA) would like to advise all Embraer 170 operators of this Service Newsletter (SNL) and its intent to replace the discrepant hardware to increase its bolt length, final torque and to introduce a new countersunk washer. ✖

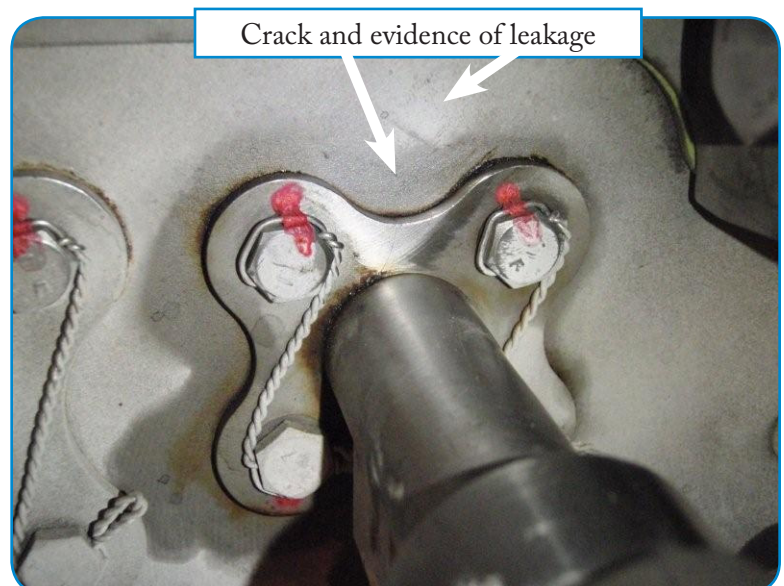
Engine Driven Pump Hydraulic T-Fitting Cracks

During a heavy maintenance “C-check” visit, maintenance found the #1 & #2 pylon engine driven hydraulic pump pressure line T-fittings cracked and with evidence of hydraulic fluid leakage.

Both pressure line T-fittings were replaced to correct the fault.

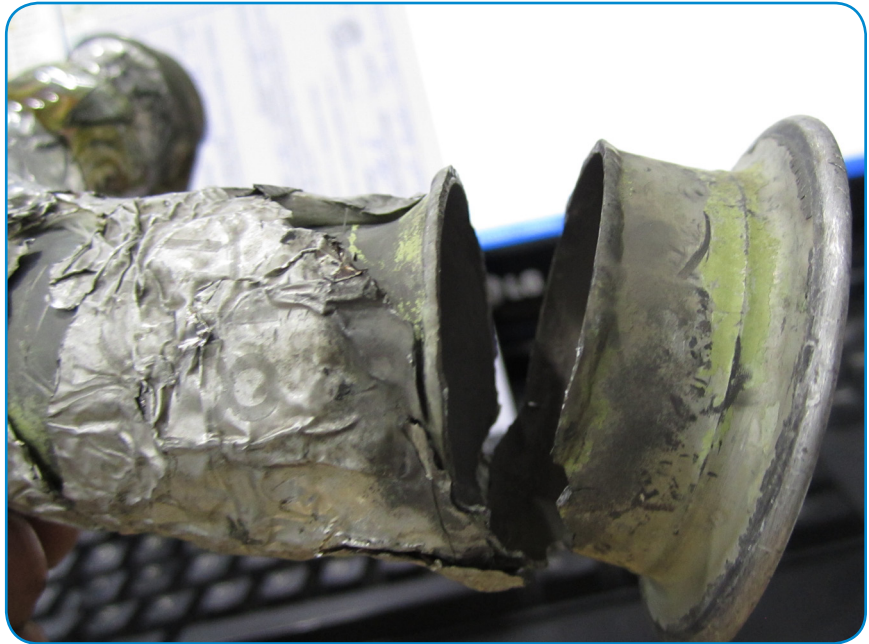
Metroliner Bleed Duct Failure

The pressurization was snagged as inoperative by the flight crew. During maintenance trouble-shooting it was noted that the engine bleed pressure would fluctuate uncontrollably and when turned to "high" only function for approximately 30 seconds. Then the eyeball vents would drop off with almost no air-flow output available.

During subsequent inspection of the right-hand wing bleed air duct plumbing, maintenance found the tube assembly from the right-hand modulating valve to right-hand cooling turbine cracked in half. The tube was replaced, ground run accomplished and the aircraft returned to service.

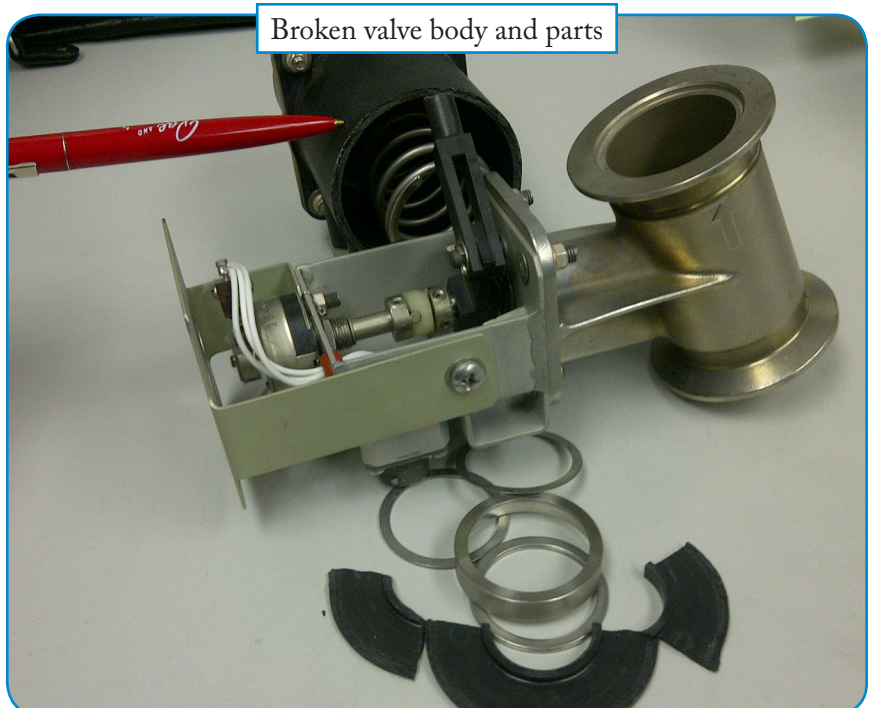
Cabin Temperature Control Valve Failure

During cruise, the cabin temperature was uncontrollable, leaving the cabin in a very warm and uncomfortable condition.

Upon maintenance investigation, the cabin temperature control valve plunger body was found cracked off, shearing the plastic link arm which opens and closes the butterfly valve and rendering it uncontrollable.

The valve was replaced and the aircraft made serviceable.

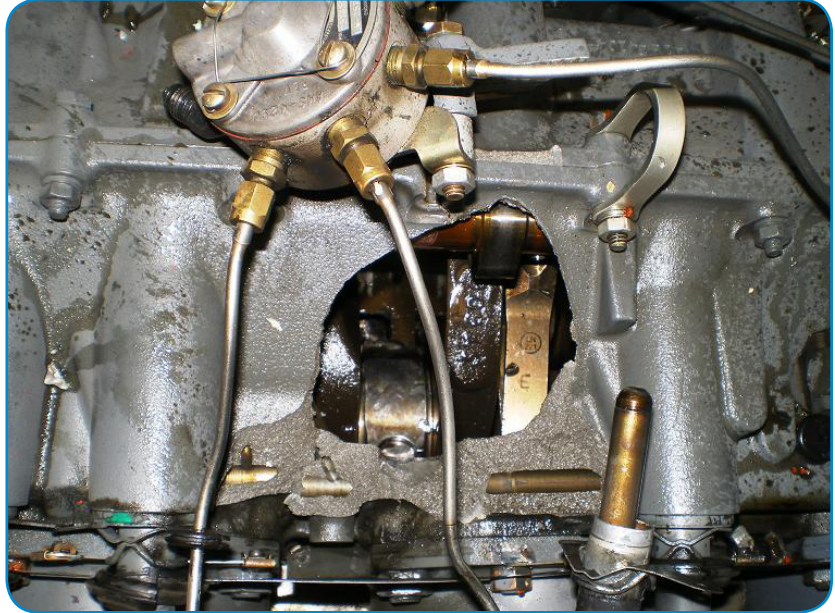
Connecting Rod Failure

The pilot reported a loud bang and subsequent engine failure. The pilot auto-rotated to an open field with no damage to the airframe during the landing. The aeroplane was removed from the field and transported to a repair facility for further investigation. Aeroplane panels were removed and a large hole in the crankcase was observed near the #3 cylinder intake lifter bore. Large pieces of crankcase debris were found on top of the engine case above the #2 cylinder area. Lycoming was advised and a field service rep came to investigate the failure on location.

Initial indications were the #4 connecting rod failed just below the piston pin area and this caused the breach in the crankcase between the #3 & #4 cylinders.

The cause of this connecting rod failure was the result of a missing wrist Pin Plug. Maintainers are reminded that all manufacturers' instructions must be followed. ✖

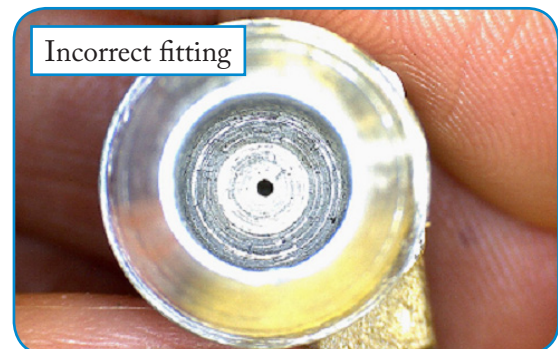
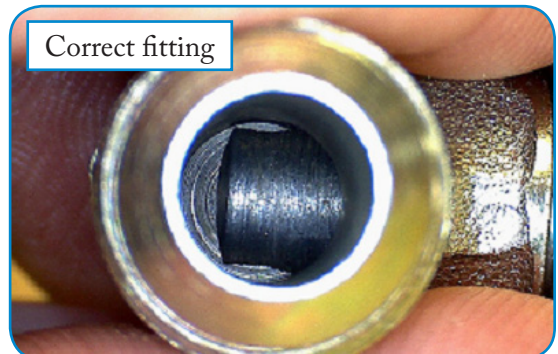
The engine was received fresh from the overhaul facility with the engine driven fuel pump and associated fittings assembled. Post install ground runs were unable to achieve take off power. After 2300 revolutions per minute (rpm) further power lever advancement resulted in loss of revolutions per minute (rpm) and increase in manifold pressure, indicating fuel starvation. Upon inspection it was found that the inlet fitting to the fuel pump was restricted (just a pin hole) either the part was not manufactured properly (not fully drilled through) or it is an incorrect part (a restrictor fitting). In either case it does not belong on the engine. The fitting was replaced with the correct part and engine runs completed.

Inventory control is of utmost importance. When receiving parts from stock or from a supplier, it is important to inspect for defects and that the part ordered is the part received. ✖

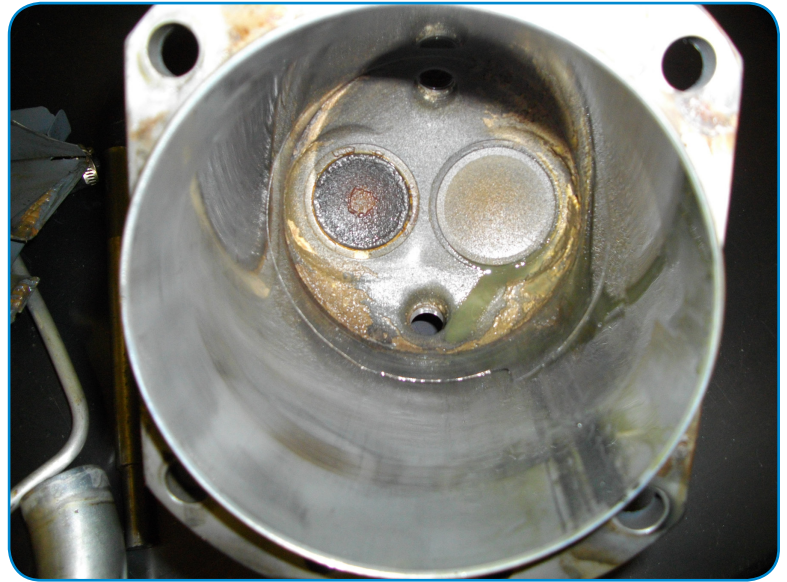
Sudden Engine Stoppage

The engine experienced a sudden stoppage in flight. Aircraft was landed and the engine was removed and shipped for inspection. Upon disassembly, it was found that the #4 cylinder failed due to a crack that progressed from near the top of the barrel almost all the way around the circumference. This failure seized the engine. This cylinder appears to be a field overhauled unit and has been sent to Transport Safety Board (TSB) for inspection. The last engine logbook entry has 488.9 hours since overhaul. The engine was last overhauled June 19, 2009 and was installed October 23, 2009.

It is likely that this crack was almost undetectable using visual inspection technique before the catastrophic failure. Field overhauls must be completed in accordance with the manufacturer's instruction and include any required Non-Destructive inspections carried out by an appropriately rated facility. ✖

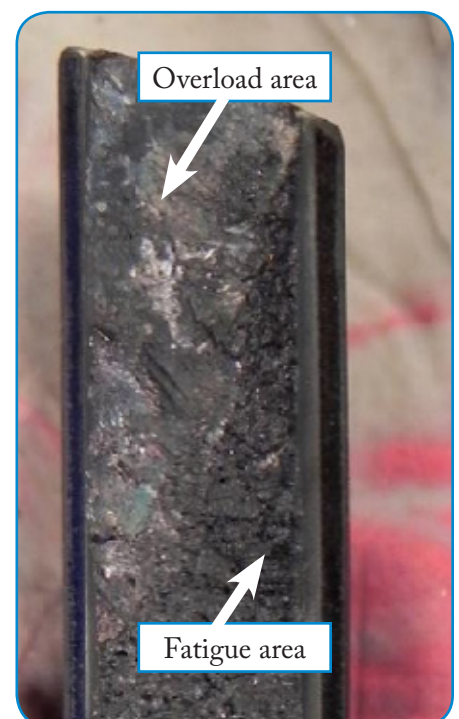
Power Turbine Failure

The engine was removed subsequent to a catastrophic failure during takeoff roll. The pilot reported, "engine failed on takeoff roll, audible noise, metal exiting exhaust duct, engine went to minimum flow and takeoff aborted".

During a dismantle investigation, the power section was found excessively damaged and it appeared that the failure occurred in the power turbine area. The 1st stage power turbine blades were found broken close to the platform areas. The fracture surface exhibited rough appearance with textures of brittle overloading fracture. The 2nd stage power turbine blades were found broken; the breakage varying from below shrouded the blade tip to above the blade platform.

Service Bulletin (SB) 14369 was released to address a premature failure issue and Service Bulletin (SB) 14003 provides relevant life limit recommendations for pre-service bulletin 14369 2nd stage power turbine blades. ✖
