AVIATION INVESTIGATION REPORT A08O0029

CONTROLLED FLIGHT INTO TERRAIN

**CANADIAN HELICOPTERS LIMITED
SIKORSKY S-76A (HELICOPTER), C-GIMR
TEMAGAMI, ONTARIO
08 FEBRUARY 2008**

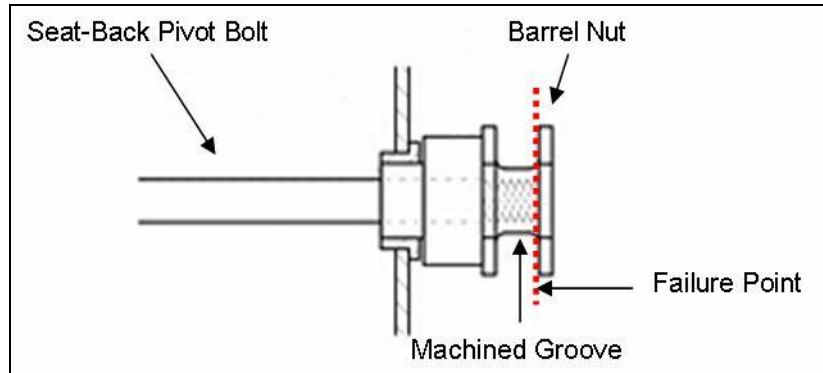
Figure 1. Lap belt attachment point

barrel nut, which is threaded onto the seat-back pivot bolts. The seat-back pivot bolt is designed to pass through the barrel nut to the end of the machined groove. The barrel nut failed where the bolt ended (see Figure 1). There was thinning of the material in the groove of the barrel nut due to wear from the stainless steel lap belt attachment.

The lap belt barrel nut attachment failed due to several factors. First, the barrel nut was weakened due to wear from the stainless steel lap belt attachment. Second, the seat-back attachment bolt did not pass completely through the barrel nut, but instead passed only part of the way through to the end of the machined groove. This created a weak point on the assembly at the outside edge of the barrel nut. Under normal loads, such as forward and aft g-forces, this

would not be an issue because the main load would be over the machined groove and seat-back attachment bolts. However, with a side impact, the main loads are in a sideways direction on the end barrel nut. This placed an abnormal load on the end of the barrel nut, which caused it to fail at the weakest point.

1. The right rear aft-facing paramedic seat lap belt attachment barrel nut was worn in the groove where the seat belt attaches, weakening the barrel nut's structural integrity, thereby increasing the risk of failure.
2. The helicopter crashed on its side, placing an abnormal side load on the right rear aft-facing paramedic seat lap belt attachment barrel nut, thereby causing it to fail.

Following the occurrence, JCM Aerodesign Limited, the supplemental type certificate (STC) holder for the emergency medical services (EMS) interior utilized in the S-76, issued Service Bulletin No. SB-EMS76-1. This service bulletin identified the affected helicopters and called for the replacement of the existing barrel nut lap belt attachment with a steel shackle. All affected helicopters have complied with the service bulletin.

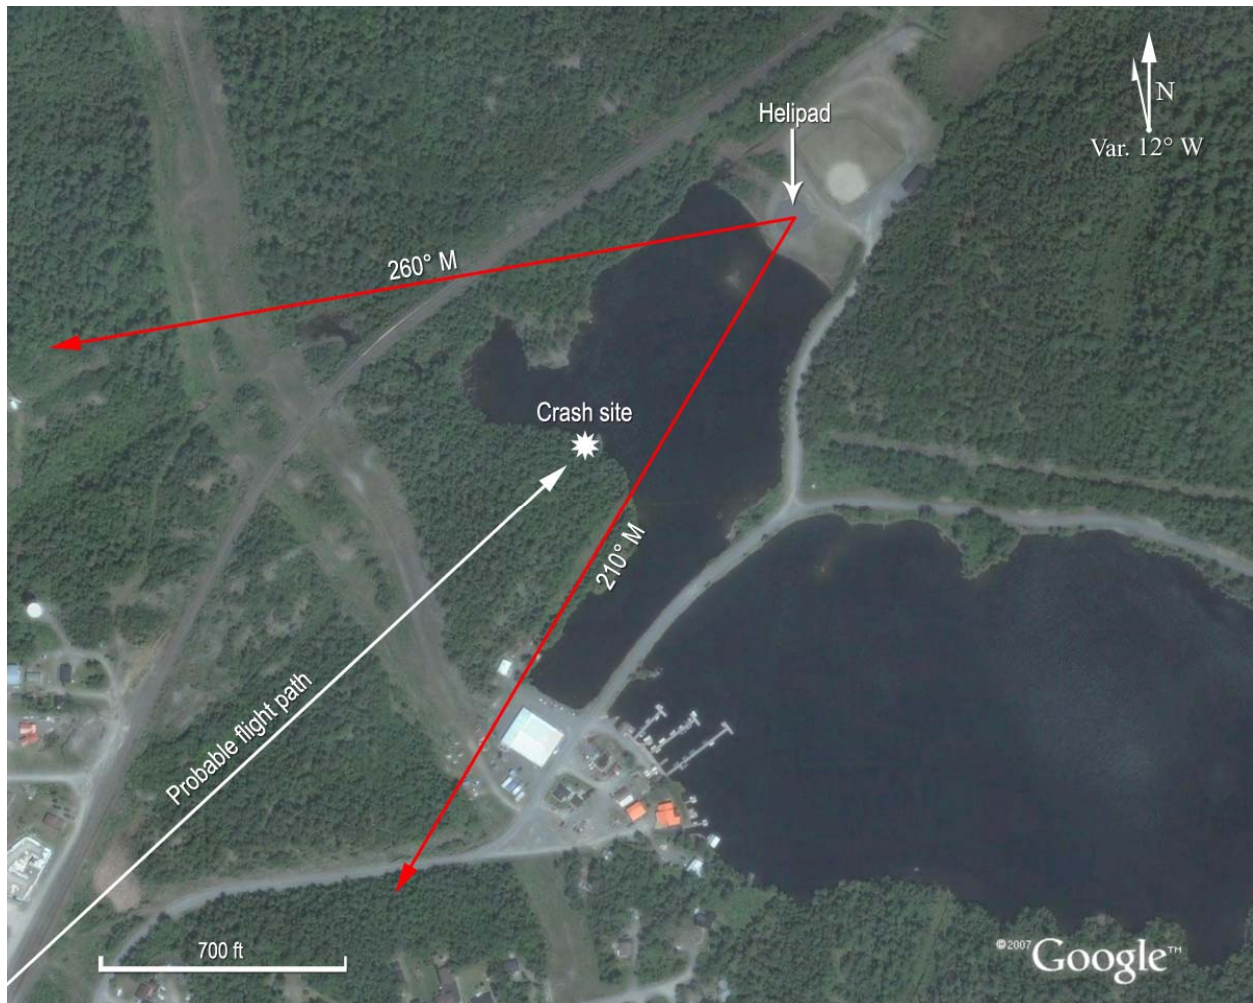
Appendix B – Snake Lake Helipad

The helicopter approached the helipad from the southwest on a heading of approximately 048°M and entered the trees near the edge of the lake approximately 814 feet horizontally from the helipad (see Appendix B – Snake Lake Helipad).
