**AVIATION INVESTIGATION REPORT  
A08O0035**

**RUNWAY OVERRUN**

**WESTJET AIRLINES  
BOEING 737-700, C-GLWS  
OTTAWA, ONTARIO  
17 FEBRUARY 2008**

Report Number A08O0035

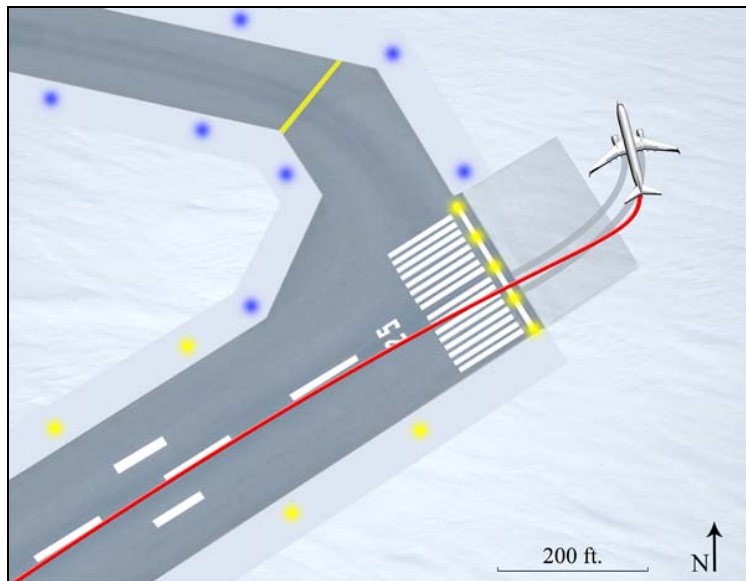
**Figure 1.** Site diagram

The landing flare was initiated at approximately 50 feet agl and 149 knots (Vref + 19). At 2258, the aircraft touched down (both main wheels on the ground) approximately 2300 feet past the threshold. The airspeed at touch down was 140 knots, Vref + 10 knots. The radio altitude indicated a significant decrease in descent rate (float) before touchdown. Although autobrake 3 was selected, manual braking was applied one second after touchdown. The captain initially assisted the first officer with the braking and then took control of the aircraft. Full manual braking was applied and held until the aircraft came to rest. The number 1 engine reverser deployment was activated approximately 1.5 seconds after initial right wheel<sup>9</sup> contact and full deployment occurred approximately 4.5 seconds after initial right wheel contact. Maximum reverse was commanded 11 seconds after initial right wheel contact and remained at maximum until the aircraft came to rest. Because the speed brake was not armed, spoiler deployment was

automatically initiated with application of reverser. The ground spoilers were fully deployed approximately two seconds after initial right wheel contact. The aircraft departed the end of the runway at 40 knots and overran the end by 215 feet (see Figure 1). There was a depth of approximately two feet of snow in the overrun area.

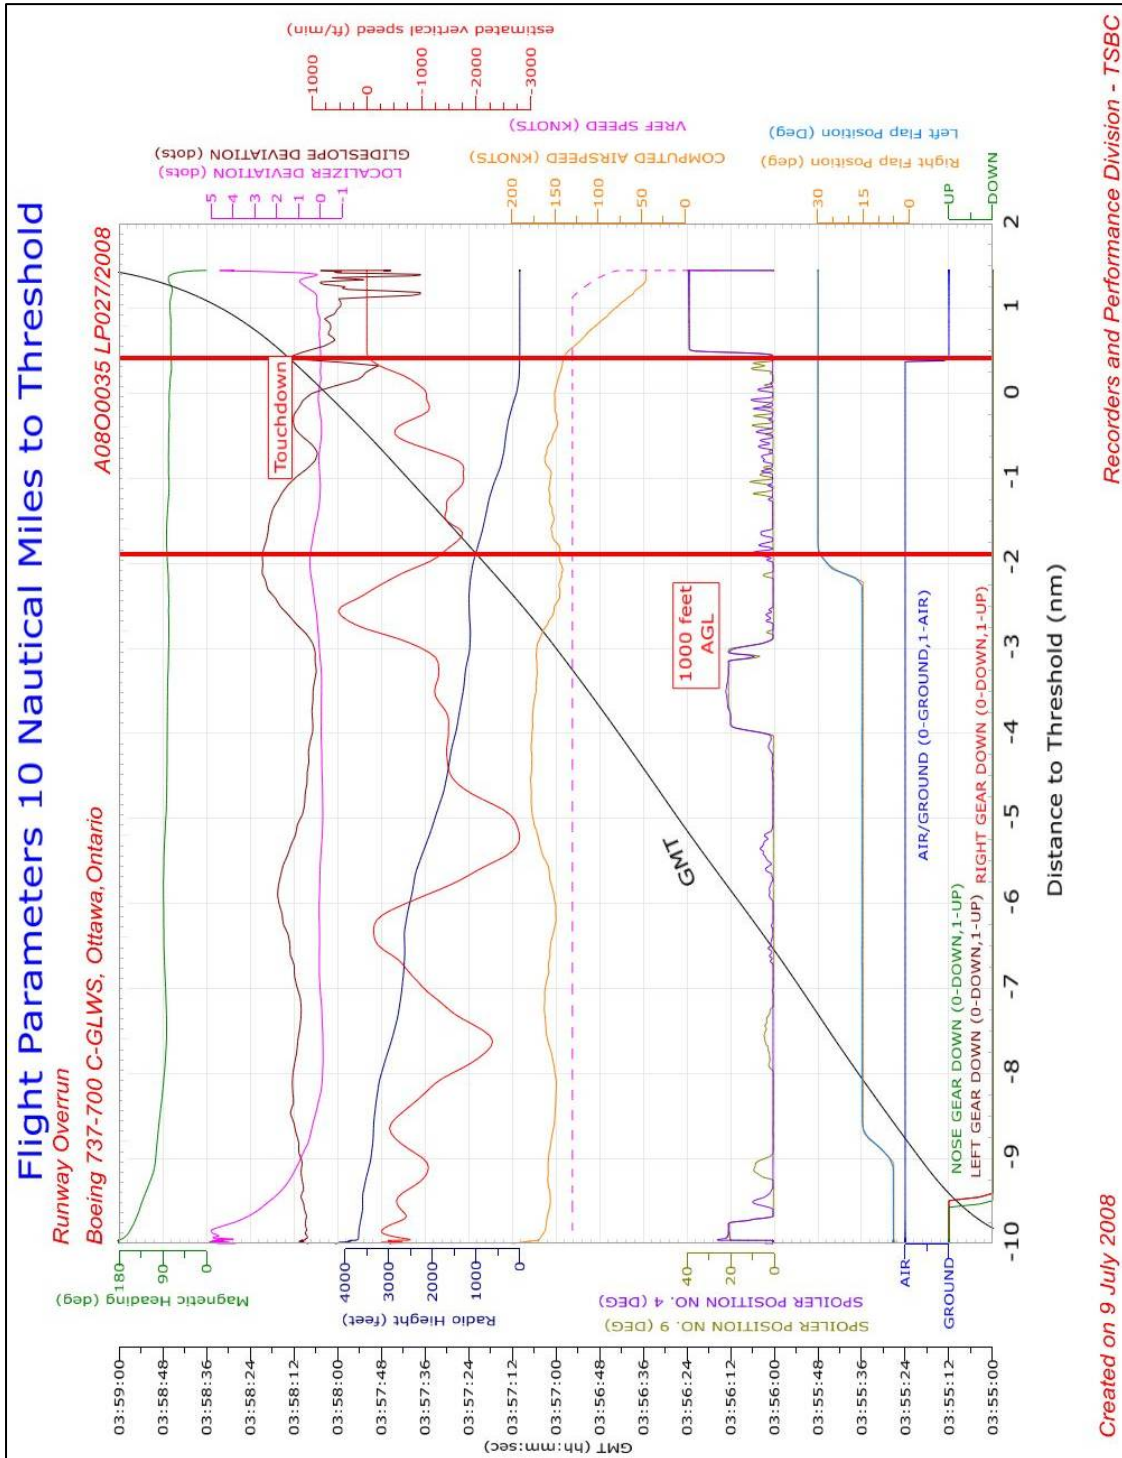
# Appendix D – Flight Data Recorder Plot, Last 10 Nautical Miles

At 2256:32, the glide path was intercepted, and in accordance with company standard operating procedures (SOPs), flaps 30 should have been selected. However, the aircraft speed was above the flaps 30 selection speed and the speed brakes were deployed to reduce the airspeed. The crew had not yet contacted Ottawa Tower and at 2257:06, WJA 846 was asked by the tower if they were on frequency. A 20-second communication exchange ensued during which several activities were concurrently happening in the cockpit. WJA 846 advised that they had a strong tailwind and might have to initiate a go-around. At approximately 1500 feet above ground level (agl), the crew disconnected the autopilot in order to level off and reduce airspeed for the flaps 30 selection. The speed brakes were then stowed, but not re-armed for landing and flaps 30 was selected. The airspeed on final approach varied between 145 and 177 knots (see Appendix D - Flight Data Recorder plot, last 10 nautical miles).

Immediately following the flaps 30 selection and the conversation with tower, the crew momentarily considered the requirement to conduct a missed approach. The decision was deferred even though the aircraft was approaching the 1000-foot above airfield elevation point. At the 1000-foot point, the aircraft flight parameters were as follows: in final landing configuration, thrust levers idle, airspeed 145 knots, and above glide path. Except for the momentary level-off, the thrust levers were at idle for the entire final approach. The aircraft was above glide path during the final approach except for three brief moments: at three nautical miles (nm), at  $\frac{3}{4}$  nm from the threshold, and at threshold crossing (at 50 feet agl). The rate of descent was in excess of 1000 feet per minute for most of the final approach (see Table 1).
