**AVIATION INVESTIGATION REPORT
A08P0011**

LIMITED POWER – HARD LANDING

**PRISM HELICOPTERS LIMITED
EUROCOPTER AS 350-B3 (HELICOPTER) N530NA
PITT MEADOWS, BRITISH COLUMBIA, 2 nm W
10 JANUARY 2008**

Report Number A08P0011

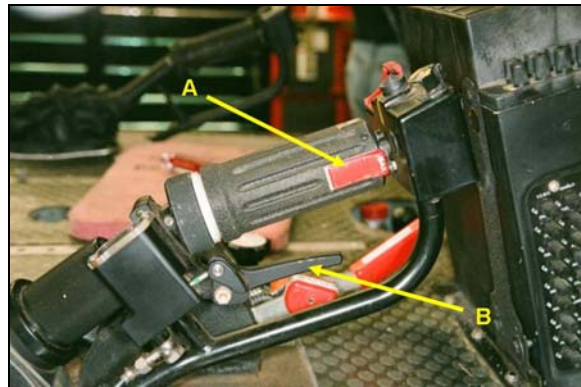
The controls installed to accommodate a second pilot in the left front seat were different from the right seat position. The normal pilot position (right) controls have a collective lever that incorporates a throttle lock referred to as flight notch in the RFM (see Photo 1). In case of emergency, releasing the lock allows manual fuel control operations at all power settings. The left seat throttle control does not have the lock (see Photo 2). Newer versions of the AS 350-B3 incorporate an electrical release that functions automatically when MANUAL MODE is selected, or when the red GOV light is triggered.

Photo 1. Right seat collective showing throttle lock (A) and cargo release (B).

The left seat controls did not have a release mechanism for the throttle lock. Therefore, the PIC was unable to initiate manual control of the throttle. There was insufficient fuel flow to provide the power necessary to arrest the rate of descent and a hard landing ensued.

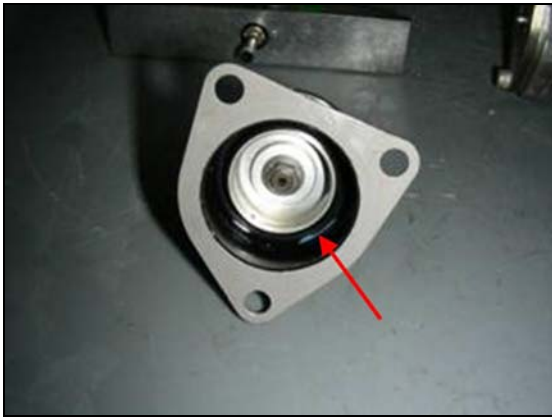
A detailed disassembly and examination of the HMU by Turbomeca, Thales, the BEA, and TSB Laboratory personnel revealed the presence of a contaminant within the HMU fuel channels. This contaminant was determined to be a small sliver of O-Ring seal material resting in the delta P diaphragm chamber (see Photo 3 and Photo 4). There was no metal generated within this component. The stepper motor and DECU were extensively tested individually with no results that could explain the condition experienced. A detailed diagram of the metering unit assembly is provided at Appendix A.

Photo 3. Debris in delta P diaphragm chamber

According to Turbomeca, *“it is impossible for the sliver found in the HMU to obstruct the fuel metering valve”*. In addition, Turboméca stated that *“if this sliver had gone through the fuel metering valve, there is very low probability that it would end up in the delta P diaphragm; it would have gone with the fuel flow.”*

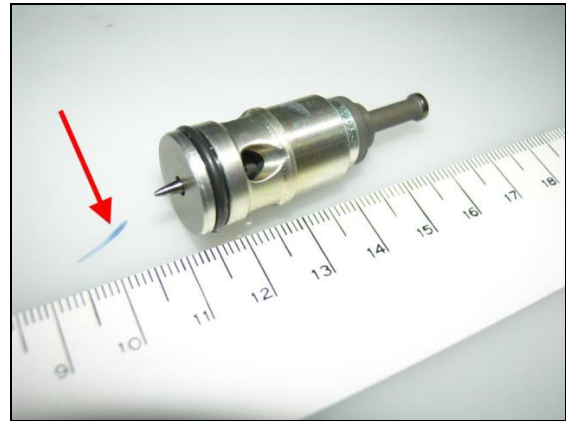
The TSB Laboratory investigation determined that the portion of blue O-ring was not part of the O-rings installed on the system and therefore had likely been introduced into the system during previous maintenance work or during the initial manufacture of the system.

Photo 4. O-ring material and metering valve

A sliver of O-Ring material found in the HMU fuel channels could have obstructed the fuel metering valve. It was not large enough to completely obstruct the orifice; however, it could impede the movement of the valve if it were to try and close as the sliver was wedged between the needle and the orifice. This could result in a differential between the resolver and stepper motor positions and cause a fixed fuel flow condition. The governor could not deliver the increased fuel flow required to maintain the high hover and the helicopter descended.
