## AVIATION INVESTIGATION REPORT

A08A0106

**LOSS OF CONTROL – STALL / SPIN**

**KITFOX IV C-GCSU  
HUNTINGTON, NOVA SCOTIA  
18 AUGUST 2008**

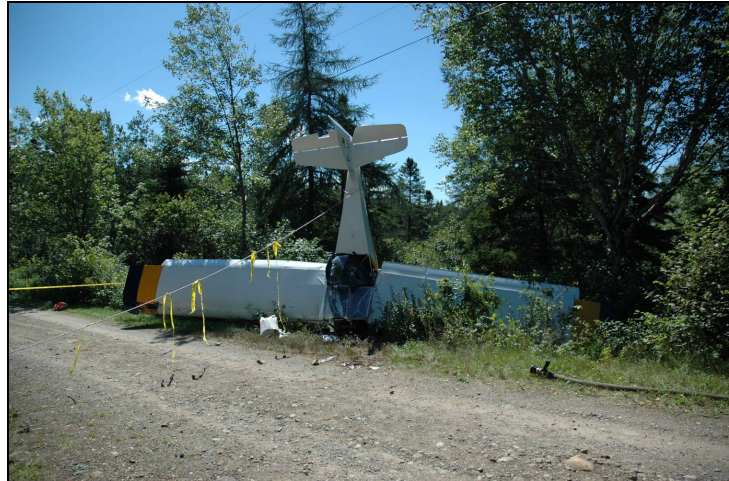
The aircraft impact orientation (See Photo 2) and airframe damage was consistent with a steep nose-down inverted attitude typical of a low-altitude aerodynamic stall/spin event <sup>2</sup>. The accident aircraft was not equipped with a stall warning device, nor is one required for this category of aircraft.

**Photo 2.** Aircraft impact orientation

The aircraft’s impact orientation indicates there was a departure from controlled flight, resulting from a stall/spin scenario. The stall/spin scenario was not a result of a structural failure in flight, no engine or control anomalies were noted during the wreckage examination, the weather was determined not to be a factor, and a stall/spin scenario would not have been deliberately initiated at such a low altitude. The most likely scenario leading to the accident would be the pilot’s lack of currency and inexperience on type, leading to a failure to detect the symptoms of an approaching stall and apply the appropriate corrections in a timely manner,
