AVIATION INVESTIGATION REPORT A09P0096

LOSS OF SEPERATION

NAV CANADA – VANCOUVER AREA CONTROL CENTRE PENTICTON, BRITISH COLUMBIA, 20 nm SW 24 APRIL 2009

Report Number A09P0096

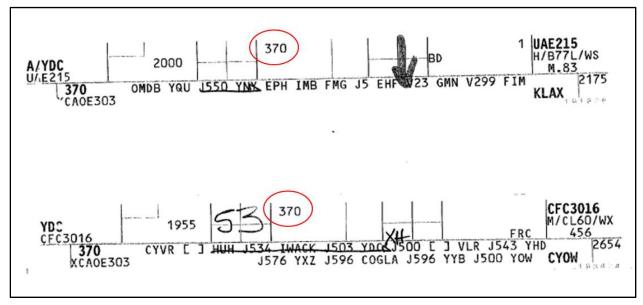
Figure 1. Flight Progress Strips showing flight levels

Flight progress strips are distributed to appropriate sectors at least 15 minutes prior to transfer of control to the controller. Shortly after the controller took over the position and UAE215 was transferred to the control of the Mountain High Specialty, the controller noted from the printed flight progress strips in the strip bay that both aircraft would be at FL370. The controller had identified the potential problem between CFC 3016 and UAE 215 which were both cleared to FL370 and on crossing tracks. Contrary to ATC MANOPS, red Ws had not been posted on the flight progress strips. It is unknown whether the flight progress strips were cocked.

The controller identified the conflict between CFC3016 and UAE215 early on. The controller resolved to change UAE215's route toward the west and issue a climb to FL380. A solution in hand, the controller did not think it necessary to mark the flight progress strips with the required red W. Thus, an important aide-memoire was not used. The controller's attention became focused on other traffic in the sector. The conflict went unresolved until the TFC CA sounded.

The controller's solution required two parts: a heading change and an altitude change. The altitude change was dependent upon identifying that a westbound track change had been achieved. A two-part resolution to the conflict requires a means of remembering that a second part must be performed in order to resolve the conflict. The use of the red W serves to remind the controller that the conflict has yet to be resolved. As the controller did not use this aidememoire, the altitude change was not completed.

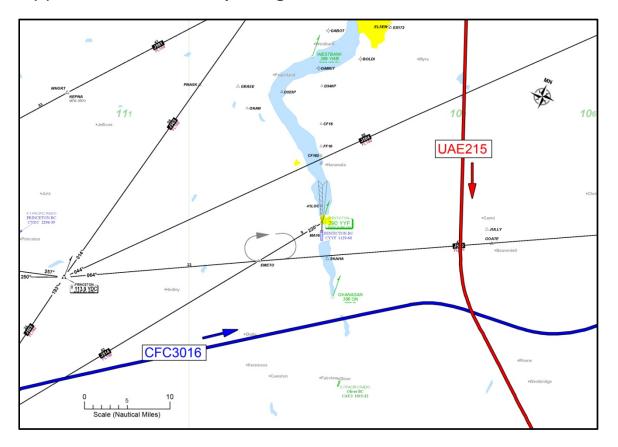
Appendix A – Aircraft Flight Paths

At 1258:39, the controller instructed UAE215 to turn left. No acknowledgement from the crew was received and so, at 1258:45, the controller re-issued the turn. At 1258:51 UAE215 began the process of changing heading. (See Appendix A – Aircraft Flight Paths).

At 1259:33, vertical spacing of 1000 feet had been achieved between the two aircraft at which point the horizontal spacing was 1.8 nm. The minimum required spacing was 1000 feet vertically or 5 nm horizontally. The turns issued to the aircraft resulted in UAE215 directly overflying CFC3016 (see Appendix A – Aircraft Flight Paths). The TCAS is an airborne system that alerts flight crews to other aircraft in their vicinity that pose a potential collision hazard. TCAS equipment interrogates other aircraft transponders to determine their range, bearing and altitude. The TCAS generates a traffic advisory (TA) when another aircraft is approximately forty seconds from the point of closest approach. A resolution advisory (RA), in the form of a vertical manoeuvre, is generated when the other aircraft is approximately 25 seconds from the point of closest approach. The RA provides a vertical restriction or manoeuvre to maintain or increase separation.

The controller cleared CFC3016 to turn right, and UAE215 to turn left. The geometry of this crossing track conflict was such that the turns resulted in one aircraft flying directly overtop of the other. The turns issued by the controller were ineffective in establishing the minimum lateral radar separation. Altitude spacing was achieved by the controller's initial descent instruction to CFC3016 and UAE215's response to the TCAS RA.
