**AVIATION INVESTIGATION REPORT
A09C0120**

LOSS OF CONTROL AND COLLISION WITH TERRAIN

**PIPER PA-46-310P, C-GUZZ
KAMSACK, SASKATCHEWAN
19 JULY 2009**

Report Number A09C0120

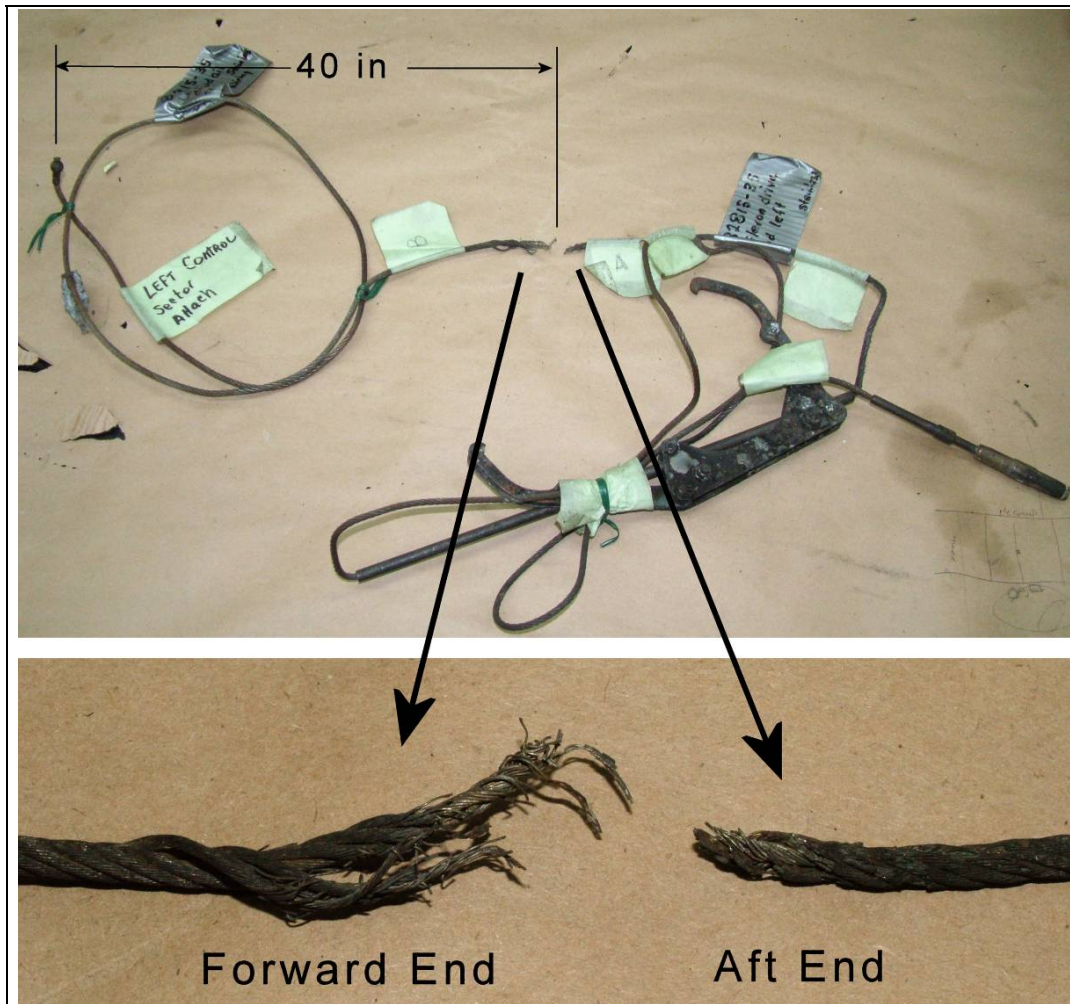
Displaced away from the fracture location, some cable strands and splayed wires were found at the forward end of the fracture at the 40-inch location. The aft end of the fracture was roughly cone-shaped (see Figure 1).

Figure 1 - Fractured left forward aileron drive cable assembly, as received at TSB Laboratory.

The cable fracture surfaces had deposits of solidified molten material. The forward and aft fracture surfaces were held together by re-solidified metal and a few embrittled wires, which separated during initial handling. Exposure to the post-impact fire had corroded and sooted the cable, destroying all non-ferric material near the cable fracture.

The TSB Laboratory examined the fractured cable ends using a scanning electron microscope. Some wires exhibited localized indentations, suggestive of crushing or pinching. None of the wires had been flattened by abrasion against other objects. Examination of representative solidified molten metal revealed the presence of aluminum and stainless steel, likely from surrounding aluminum aircraft structure and the aileron cable itself. Wire fracture faces included flat square surfaces, indicative of cleavage fracture of embrittled wires during post-occurrence handling, surfaces with dendritic features, indicating they had been subjected to melting, and some flat square surfaces covered in heavy oxidation from the fire, but without dendritic features indicative of melting.

It is highly improbable for a wire to fracture in a brittle manner during a fire, as the hot metal would flow plastically, resulting in a necked tip. Therefore, it is likely that the wires with the

flat square surfaces covered in heavy oxidation were fractured before they were exposed to the fire.

Due to the fact that the wires had been embrittled by the fire, any bending of the wires during wreckage recovery likely would have resulted in their brittle fracture. Therefore, it is improbable that the splaying could have occurred during wreckage recovery. Although this splaying may have occurred during the break-up of the aircraft, it is possible that it was present before the occurrence as a result of progressive damage. The splaying of portions of the forward end of the cable is indicative of cable travel restriction. The presence of flat square fracture surfaces with an oxide layer is considered to be direct evidence that some of the wires had pre-existing progressive fractures. However, the features on the cable fracture surfaces were substantially obliterated by the post-impact fire, and it could not be established that fatigue caused the partial cable fracture.

The fourth fracture location, at the 40-inch point, was unusual. It occurred in a straight portion of the cable with no cyclic bending stresses and did not show signs of abrasion. The forward end of the fracture included splayed and displaced wires. The splayed wires are indicative of cable wires bunching prior to the post-impact fire; however, it could not be determined whether the wire splaying occurred prior to impact or during the crash sequence.

As the splayed wires were co-located and accompanied with pre-existing progressive wire failures, it is possible that, as the progressive wire failures occurred, they became displaced from the cable. For the splaying to occur, the displaced wires would have to come into contact with a nearby object or structure. The location of the fracture was in an area under the cockpit floor near two fuselage bulkheads with lightening holes, which are equipped with nylon grommets to provide cable protection. The grommets can become brittle with age and detach; however, due to the destruction caused by the post-impact fire, it could not be determined whether such aging and debonding took place. Cable tension can change over time, allowing the cable to contact the grommet or, should the grommets become detached or worn, the bulkhead.

The cable was splayed at the 40-inch fracture location. Assuming the splaying occurred prior to impact, it is possible that cable movement was restricted such that the pilot could not take effective action to counter a roll.

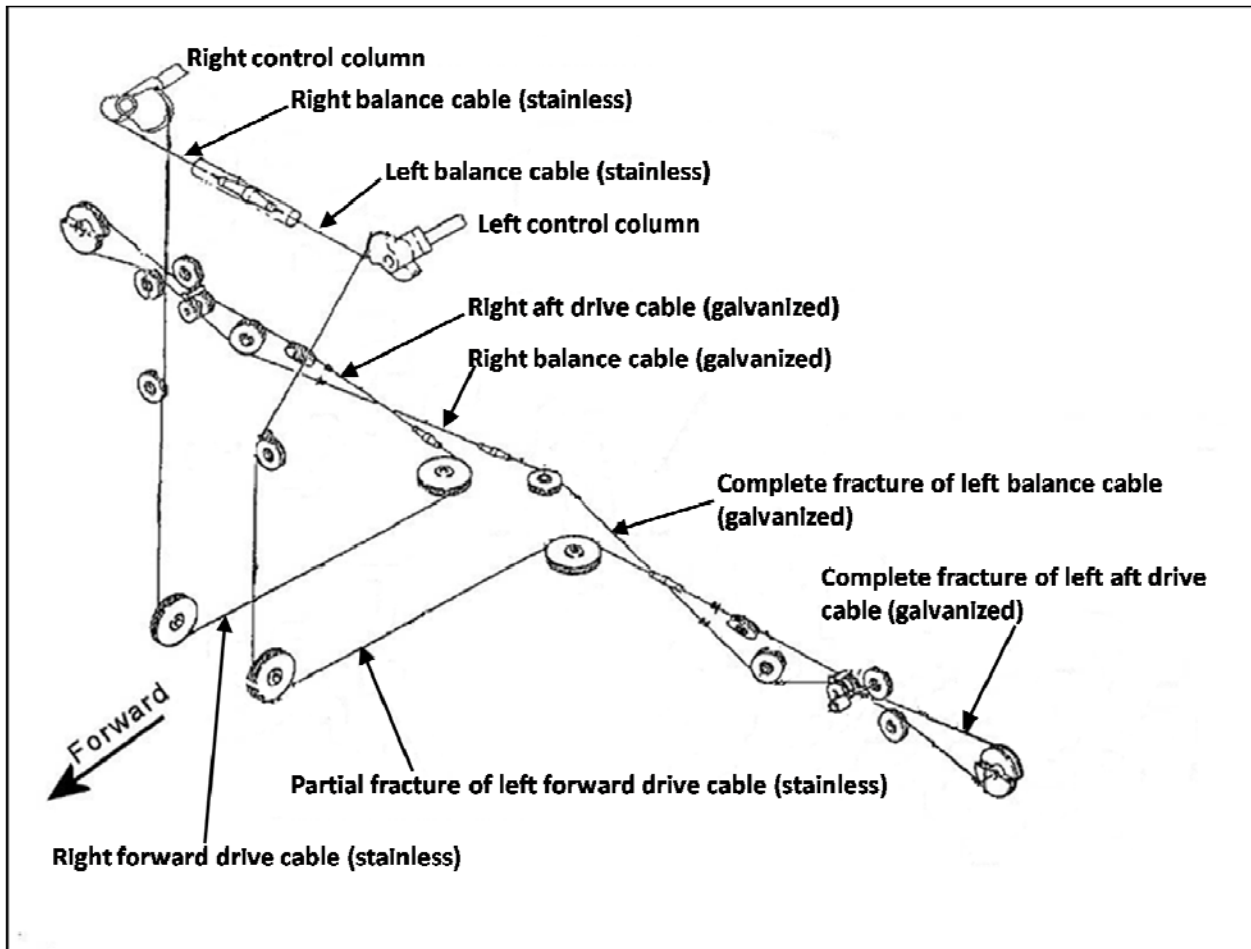
Appendix A – Aileron Cable System Schematic

All aileron cable components were present in the wreckage. Fractures in the aileron control cable system were identified at three locations:

- the galvanized steel, left aft aileron drive cable was fractured at the left outboard flap track;
- the galvanized steel, left aileron balance cable was fractured at a point that would have been just inside the fuselage adjacent to the left wing root; and
- the stainless steel, left forward aileron drive cable was almost totally fractured at a point 40 inches from the cable ball-end attachment to the left aileron quadrant assembly (see Appendix A - Aileron Cable System Schematic).

TSB Laboratory examination of the left aft drive cable and left balance cable fractures concluded that they had resulted from impact-related overstress.

Schematic of aileron cable system (modified for clarity and not to scale) identifying the cables and showing the locations of the three cable fractures.
