AVIATION INVESTIGATION REPORT
A09P0156

ENGINE POWER LOSS – FORCED LANDING

AMATEUR-BUILT GLASTAR C-GMDP
CHETWYND, BRITISH COLUMBIA, 6 nm SSW
12 JUNE 2009

Report Number A09P0156

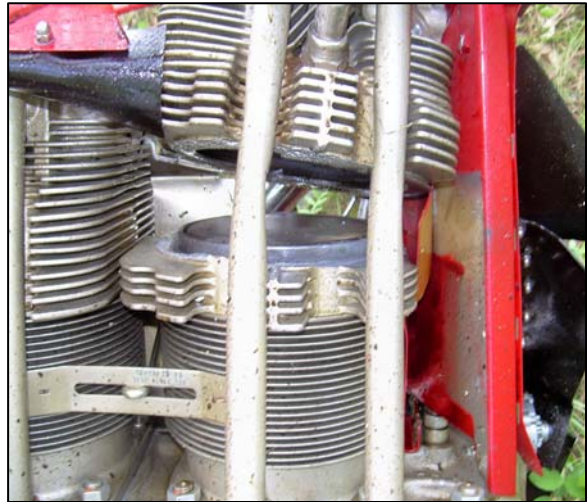
Photo 1. Number two cylinder head

Examination of the wreckage revealed that the number two cylinder head had separated from the base (See Photo 1) and the crankshaft was severed at the propeller flange. The engine had 212 hours total time since new (TTSN) when the failure occurred.

The failed cylinder assembly was sent to the TSB Laboratory for examination. A fracture surface analysis of the number two cylinder and sheared crankshaft was completed. The crankshaft propeller flange showed signs of minor hydrogen embrittlement. The sheared crankshaft was determined to be from overload fracturing due to impact. The minor hydrogen embrittlement was not causal to the accident.

In the fall of 2008, the FAA issued Airworthiness Directive (AD) 2008-19-05 regarding ECi cylinder assemblies installed on the Lycoming engines. The AD addressed a manufacturing defect that caused the cylinder head to separate from the base. It did not, however, address engines with increased compression ratios. Engines that are not type-certificated, such as the Aero Sport Power engines, were not mentioned in the AD. The cylinder head failure fracture surfaces were typical of fatigue failures addressed by this AD.

The failure of the cylinder head occurred at 212 TTSN, well in advance of the 350-hour limit set out in the AD. Compression checks completed 22 hours prior to the accident failed to detect a problem. This is not uncommon because compression tests will not necessarily detect an impending failure. It is possible that the premature failure of the cylinder head was due to the increased compression ratio of the engine.

1. The failure of the number two cylinder caused the engine to lose power.
2. During the attempted forced landing, the aircraft struck power lines, control was lost, and the aircraft collided with trees and terrain.

Aero Sport Power has notified all engine owners potentially affected by Airworthiness Directive (AD) 2008-19-05 and those who have increased the compression ratio.

Danbury Aerospace, the parent company of Engine Components Inc. (ECi), has elected to limit the compression ratio of cylinders sold in engine kits.

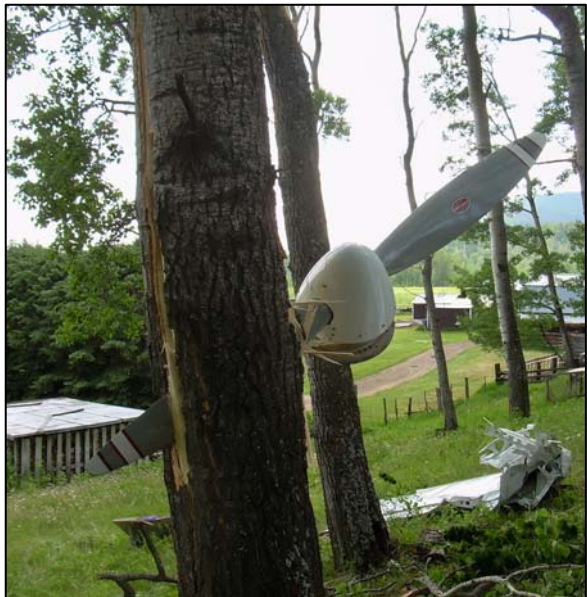
Photo 2. Propeller from C-GMDP

The engine crankshaft sheared at the propeller hub and the propeller was found embedded in a tree at the accident site (See Photo 2). The propeller was nicked and scuffed in a manner consistent with striking the severed power line.

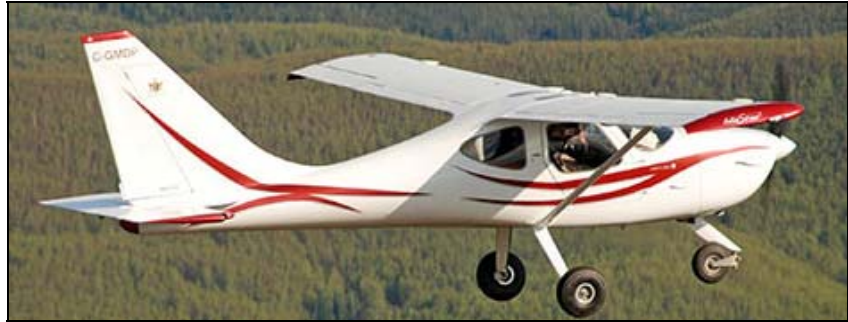
Photo 3. Amateur-Built Glastar, C-GMDP

The Glastar has a high-wing, two seats side-by-side, tricycle landing gear, and a 190-horsepower Aero Sport Power O-360-A2A engine (serial number 0808-SPE). The aircraft was well-equipped and maintained (see Photo 3).
