## **AVIATION INVESTIGATION REPORT**

**A09W0146**

### **LOSS OF CONTROL - TAIL STRIKE**

**ROBINSON R44 RAVEN II (HELICOPTER) C-GNYT**

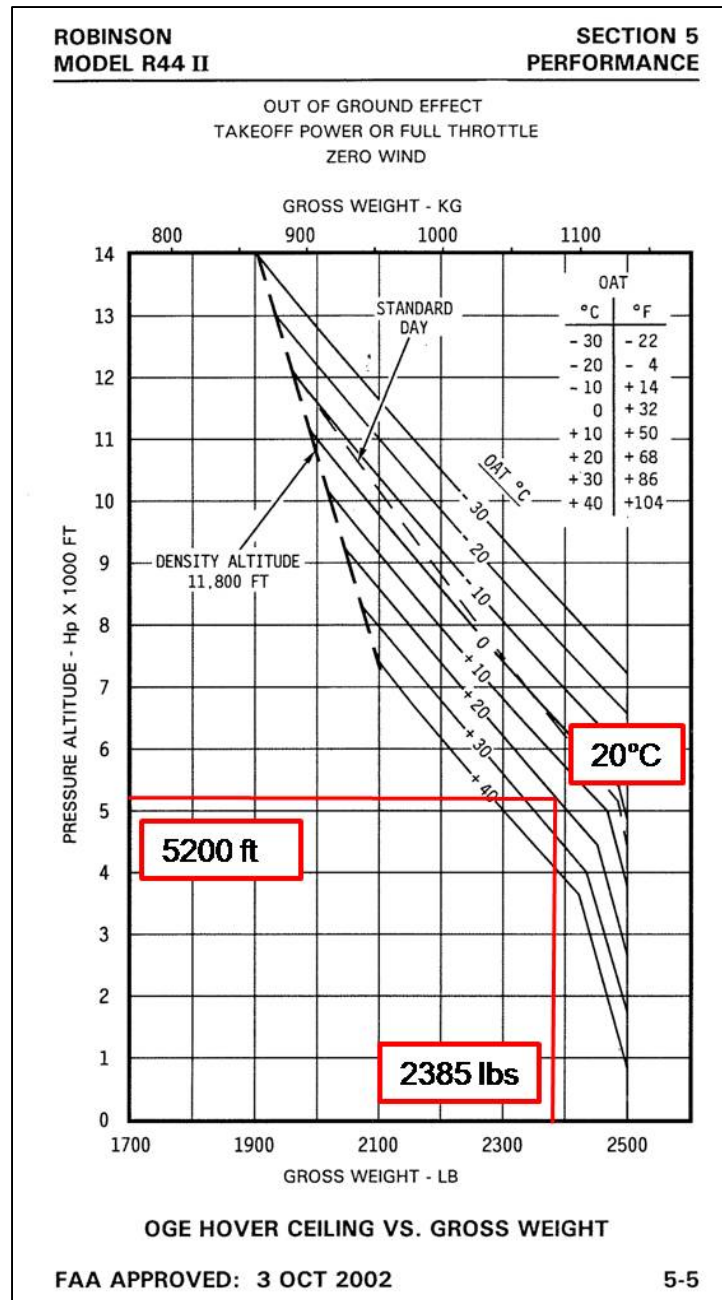
# Appendix A – Hover Out of Ground Effect – Robinson R44 Raven II

The engine was developing full available power and no mechanical flight control difficulties were encountered during the occurrence. Performance charts in the pilot's operating handbook indicate that, at 2385 pounds, at 20°C, zero wind and 100 per cent main rotor rpm, the maximum pressure altitude for hover out of ground effect is 5200 feet (see Appendix A). The maximum pressure altitude for hover in ground effect under the same conditions is 8760 feet, which indicates a large difference in power requirements between hover in and out of ground effect. The pressure altitude at the attempted landing site was 5100 feet, where the helicopter would be operating with an out of ground effect margin of 100 feet.
