AVIATION INVESTIGATION REPORT

A09Q0190

COLLISION WITH CABLE

ROBINSON R44 II RAVEN (HELICOPTER) C-GJMP

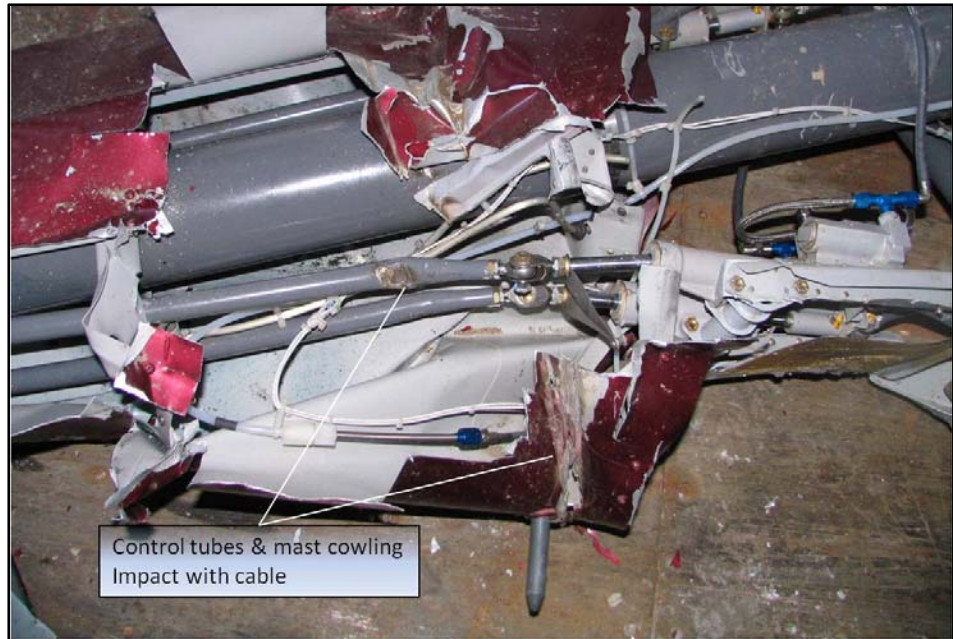
Photo 1. Cable marking on control tubes

Collision with the ground wire was evident at the left bottom of the mast fairing area just below the pitot tube. No wire markings were evident on the right side of the mast fairing. The collective and cyclic control tubes running vertically alongside the rotor mast were bent and showed marks from impact with the wire (see Photo 1). The bending of the control tubes rendered the collective and cyclic controls partially inoperable, likely allowing the pilot limited control of the helicopter during the descent towards the river.

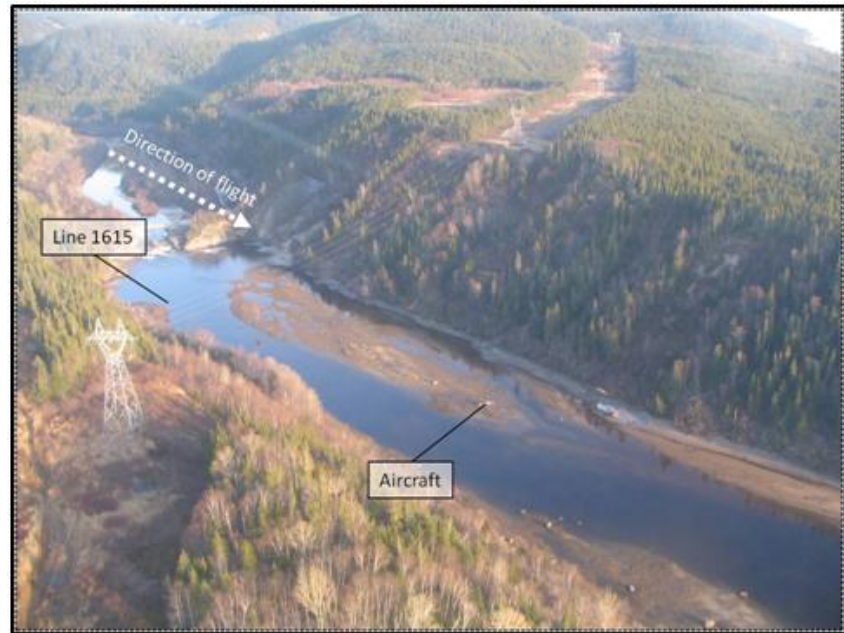
Power Line 1615 crosses the Franquelin River (see Photo 2). There are no markers on the wires crossing the river nor are they required by regulation. The pylons supporting the wires are 107 and 77 feet agl and are situated on each side of the river bank. The lowest height at which the top ground wires hang is 283 feet above the river when the water is at low tide. The main transmission lines hang 36 feet below the ground wires; 247 feet above the river.

Photo 2. Aerial view of accident site

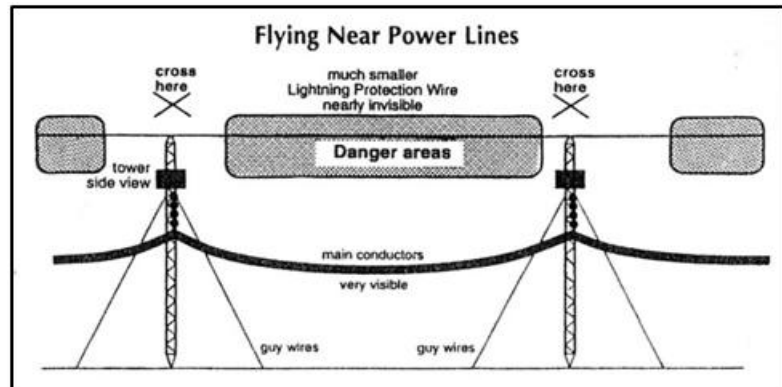
The Transport Canada *Aeronautical Information Manual* (AIM), TP 14371E, a reference often studied and used by pilots, states that pilots should use caution when operating at low level because power lines, especially the ground wires hanging above the main conductor wires, are more difficult to see even in good visibility (see Figure 1)¹¹. Pilots

Figure 1. Flying near power lines

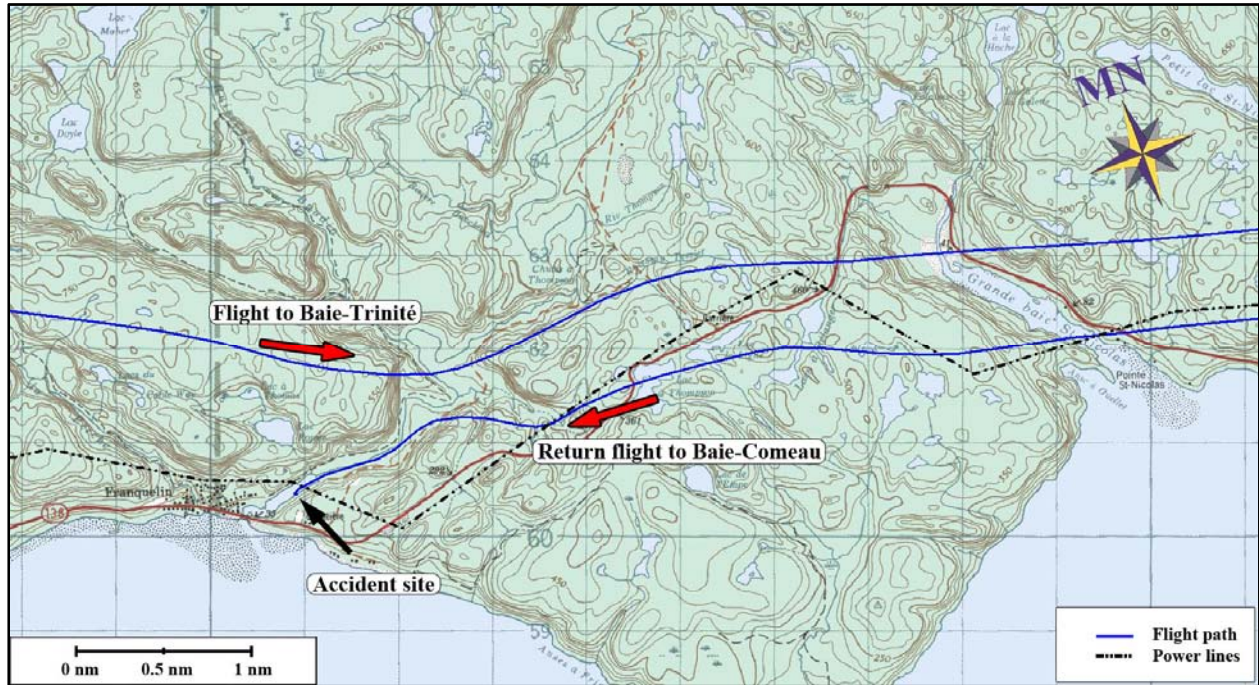
Appendix A – Occurrence Flight Path

After taking off from Baie-Trinité, the helicopter was flown south towards the St. Lawrence River, then west past the Pointe-des-Monts lighthouse and the town of Godbout, Quebec, towards Baie-Comeau (See Appendix A – Occurrence Flight Path). When the helicopter reached the Franquelin River ², 10 nautical miles (nm) east-northeast of the city of Baie-Comeau, the flight continued through the river valley towards the St. Lawrence River in a west-southwesterly direction, initially at approximately 426 feet above sea level (asl) then descending to 255 feet asl. ³
