AVIATION INVESTIGATION REPORT

A09Q0210

DECREASE IN ROTOR SPEED FOLLOWED BY COLLISION WITH TERRAIN

ROBINSON R44 II (HELICOPTER) C-GDSF
MONTRÉAL, QUEBEC
16 DECEMBER 2009

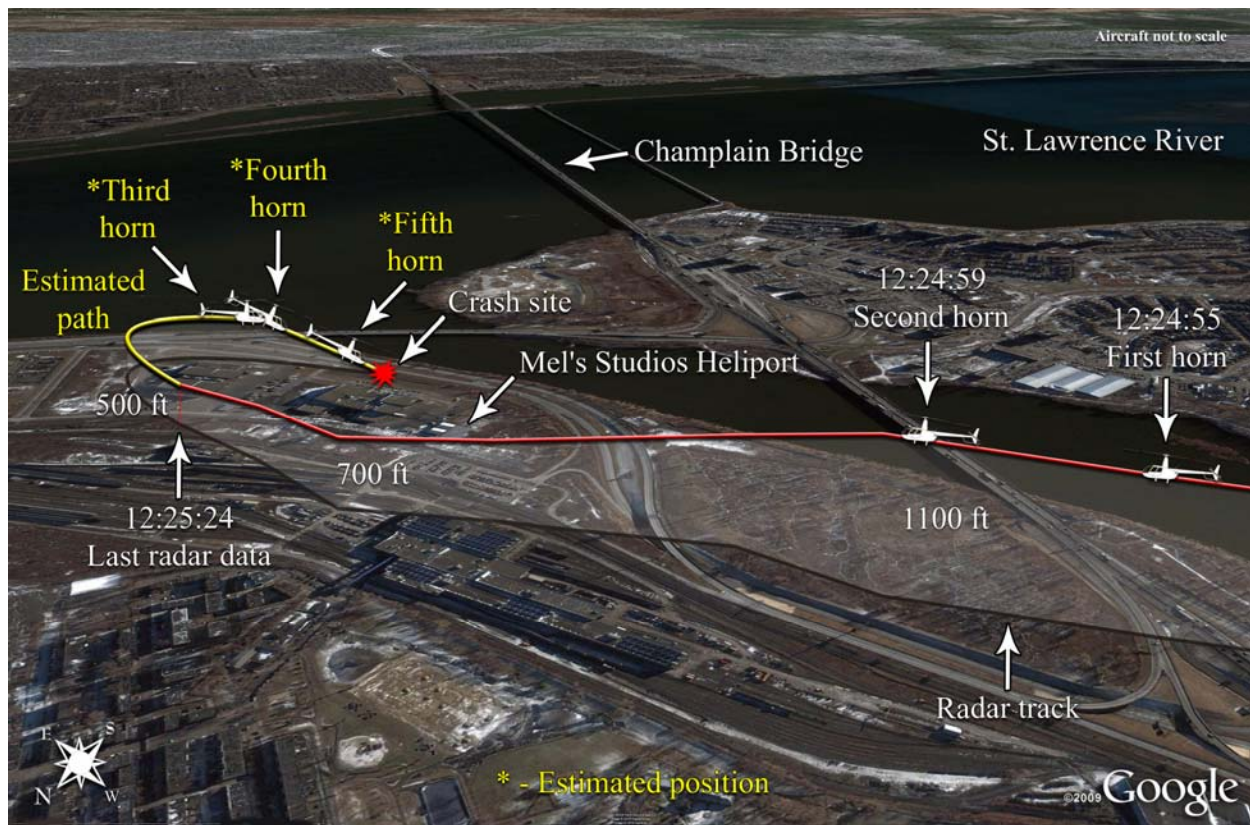
Figure 1. Helicopter's path (Times in UTC)

At 0724:55, just east of the Champlain Bridge, the low rotor speed warning horn sounded for the first time and the engine began to overspeed. The horn sounded another 4 times subsequently. At 0725:17, while at an altitude of approximately 650 feet asl, the pilot informed the controller that he was making an emergency landing at Mel's Studios ⁴. The aircraft was then somewhat north of the heliport at Mel's Studios. At approximately 500 feet asl, the pilot executed a 180° turn to the right. During the final moments of the flight, control of the aircraft's pitch and roll ⁵ response was sluggish and almost non-existent. The helicopter crashed in a ditch located between Mel's Studios and the Bonaventure Expressway (see Figure 1).

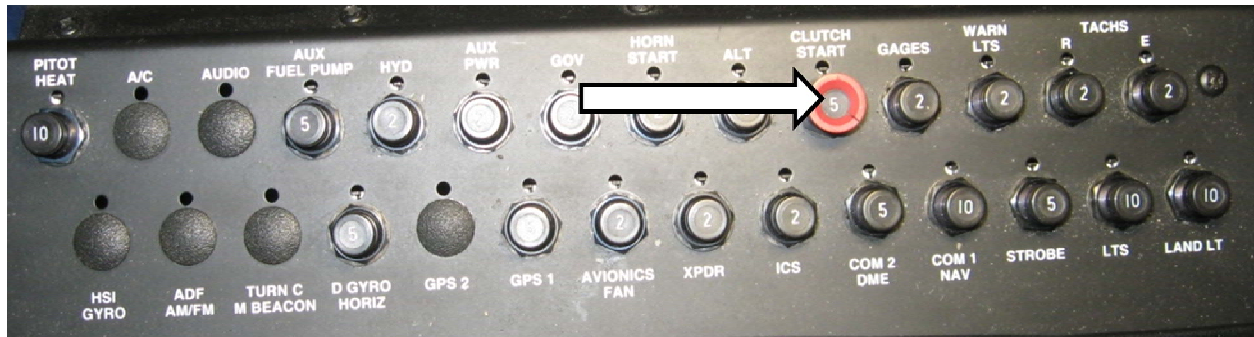
Photo 3. CLUTCH circuit breaker

It is normal for the warning light to come on during flight. However, if it remains on for more than 7 or 8 seconds, the POH recommends pulling the CLUTCH circuit breaker (see Photo 3), reducing power and landing immediately. The breaker is marked with a red ring to facilitate identification and manual activation. As well, the pilot is warned to be prepared to enter autorotation and inspect the drive system (see Figure 4).

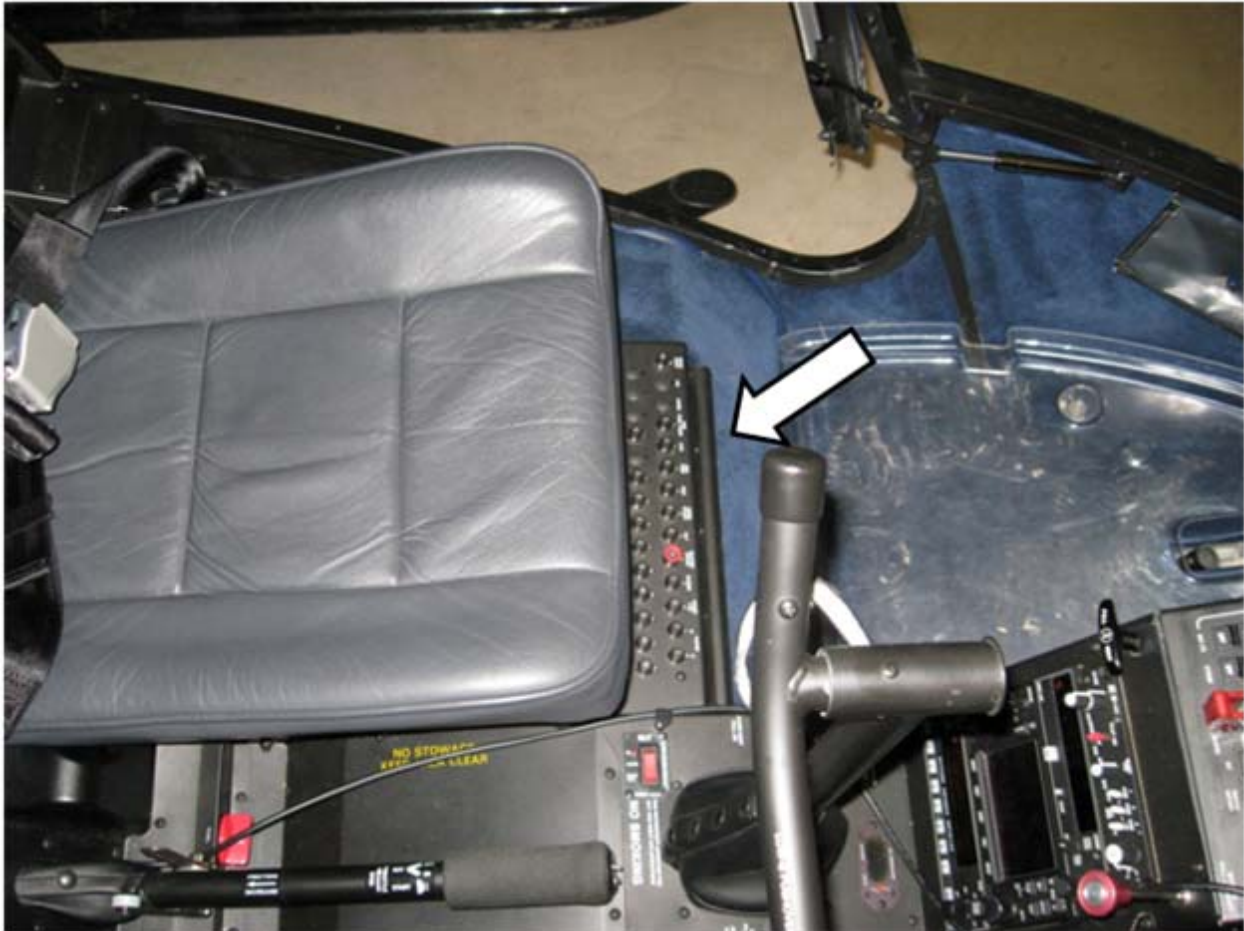
Photo 4. Left breaker panel

At the accident site, the Clutch/Start breaker, which is located on the left panel, was found in the open position. The breaker feeds the belt-tension actuator via the actuator switch. The CLUTCH warning light doesn't illuminate if power to the actuator is cut. When the breaker is opened, the actuator and the warning light stop working. An examination of the Clutch/Start breaker did not reveal any anomalies.

The Clutch/Start breaker is not exclusive to the actuator; it also powers the electrical circuits for the helicopter's main blade brakes and starter system. CARs Section 527.1357¹¹ (Circuit Protective Devices) states that "a protective device for a circuit essential to flight safety may not be used to protect any other circuit".

Since the Clutch/Start breaker is not exclusive to the clutch system, it can be tripped by a defective component in a related non-essential electrical system.¹⁹ Once tripped, the breaker no longer powers the actuator and warning light. As a result, the actuator is no longer able to tighten the belts. According to CARs Section 527.1357, the electrical system of a system essential to flight should be exclusive to that system. Although the R44's clutch system is essential to the safety of the helicopter's flight, its Clutch/Start breaker powers other electrical circuits belonging to non-essential systems.
