AVIATION INVESTIGATION REPORT
A09O0217

CONTROLLED FLIGHT INTO TERRAIN

PIPER PA-28R-180, C-FURX

10 OCTOBER 2009

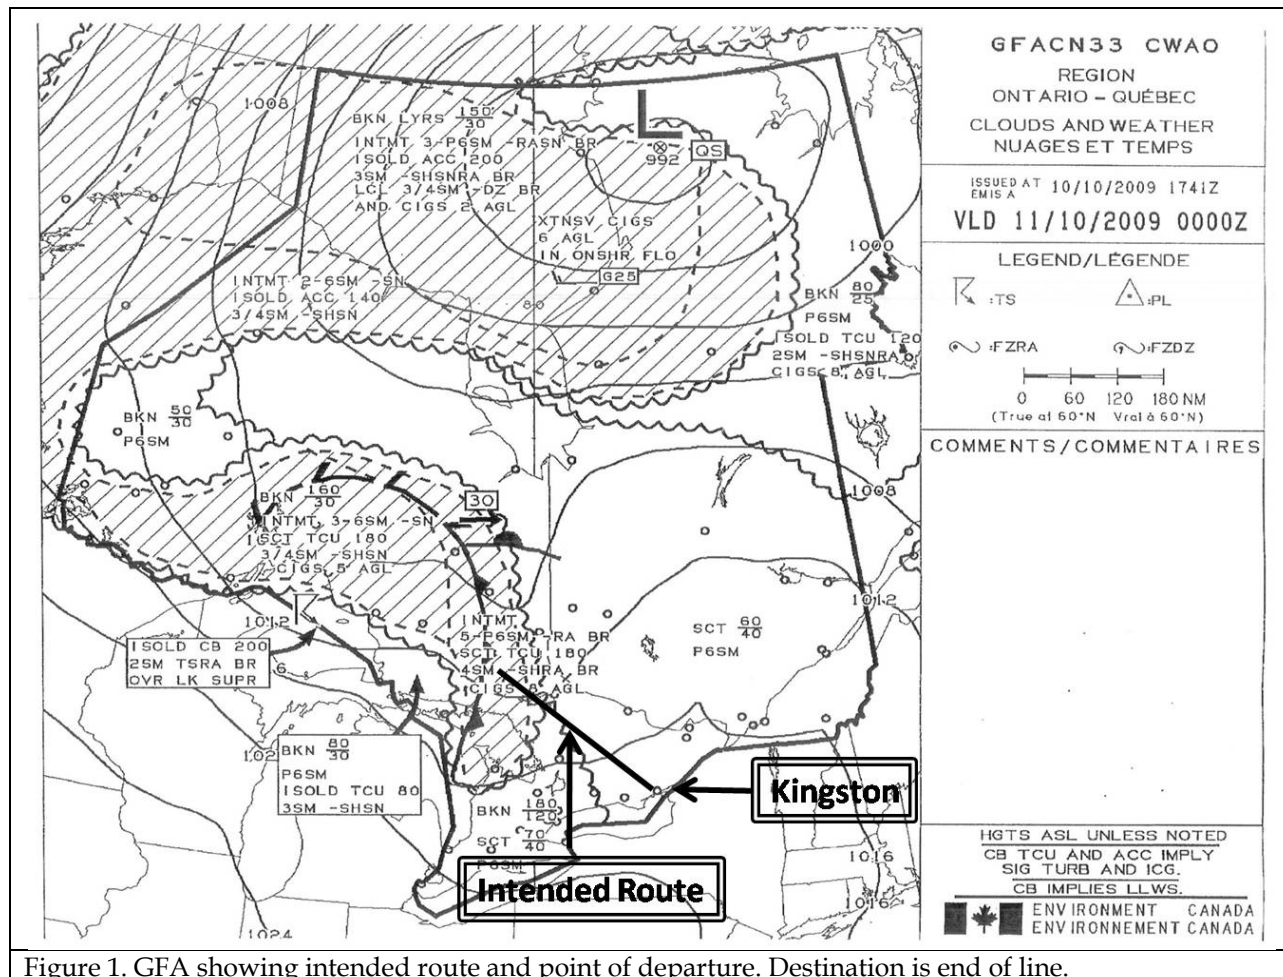
At 1655, the pilot phoned the London FIC to confirm if the forecast weather for Sudbury had improved. The London FIC provided information derived from the Graphical Area Forecast (GFA) for the Ontario/Québec region at 1341, which was valid for use from 2000 onward (see Figure 1).

Figure 1. GFA showing intended route and point of departure. Destination is end of line.

The pilot obtained a weather briefing by phone and, in all likelihood, did not have the GFA to refer to, thereby precluding any visualization of the weather. Otherwise, the pilot would have seen that the forecast weather associated with the front would be encountered en route, well before reaching the frontal surface and destination. The pilot likely assumed the weather to be strictly associated with frontal passage, hence the decision to leave as soon as possible to arrive in Sudbury before the front. Moreover, based on the briefing, the pilot focused almost exclusively on the destination forecast weather, to the exclusion of the weather forecast reported elsewhere along the flight route.

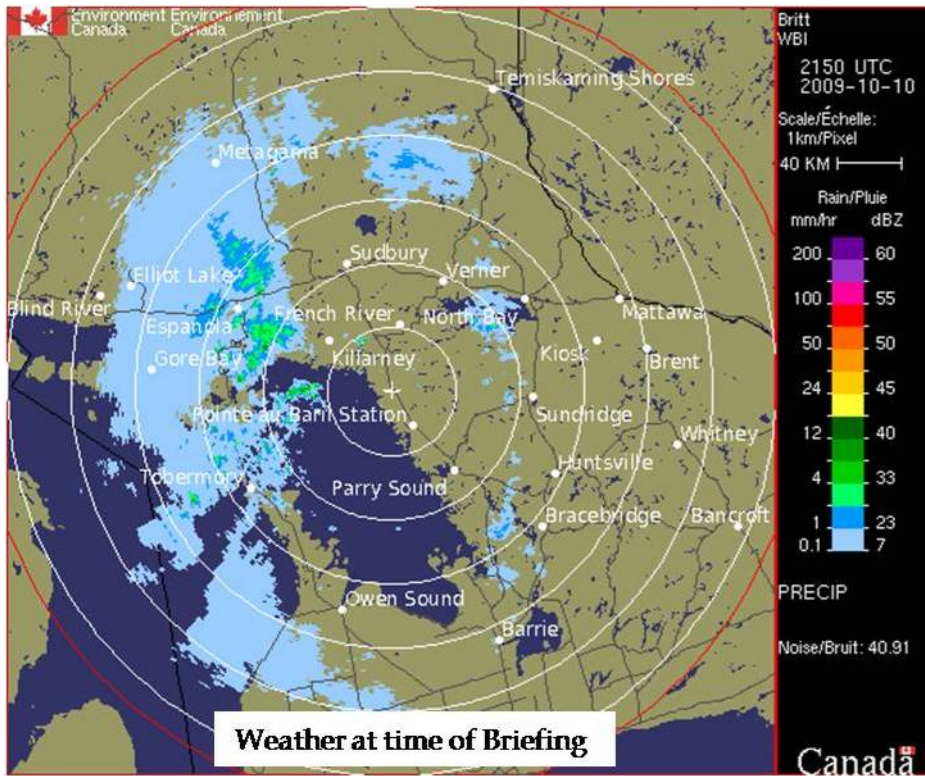
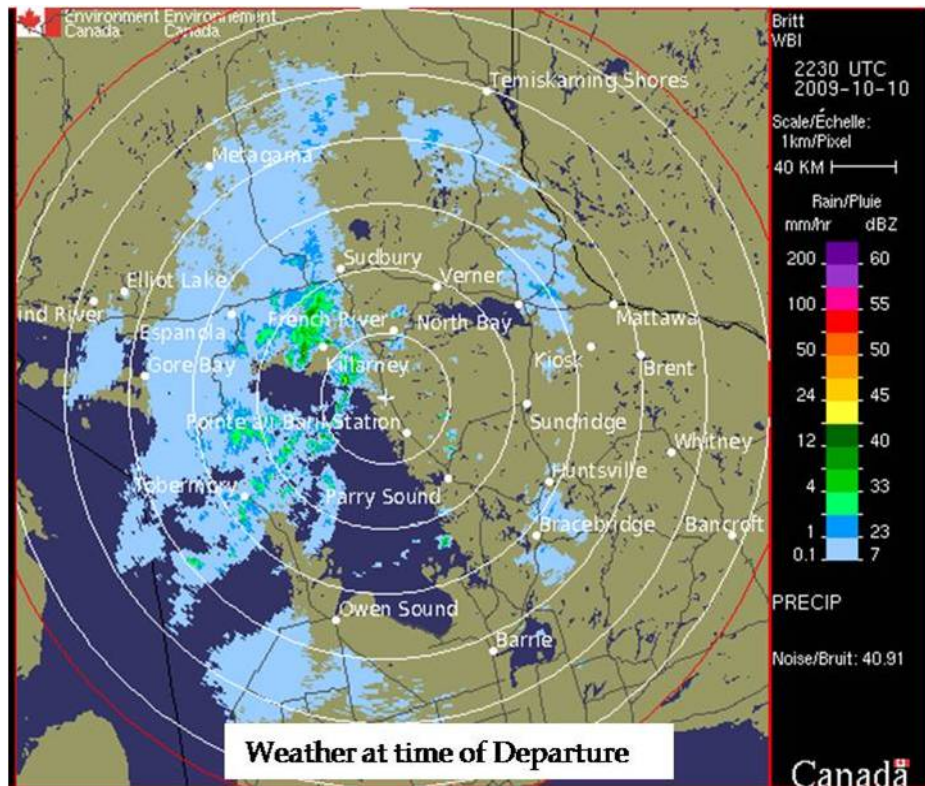
Appendix A - Weather Radar Before and at Departure

Originally shaped as a line from north to south, the weather system was moving from west to east. It covered an area from Southwest Ontario to north of Sudbury (see Appendix A.) The heaviest concentration of precipitation was at the front, where there were no weather reporting stations. A mixture of rain, snow and strong winds were also present. As it moved east, the front began to change shape and appeared to be more convex. This meant that, at the outer tips, the weather was not as severe and any available weather reports were not indicative of the actual weather likely encountered by the pilot (see Appendix B).
