AVIATION INVESTIGATION REPORT
A09Q0003

CONTROLLED FLIGHT INTO TREES

PIPER PA-28-140 C-FRZH
BUCKLAND, QUEBEC
06 JANUARY 2009

Report Number A09Q0003

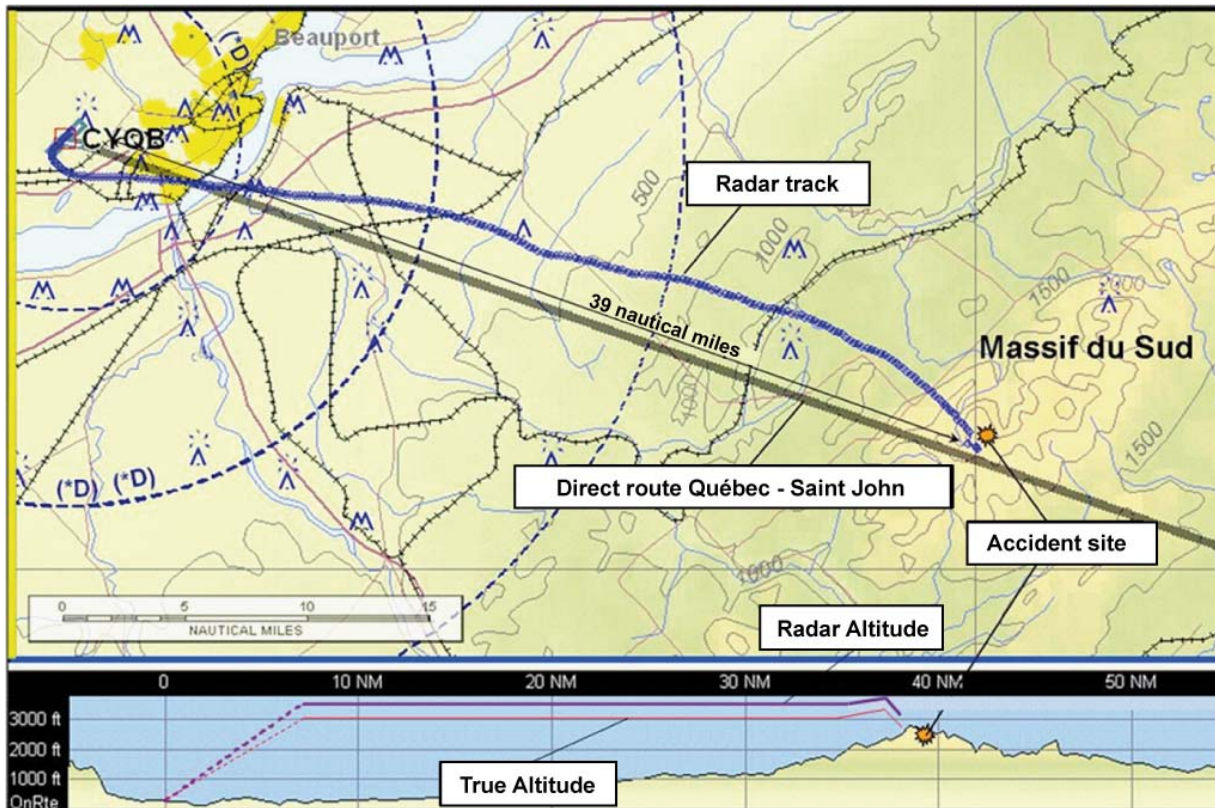
Figure 1. Aircraft trajectory.

Québec radar tracked the aircraft almost all the way to the crash site (see Figure 1). Shortly after takeoff, the aircraft deviated from the direct route. Upon leaving class D airspace, the aircraft turned onto an intercept heading of approximately 10° towards the direct route. Two minutes before the aircraft vanished from the radar screen, its ground speed decreased from 140 knots to 100 knots, then increased to 170 knots, and finally dropped to 50 knots. At the same time, the aircraft turned south and then entered a left turn to a final heading of 111°M. The aircraft's altitude went from 3800 feet asl to 3100 feet asl, then to 3400 feet asl. The aircraft disappeared from the radar screen at 0509:04.
