**AVIATION INVESTIGATION REPORT
A12C0005**

LOSS OF CONTROL AND COLLISION WITH TERRAIN

**KEYSTONE AIR SERVICE LIMITED
PIPER PA31-350 NAVAJO CHIEFTAIN, C-GOSU
NORTH SPIRIT LAKE, ONTARIO
10 JANUARY 2012**

Report Number A12C0005

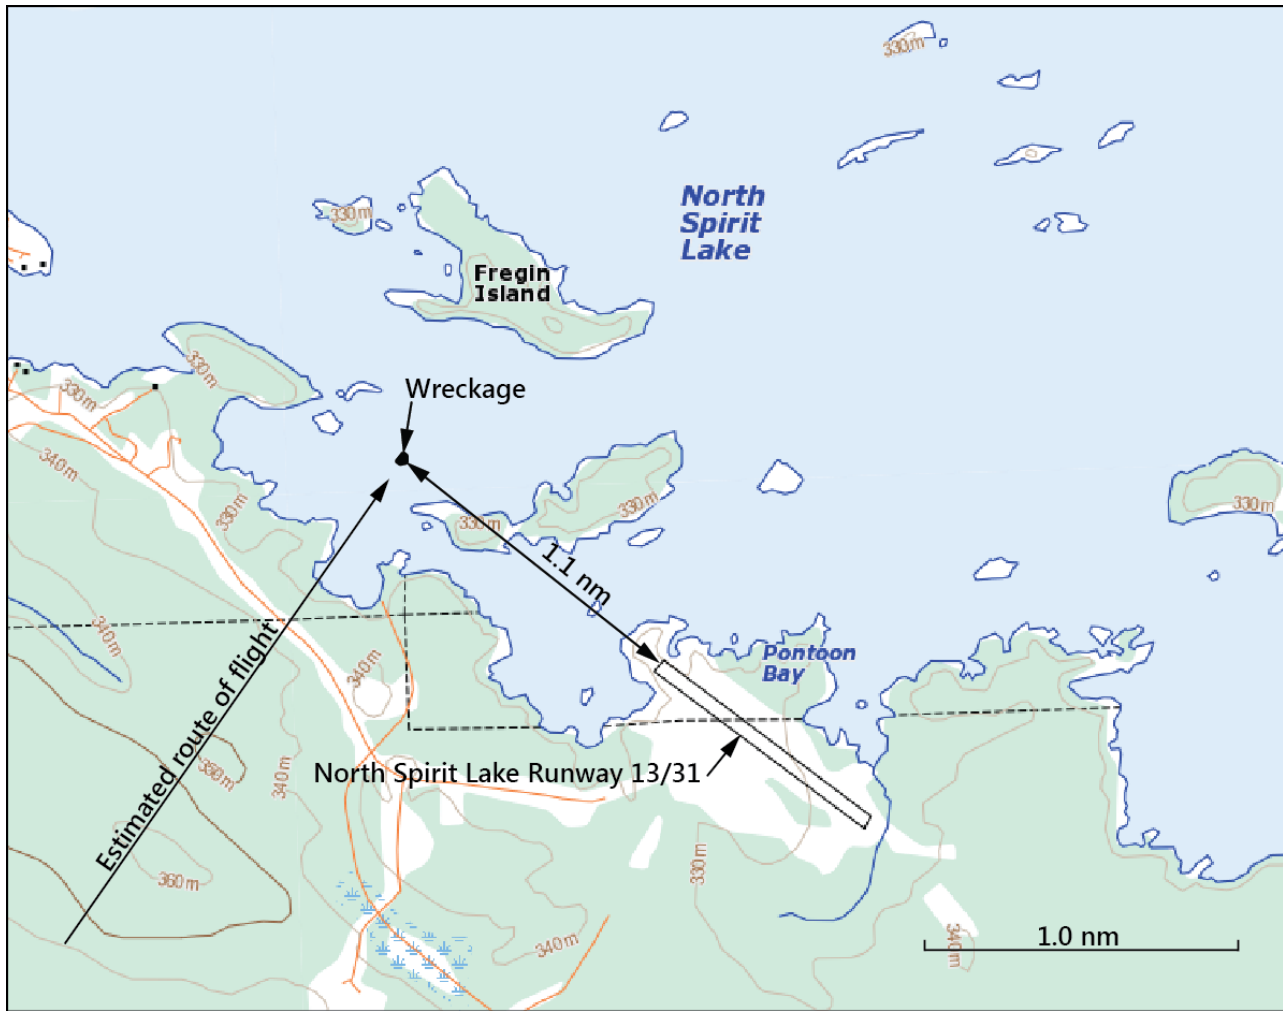
Figure 1. Wreckage location

Ice was accumulating on the aircraft's windshield during the delay. The pilot called again several minutes later to ask whether snow clearing was completed. The airport foreman advised the pilot that approximately 60% of the runway had been cleared and that the equipment was in the process of exiting the runway. The pilot commenced the approach. During the approach, the aircraft banked to the left and then steeply to the right, and then struck the ice at about 0957 (Figure 1).

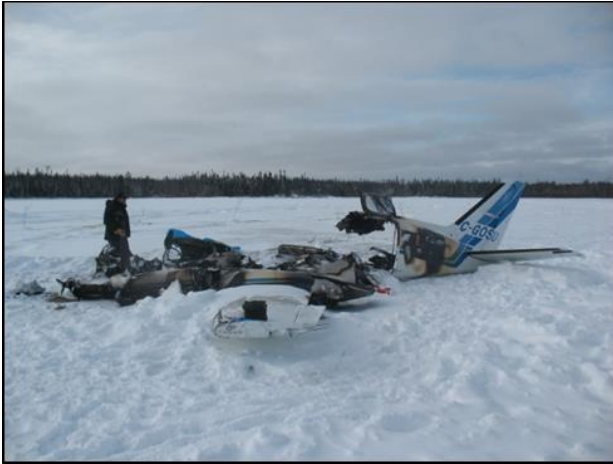
TSB investigators arrived on scene approximately 26 hours after the accident. The aircraft struck the frozen surface of the lake in a right-wing-low attitude at both a high rate of descent and forward speed. Contents of the aircraft, such as baggage and cargo, were found strewn halfway up the wreckage trail, indicating an early breakup of the cockpit and cabin area. The wreckage trail was generally aligned with the extended centreline of the runway. It was approximately 380 feet long, and the aircraft had come to a rest in an upright position, facing a southeasterly direction (**Erreur ! Source du renvoi introuvable.**). Damage to the propellers suggests that the engines were producing power at the time of the impact. A post-impact fire consumed a majority of the aircraft.

Photo 1. Wreckage on site

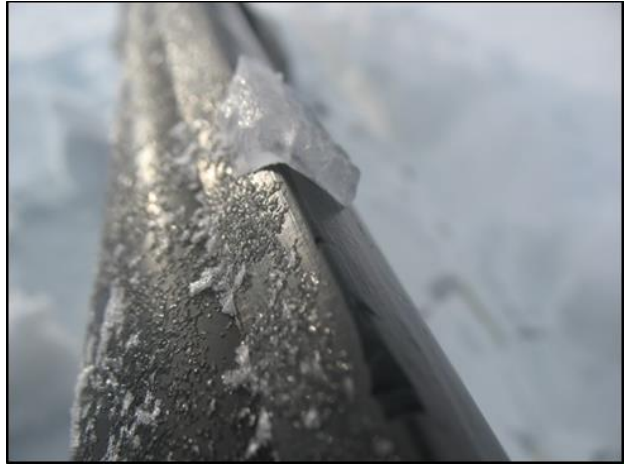
An approximate 4-foot section of the right-wing leading edge containing the stall warning vane was torn off and found approximately halfway down the wreckage trail. This section of leading edge was not affected by the fire, and exhibited some clear and mixed ice that was approximately 3/8 inch thick (**Erreur ! Source du renvoi introuvable.**). The stall warning vane was not heated, and exhibited hard packed ice inside the stall warning housing, trapping the vane in a downward position (**Erreur ! Source du renvoi introuvable.**). The left horizontal-stabilizer leading edge was also not affected by the fire, and exhibited ice accumulation (**Erreur ! Source du renvoi introuvable.**).

Photo 2. Leading edge ice

The remaining ice found on the 4-foot section of the right-wing leading edge and on the left horizontal-stabilizer leading edge indicates that a significant amount of ice accumulated on the aircraft's critical surfaces in flight. The investigation was not able to assess the serviceability of the de-ice system because of extensive impact and fire damage.

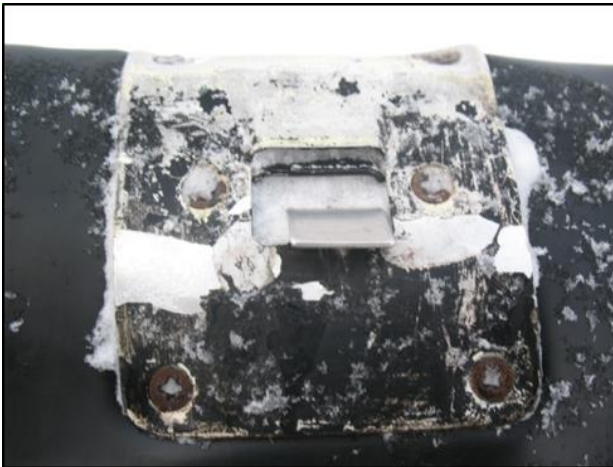
Photo 3. Stall warning vane

It is likely that once the runway was cleared, the pilot extended the landing gear and set approach flaps before turning onto final approach. With the stall warning vane trapped in a downward position, the stall warning system would have been inoperative and would have provided no warning to the pilot of a stall condition. The accumulation of ice and the change in aircraft configuration resulted in an increased stall speed and an increase in drag.

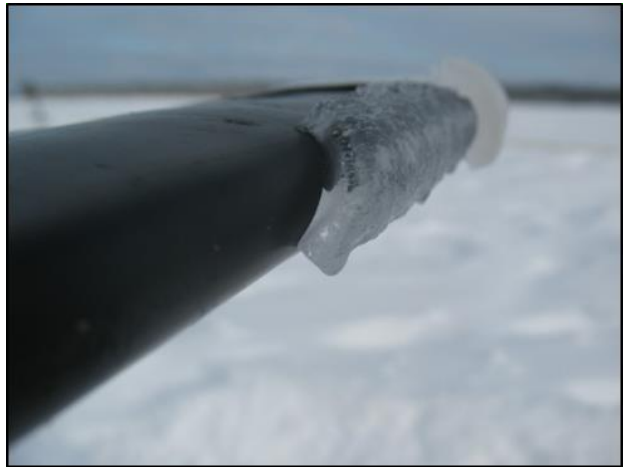
Photo 4. Ice on the horizontal stabilizer leading edge
